Inspection Report

Permit Number:	C0070011
Inspection Type:	PARTIAL
Inspection Report Date:	Mon Oct 24, 2022
Start Date/Time:	10/13/2022 13:00:00
End Date/Time:	10/13/2022 16:00:00
Last Inspection:	Tue Sep 6, 2022

Permittee: **HIAWATHA COAL CO INC**
 Operator: **HIAWATHA COAL CO INC**
 Site: **HIAWATHA MINE**
 Address: **PO BOX 1240 HUNTINGTON UT 84528**
 County: **07 CARBON**
 Permit Type: **PMT**
 Permit Status: **ACT**

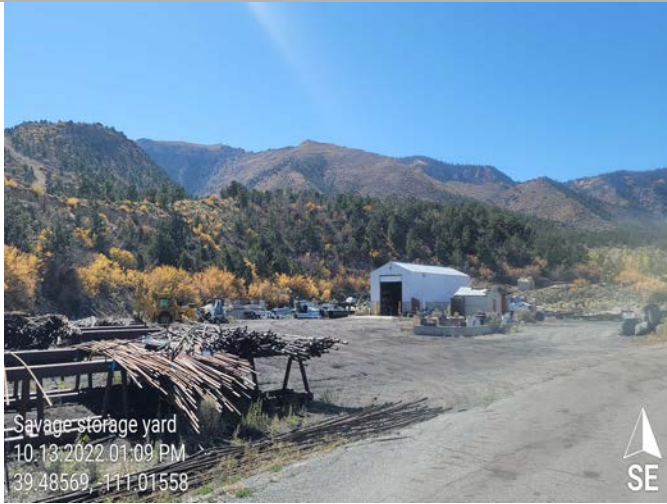
The four designated storage yards within the Hiawatha area shown on Exhibit V-9 were well organized and stored appropriate mining materials as designated within the MRP. The Permittee has been deploying further organization efforts within these storage areas to make the spaces even more functional. The Permittee has begun cleaning out the Parts Warehouse area located in the lower portion of the city, and organization efforts were taking place at time of inspection.

Photo 1
Savage storage yard

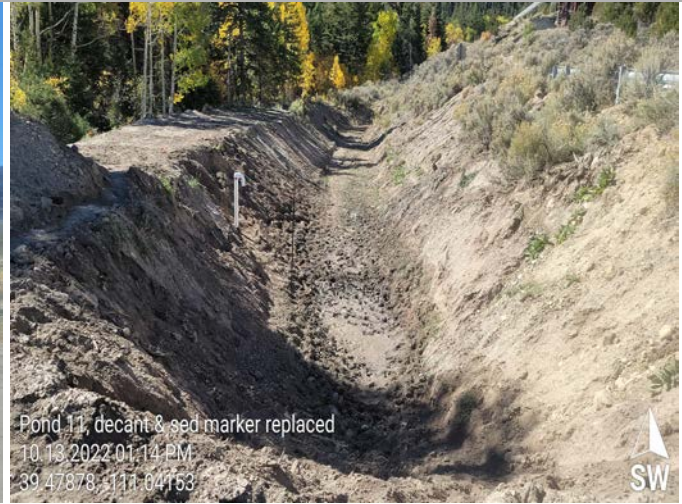
Inspection Report #8194 tasked the Permittee with cleaning all of the ponds that were severely impacted by last year's flood event. All of the ponds have been cleaned successfully with the exception of Pond 8, which is nearing completion. The decants and sediment markers have been repaired in ponds 3, 4, 6, 9, and 11. The emergency spillway in Pond 11 had not been reconstructed at time of inspection, however the area had been surveyed, flagged, and was expected to be excavated and rip-rapped within the following days.

Photo 2
Pond 11, decant and sediment marker replaced

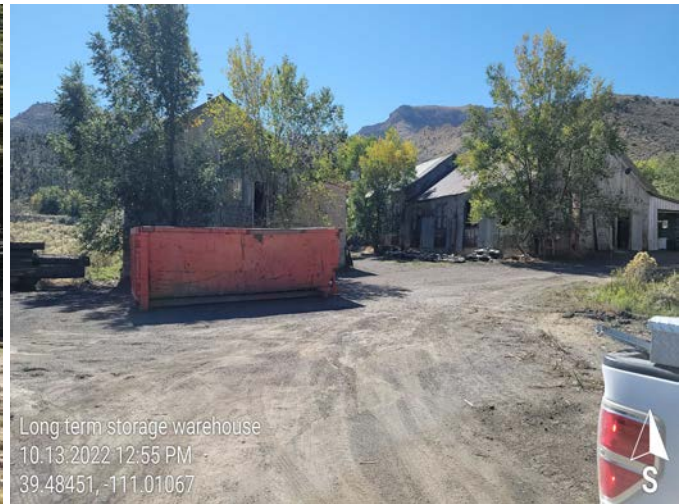
Photo 4
Long term storage warehouse

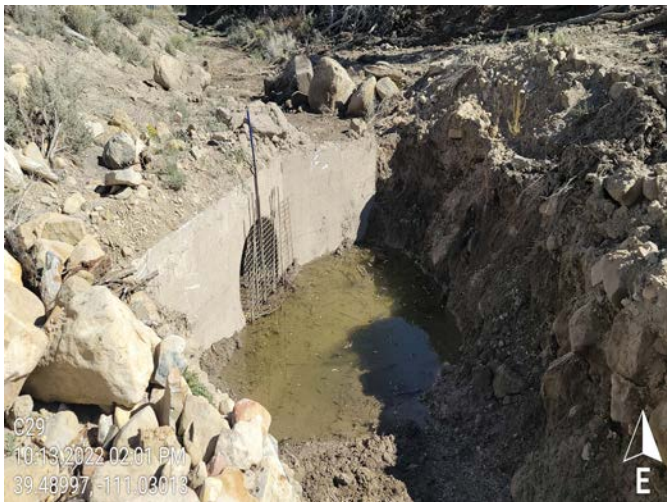
Photo 5
C29

C-29 is partially filled with sediment and needs cleaned out. The Permittee was informed that any maintenance work extending beyond culvert inlet, if needed, will require consultation with DWRi. DWRi will determine if a stream alteration permit is required.

Six culvert inlets were inspected: C-17, C-24, C-25, C-26, C-28, C-29, C-36. It was determined that the areas have been either heavily eroded by water or over excavated by the Permittee while removing debris that had been a product of the large storm events. These inlets need to be reconstructed as designed, or if not currently part of the MRP, added to the appropriate drawing files and tables as debris basins. These items are discussed as part of the DO. As debris basins, these areas are not to impound water below the culvert inlet; the culvert must properly function as intended.

ACTION ITEMS: Ensure diversions entering culverts are not over-excavated or impounding water below the culvert inlet. As part of the DO, incorporate the unnamed diversions and their designs, as well as the debris basins, into the MRP.

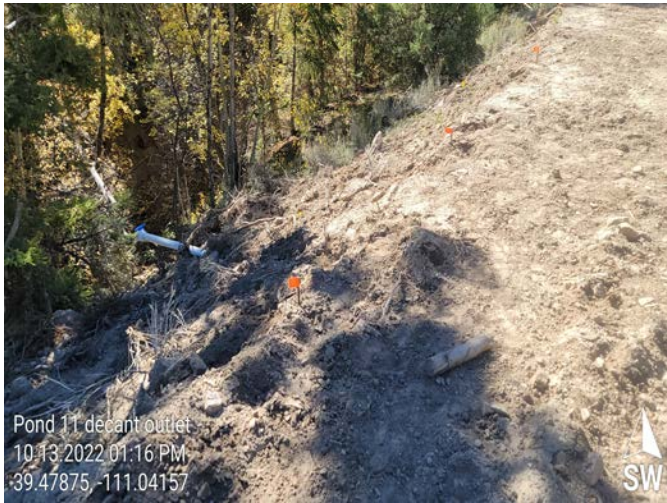
Photo 7
Pond 11 decant outlet

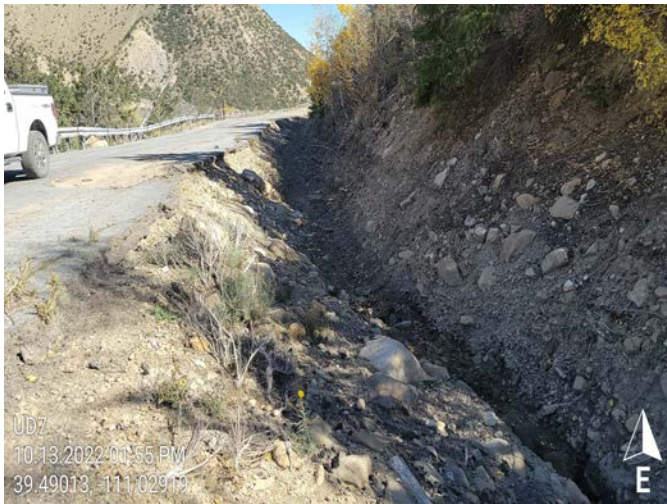
Photo 9
UD7

UD-7 extends outside of the permit area, enters an impoundment (currently holding water) constructed off the permit boundary, and then connects back to C-28. This impoundment is used by the landowner. The Permittee was instructed to put UD-7 back to its original design, bypassing the landowner pond, and entering C-28 as designed. There is also an over-excavated area at the inlet to C-28 that must be permitted as a catch basin or debris basin. This item is discussed in the DO.

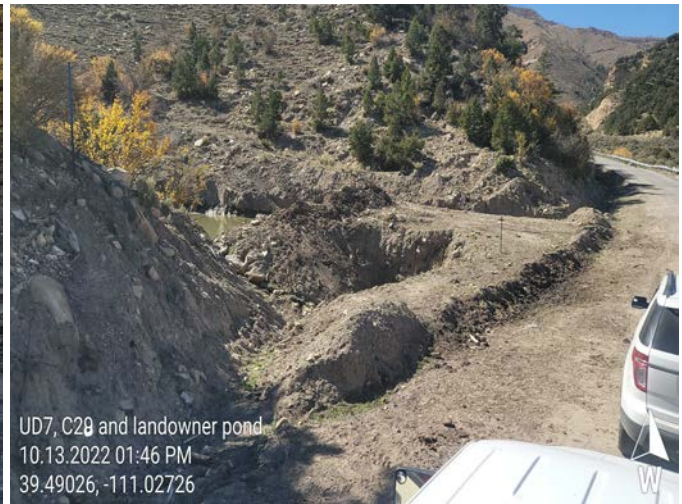
Photo 10
UD7, C28 and landowner pond

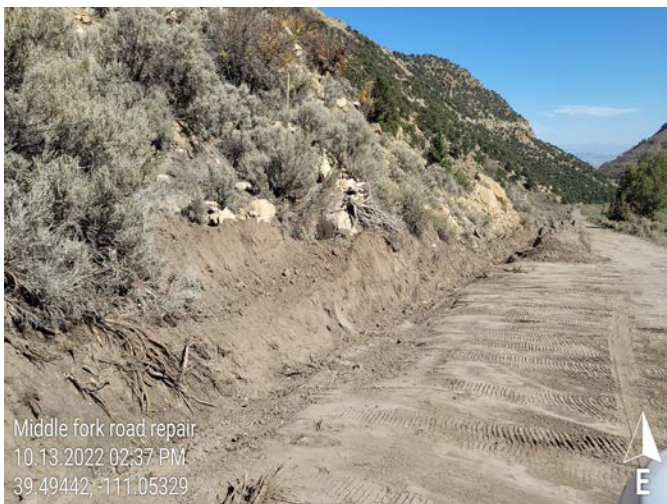
The Middle Fork access road has received significant damage due to the August 2021 flood event. The road surface has deteriorated, and UD-6 ditch that runs along the side of the Middle Fork road is severely eroded, causing numerous cuts several feet deep, as well as undercutting and sloughing of the asphalt surface.

Rock from flood debris has been separated out and is being used to fill the majority of the UD-6 to prep it for fill material from Pond 8. The Permittee has been requested to provide the Division with engineering plans for this ditch repair.

Photo 11
Middle fork road repair (2)

ACTION ITEMS: Restore the road surface and drainage control along the Middle Fork access road.

ACTION ITEMS: Provide the Division with engineering plans for the reconstruction of UD-6.

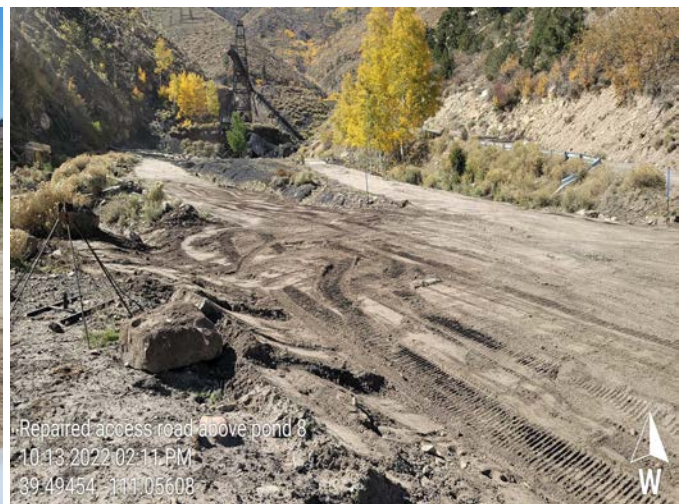
Photo 12
Repaired access road above pond 8

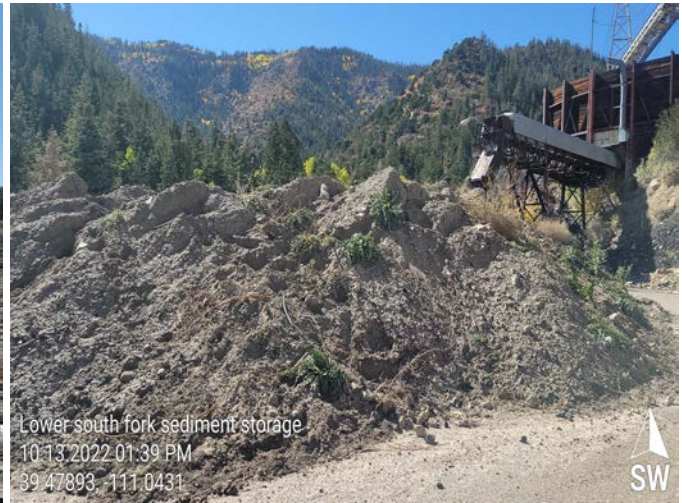
Photo 14
Lower South Fork sediment storage

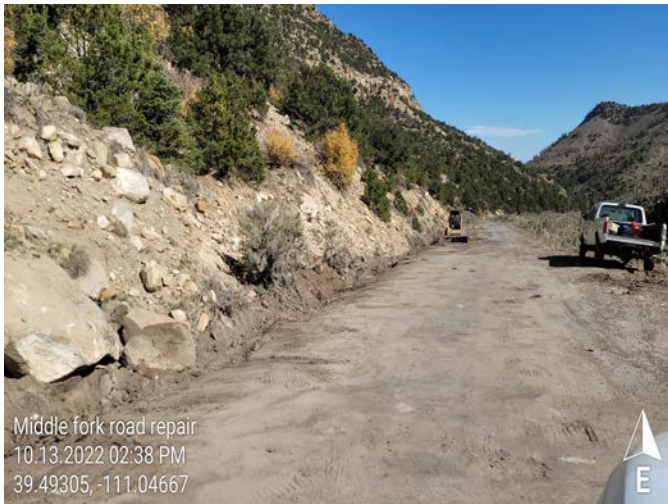
Photo 15
Middle fork road repair
