Inspection Report

Permit Number:	C0070013
Inspection Type:	PARTIAL
Inspection Report Date:	Mon Oct 24, 2022
Start Date/Time:	10/12/2022 14:30:00
End Date/Time:	10/12/2022 16:00:00
Last Inspection:	Thu Oct 6, 2022

Permittee: **EMERY COUNTY COAL RESOURCES, INC.**
 Operator: **EMERY COUNTY COAL RESOURCES, INC.**
 Site: **LILA CANYON MINE**
 Address: **PO BOX 910 EAST CARBON UT 84520-0910**
 County: **07 CARBON**
 Permit Type: **PMT**
 Permit Status: **ACT**

ATTACHMENTS - LILA CANYON MINE

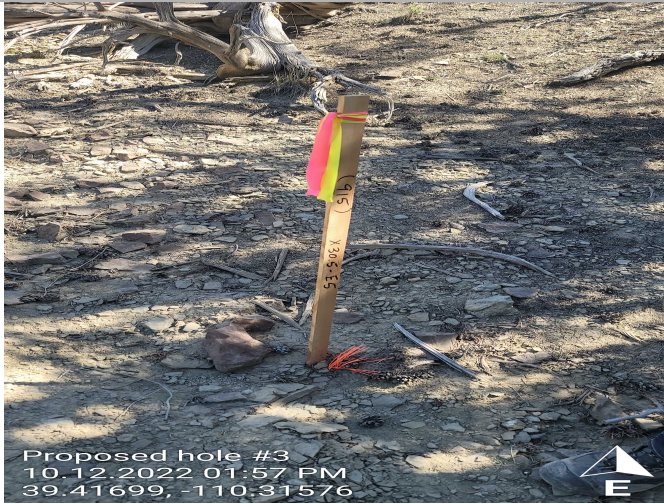
Photo 1
Proposed hole #3

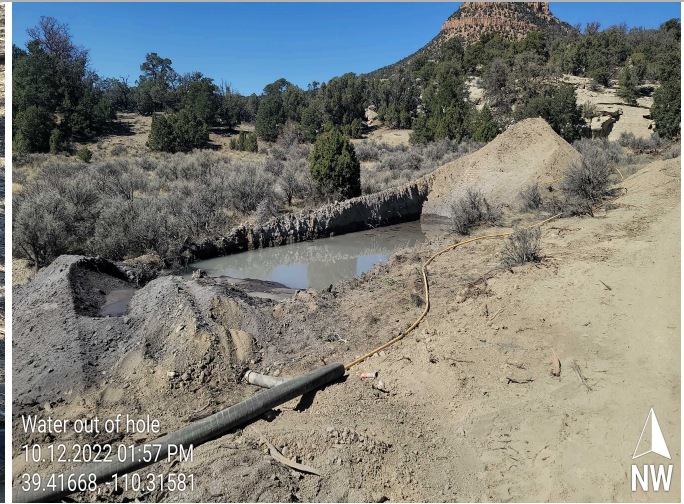
Temporary retaining ponds have been constructed on the drill pads to contain water used during the drilling process.

Photo 2
Temporary water retention pond used during drilling process

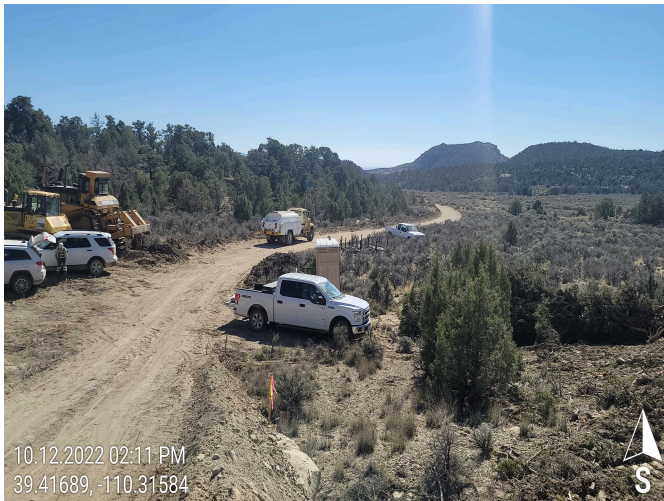
A section of new road, approximately 0.25 mile long was cut to access the project site. The road is approximately 12' wide.

Photo 3
Overview of newly cut road toward existing road

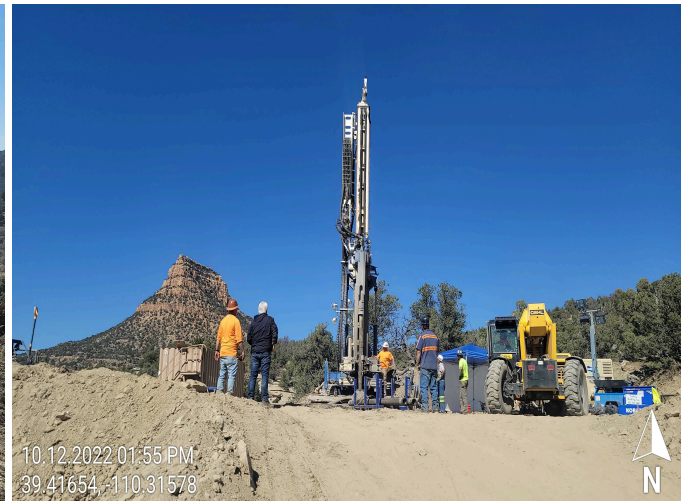
Photo 4
Project Site at Borehole #2

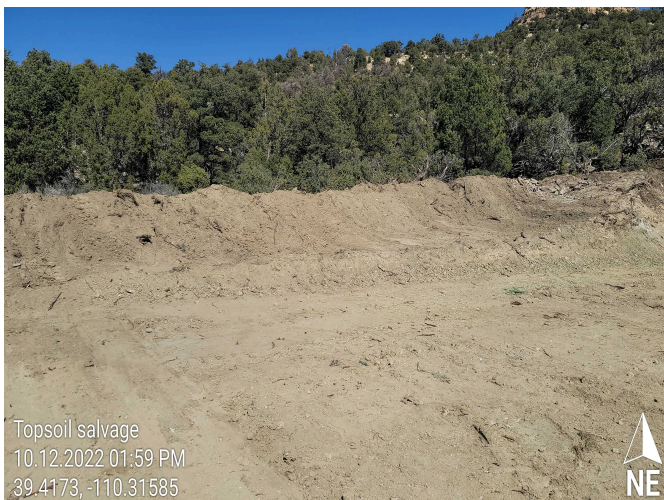
Topsoil has been salvaged from the newly disturbed road and pad areas and placed along the perimeter of the drill pads. This soil will be used during reclamation after the project is completed.

Photo 5
Topsoil salvage berm surrounding drill pads

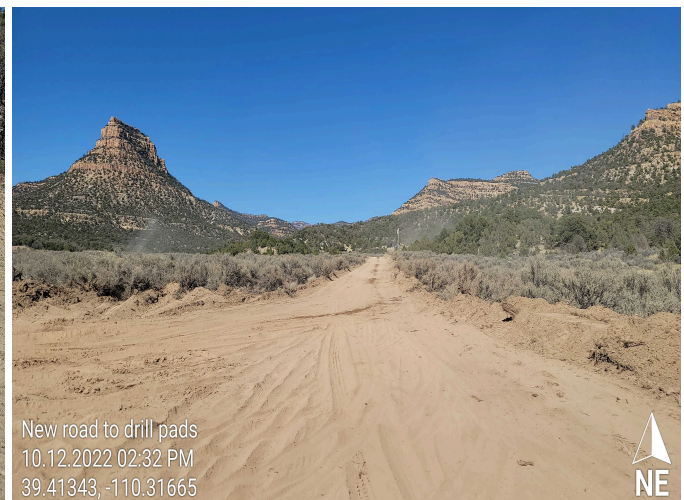
Photo 6
New road to drill pads from main road, approximately 0.25 mile in length

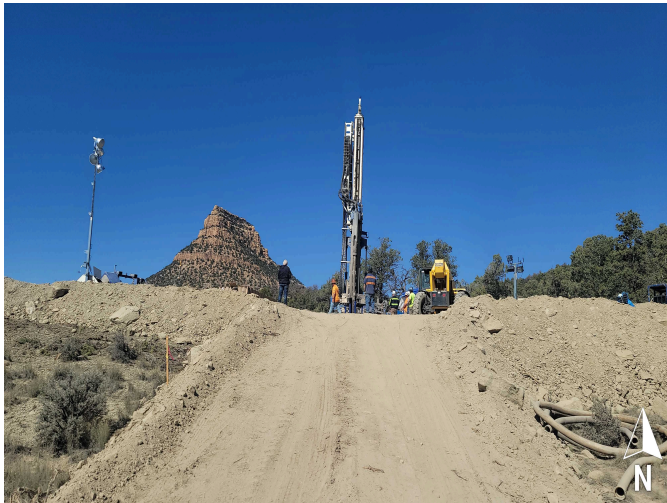
Photo 7
Drill Rigging

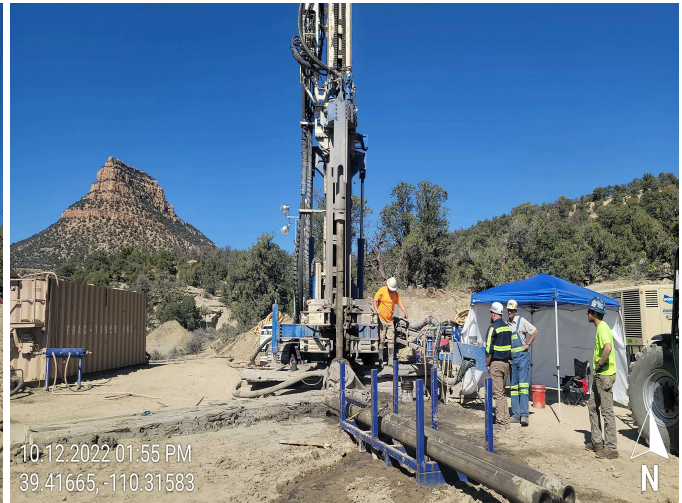
Photo 8
Drill Rig at Borehole #2

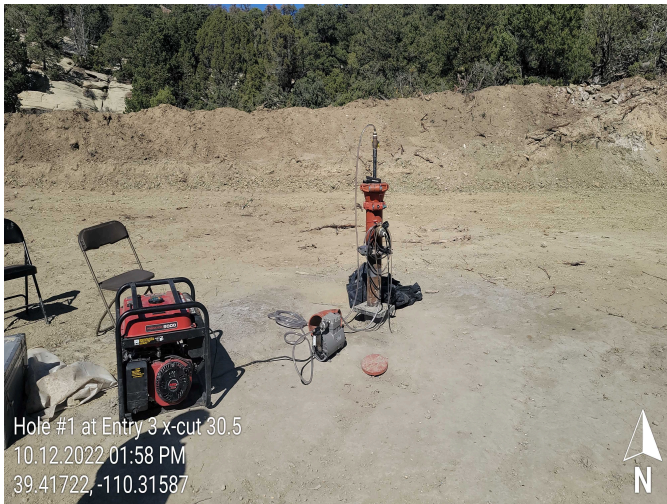
Photo 9
Hole #1 at Entry 3 x-cut 30.5

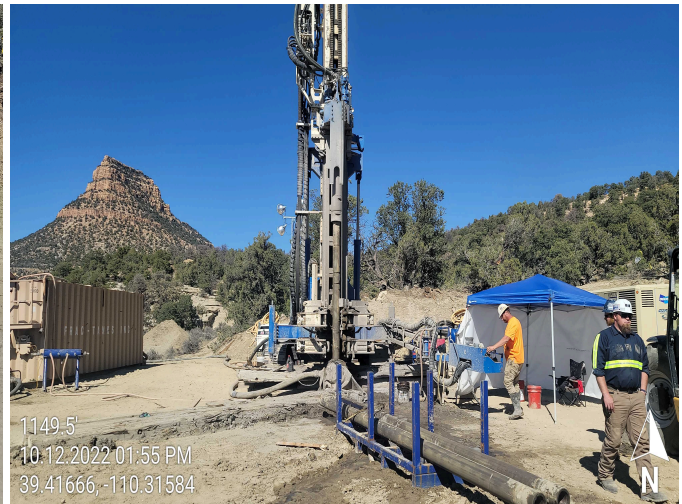
Photo 10
Borehole #2 had just broke through to the crosscut, 1149.5 feet
