### NOTICE OF INTENTION TO COMMENCE LARGE MINING OPERATIONS

### **Geotechnical study**

## GEOLOGIC HAZARDS INVESTIGATION

Subject: Geologic Hazards Investigation  
Santaquin Heights  
Approximately 650 North State Road 198  
Santaquin, Utah  
CMT Project Number: 12330

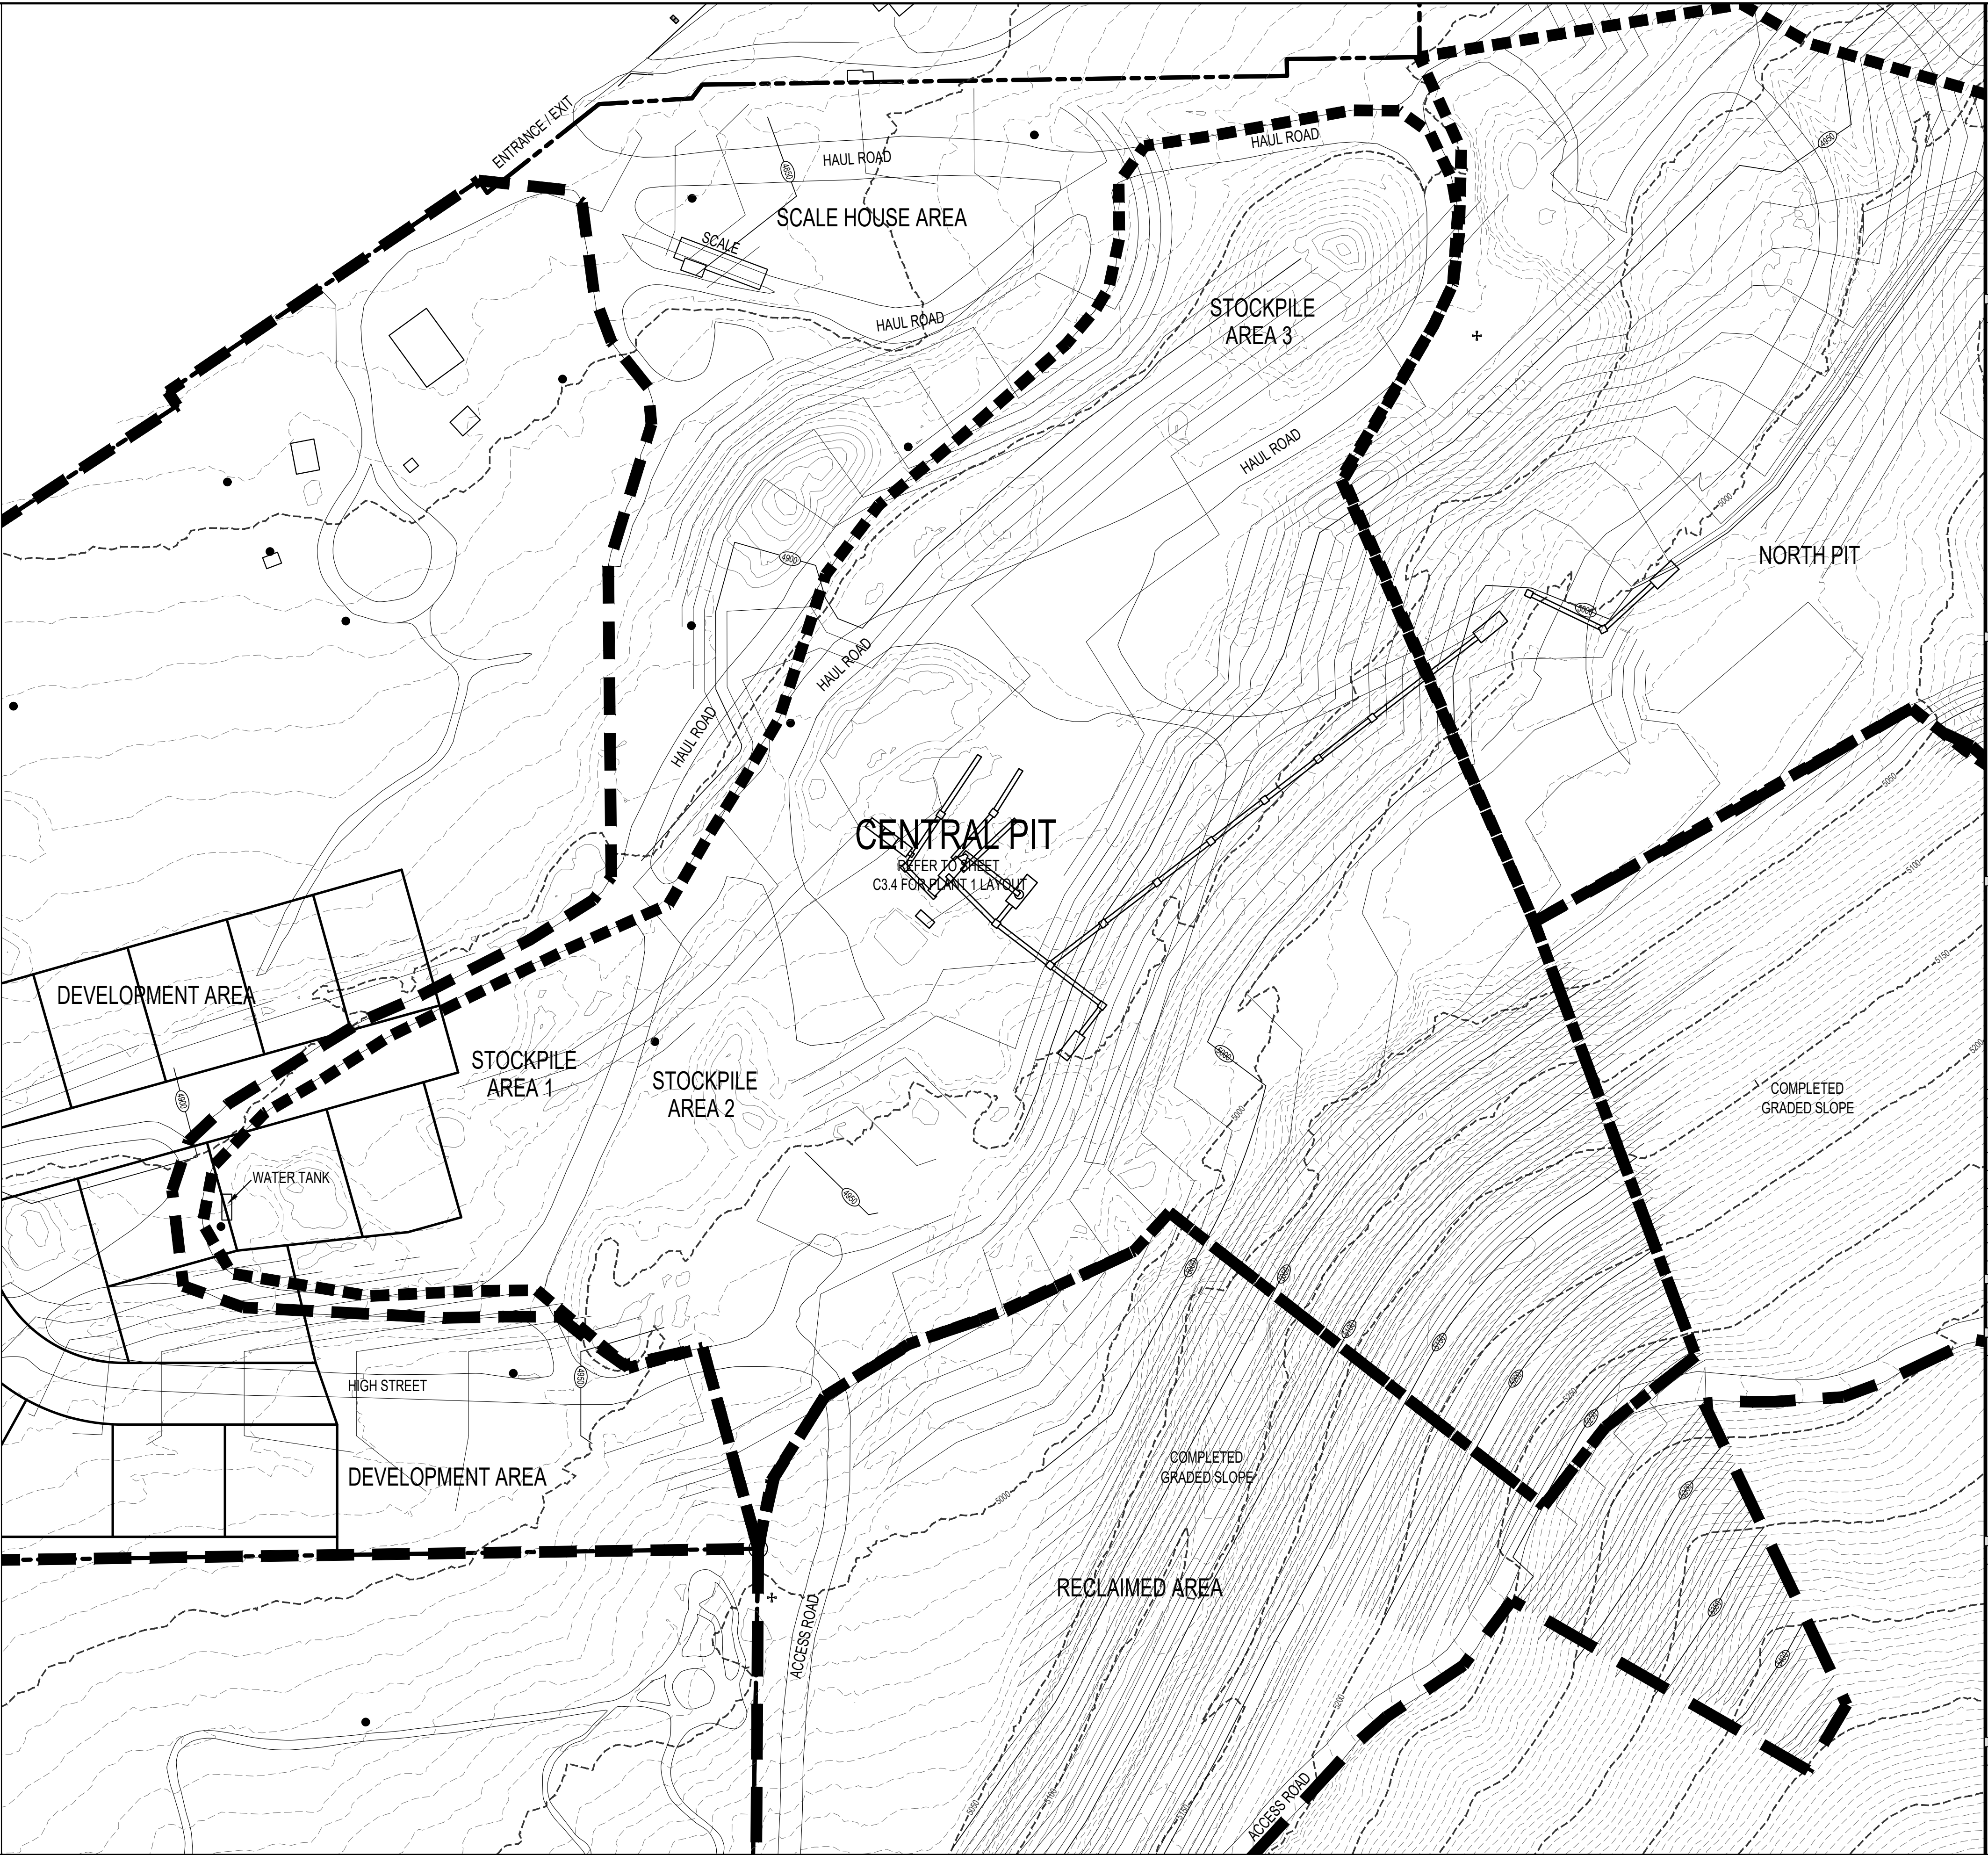
CENTRAL PIT AREA = 17.62 AC  
STOCKPILE AREA 1 = 0.60 AC  
STOCKPILE AREA 2 = 0.77 AC  
STOCKPILE AREA 3 = 1.76 AC

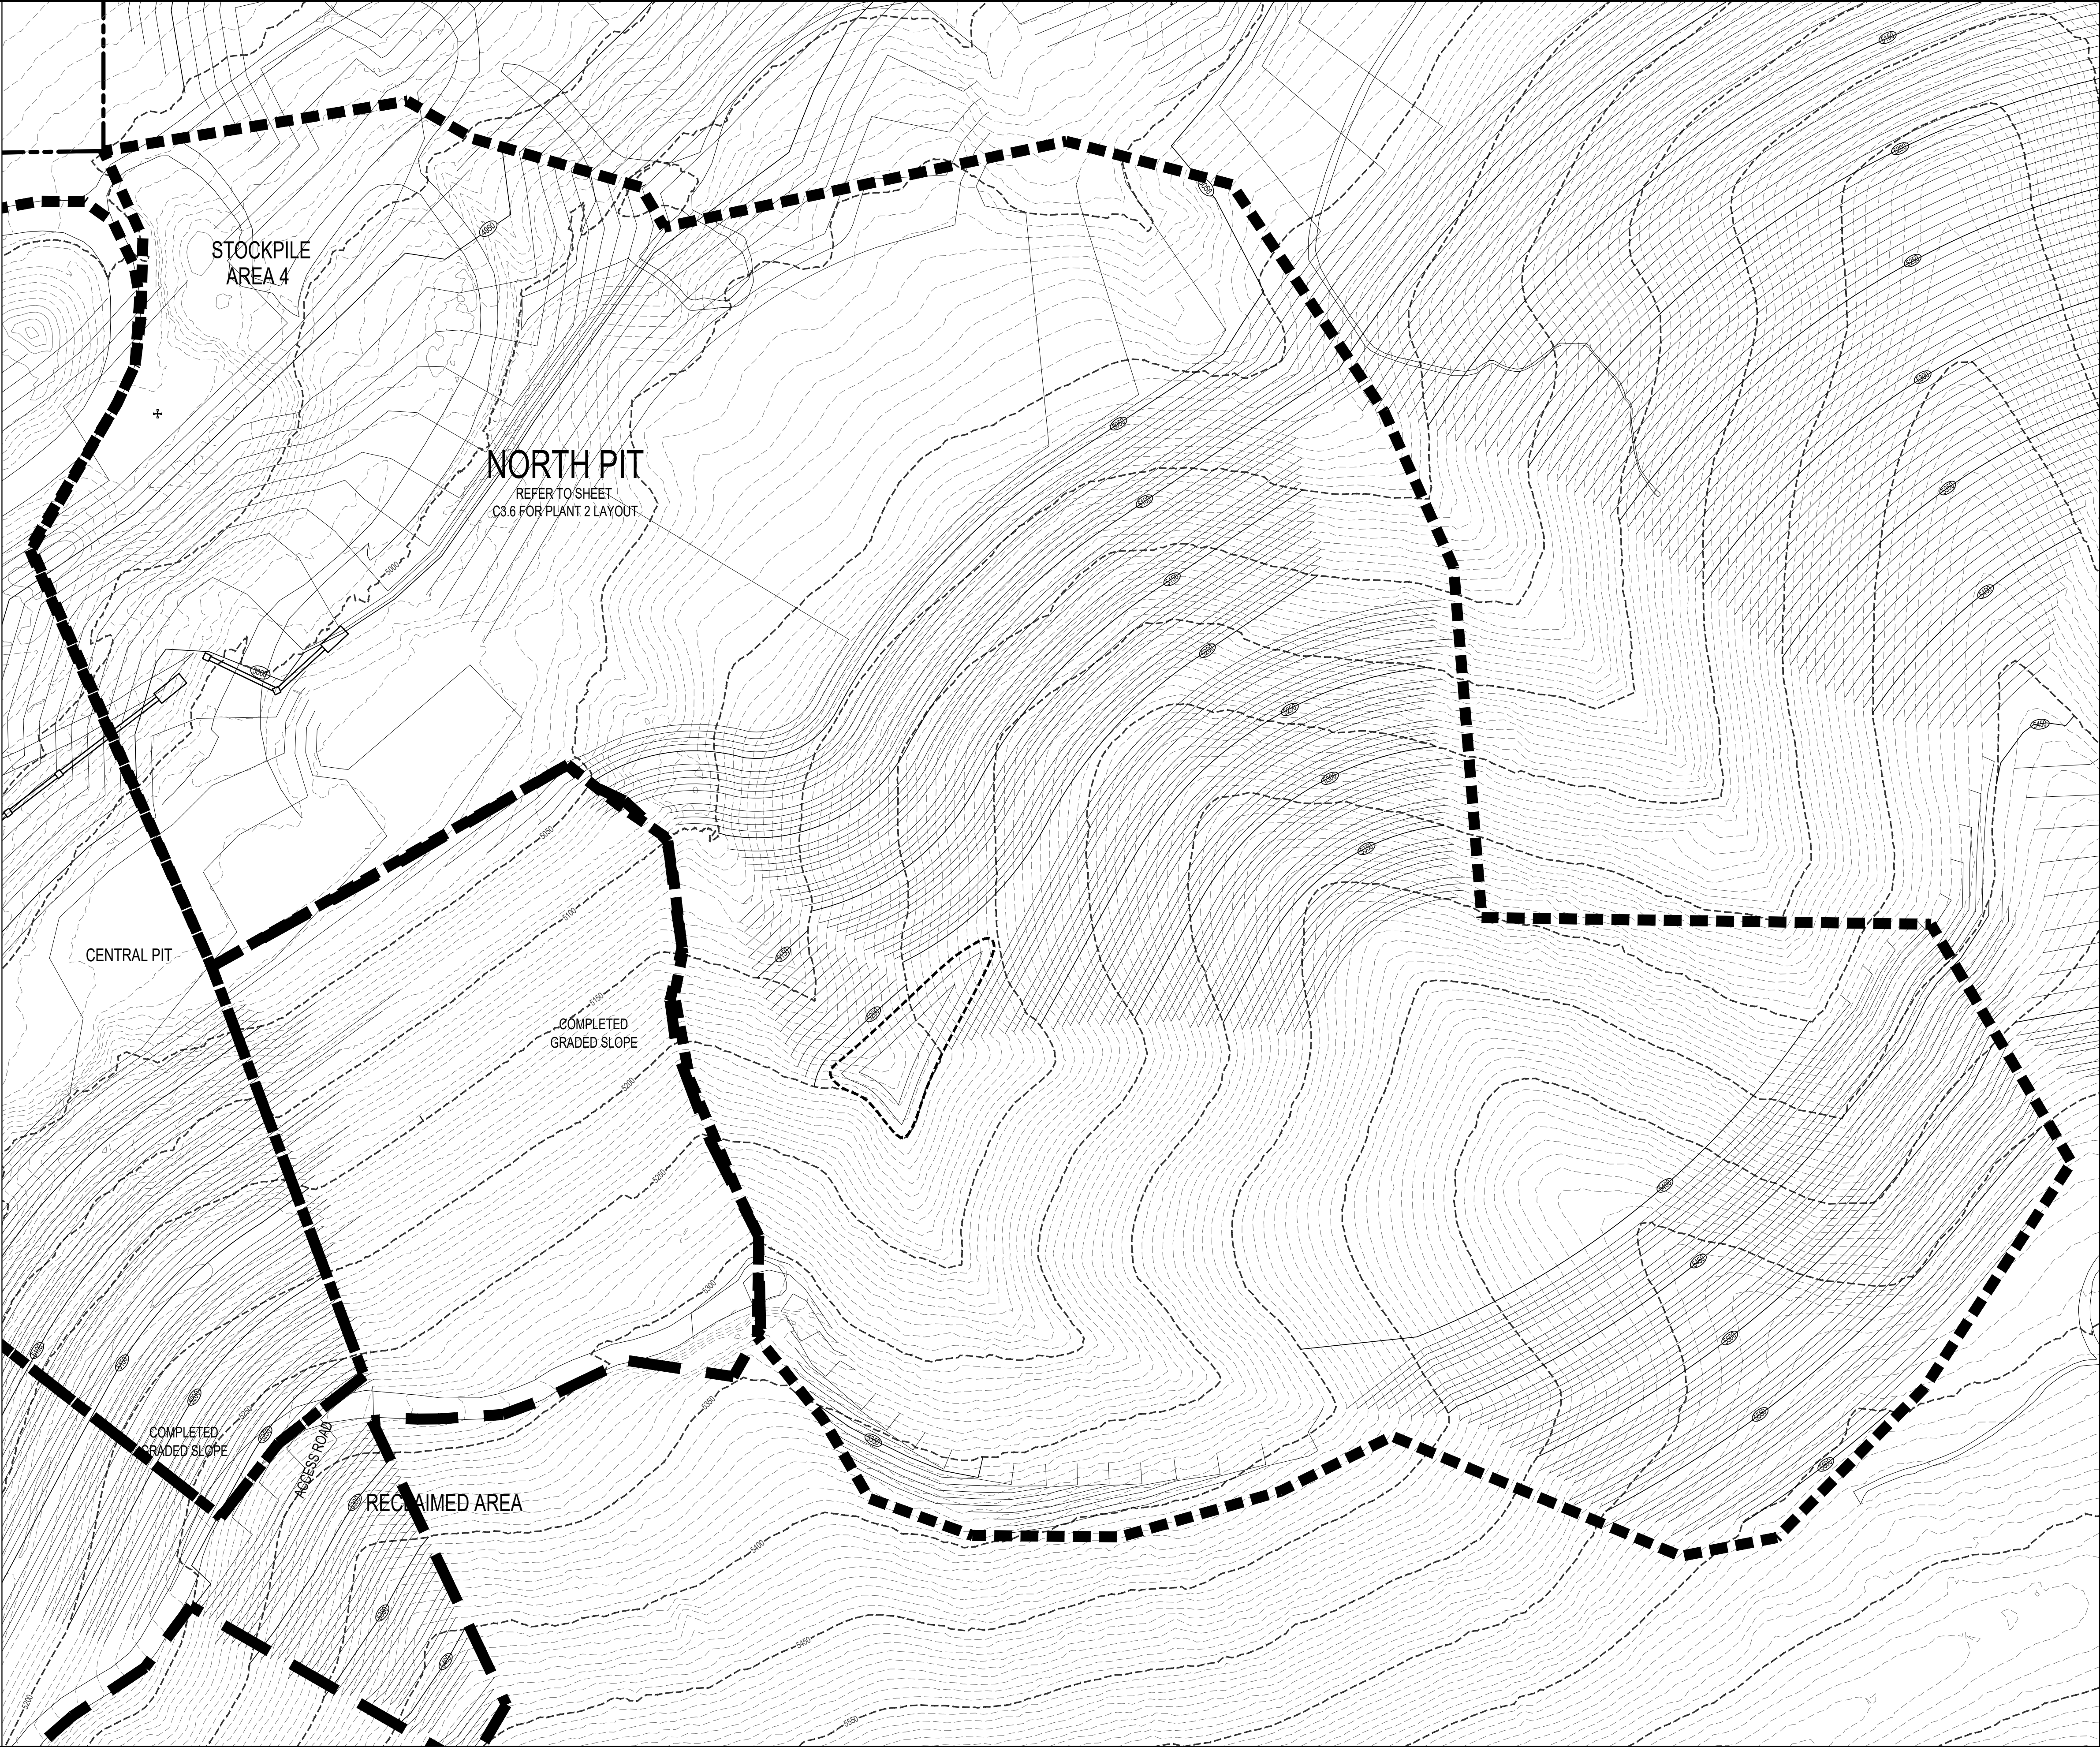
NORTH PIT AREA = 34.32 AC  
STOCKPILE AREA 4 = 1.56 AC

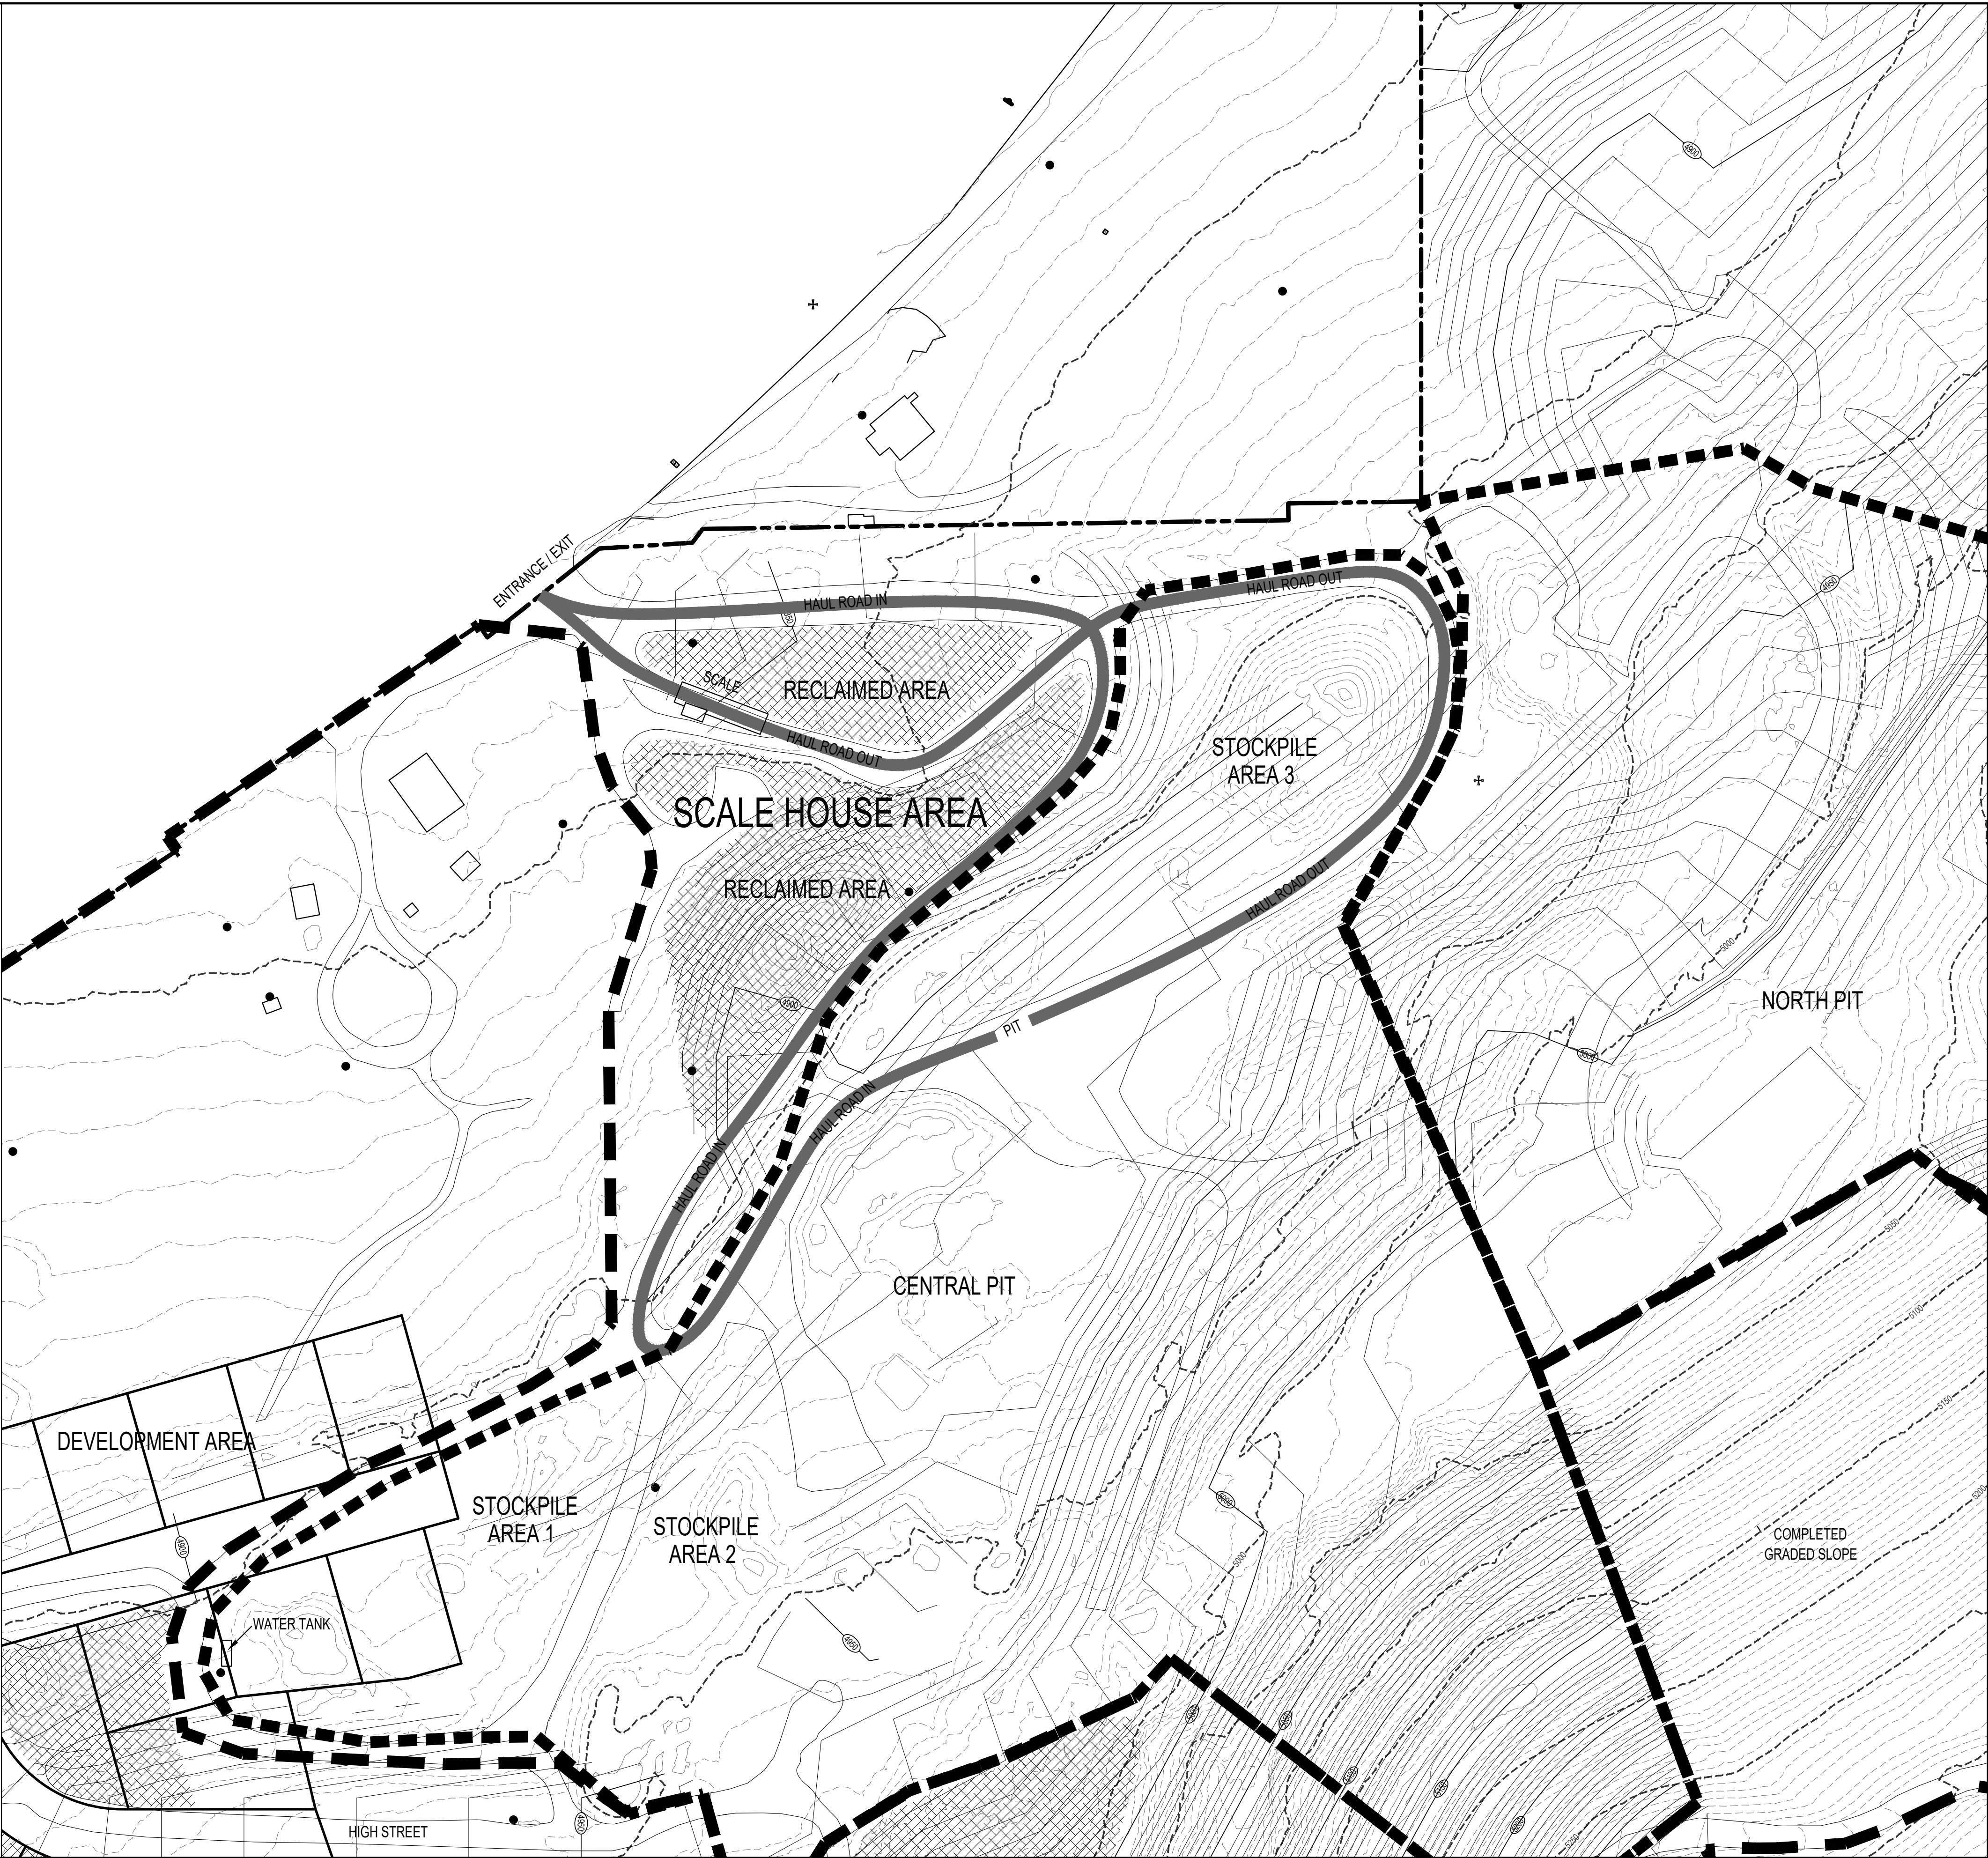
SCALE HOUSE AREA = 3.45 AC  
HAUL ROAD IN = 1730 LF  
HAUL ROAD OUT = 1460 LF

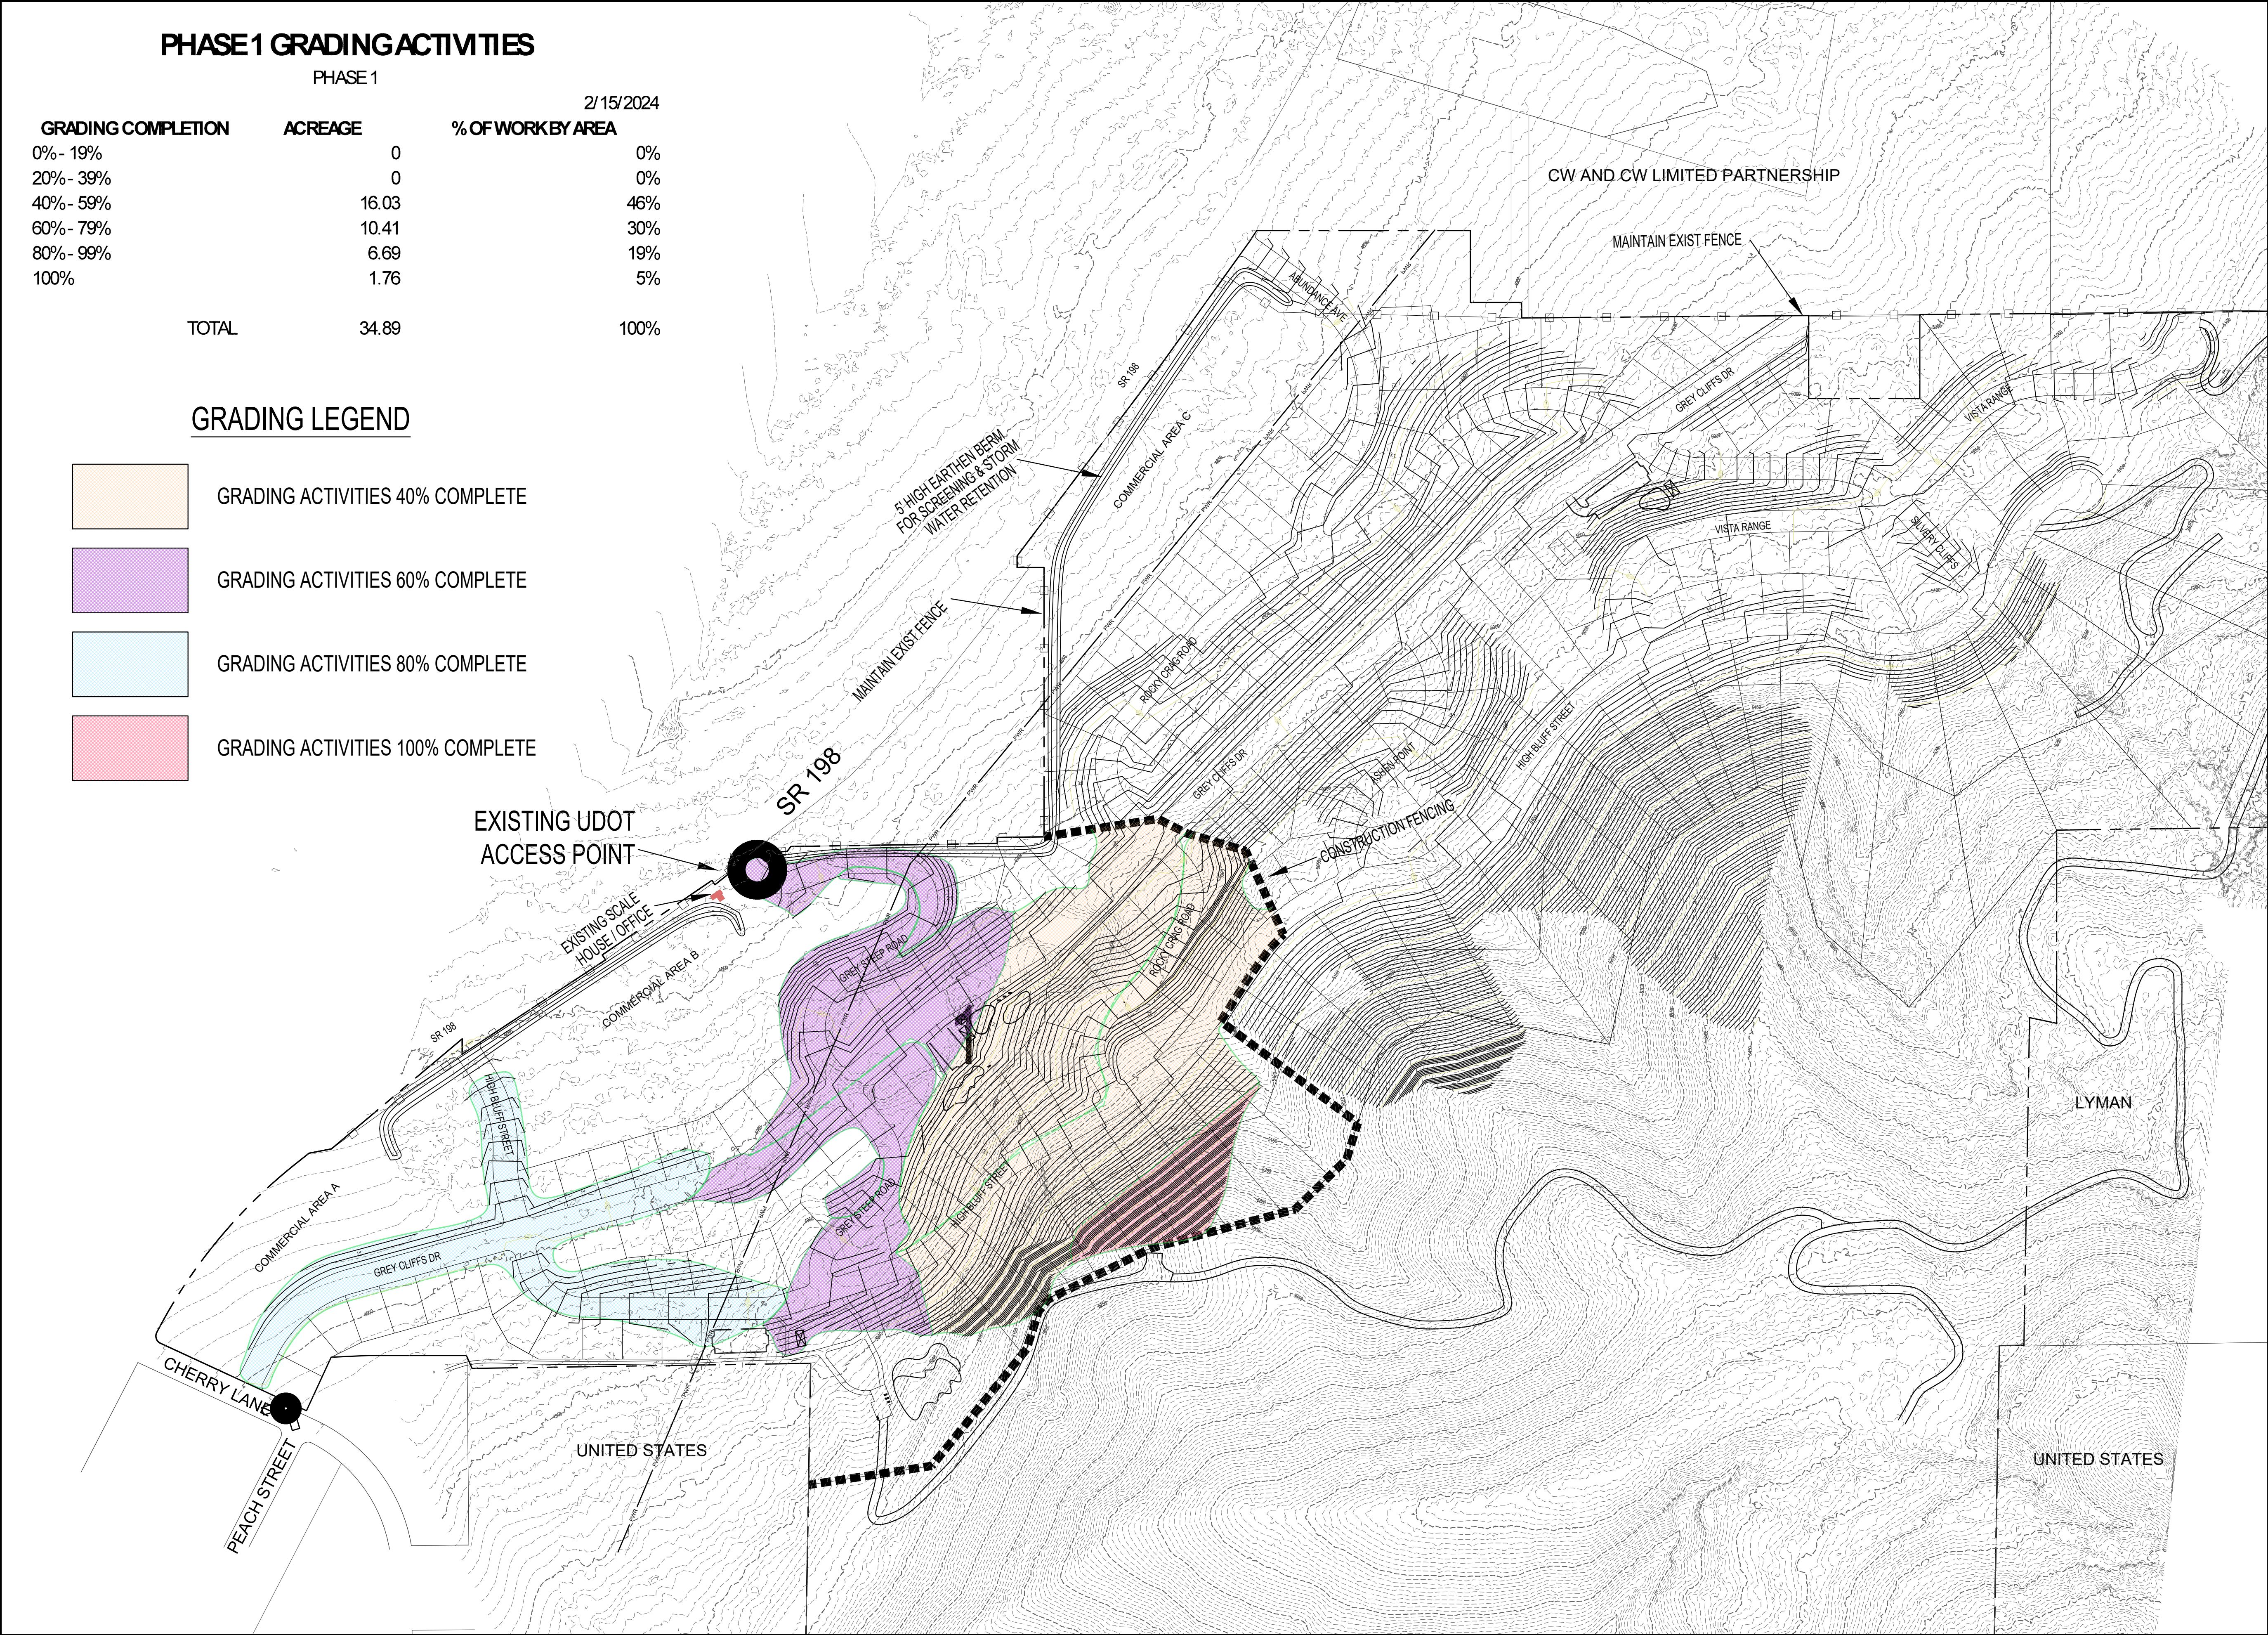
- GRADING ACTIVITIES 40% COMPLETE
- GRADING ACTIVITIES 60% COMPLETE
- GRADING ACTIVITIES 80% COMPLETE
- GRADING ACTIVITIES 100% COMPLETE

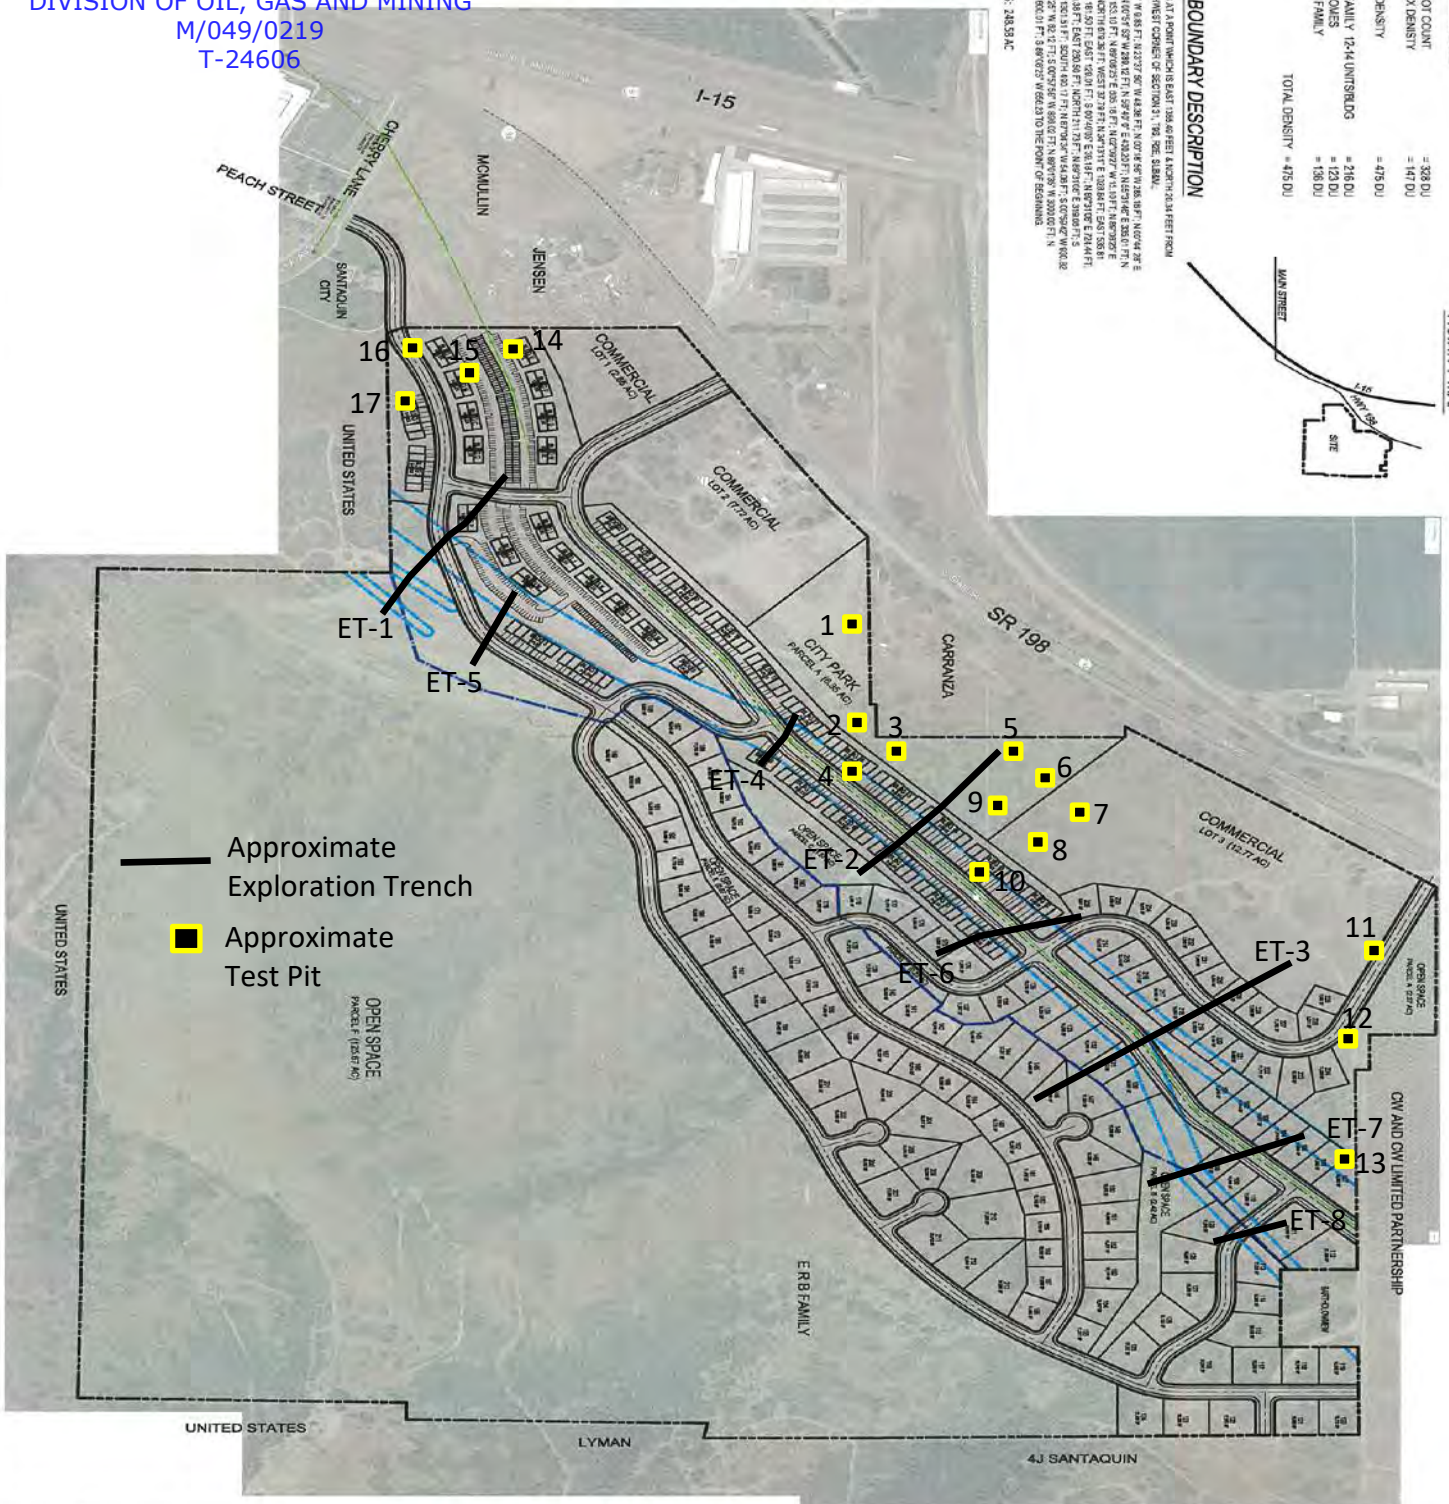
— Approximate  
Exploration Trench

■ Approximate  
Test Pit

The northern strand of the active Nephi Segment of the Wasatch Fault Zone (WFZ) has been mapped crossing the subject site through areas where future development is proposed (see Section 4.0). For residential development the UGS typically defines a surface fault rupture special study area to be all areas within 500 feet of a mapped, Holocene fault on the down-thrown side of the fault and all areas within 250 feet on the up-thrown side of the fault. To observe the subsurface deposits within these areas at the site in relation to previously mapped Holocene faulting for evidence of surface fault rupture and/or related ground deformation, eight (8) exploration trenches were excavated at the site between February and May 2019. Weather conditions and excavation equipment availability largely controlled the timing of the field exploration work. The trenches were designated as ET-1 through ET-8. The locations of the trenches, as surveyed by the client, are shown on **Figure 2, Locations of Explorations**, at the end of this report.

Seventeen (17) test pits were also excavated on portions of the subject site to aid in our analysis of potential debris flow and alluvial flood hazards at the site. The approximate locations of the test pits are also shown on **Figure 2**. The findings of the test pits with regards to potential debris flow hazards at the site are discussed in Section 4.7.

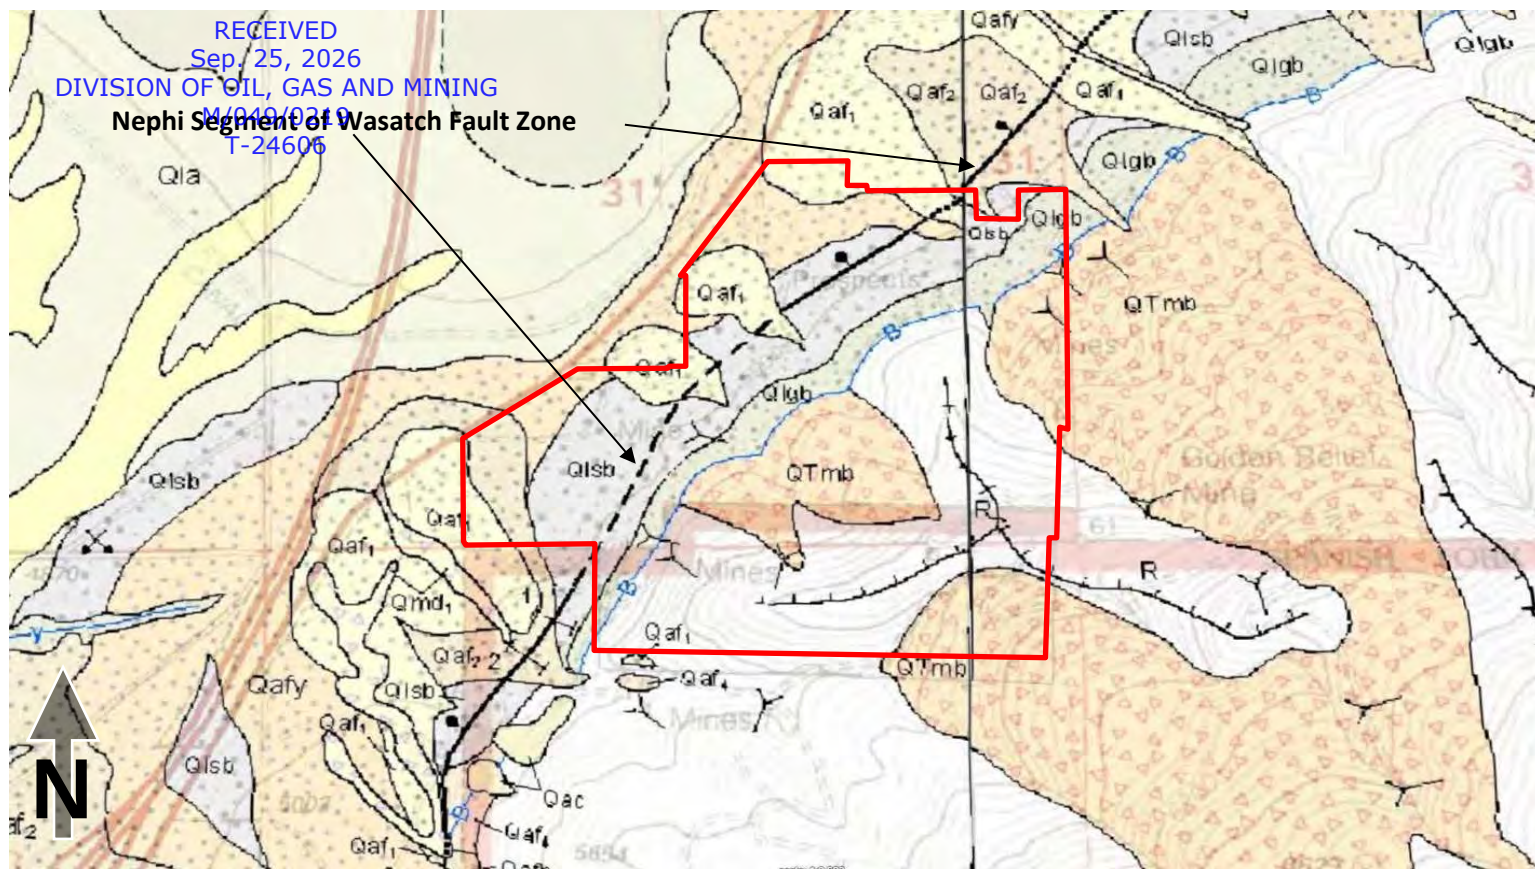
Map from: Solomon, 2010, 2010

#### **Geologic Units Mapped at Site (Section 4.4)**

As discussed in **Sections 4.3 and 4.4** and shown on **Figure 3**, the northern stand of the Nephi Segment of the WFZ crosses the portions of the subject site where development is planned in a southwest to northeast direction. The fault was encountered in the exploration trenches at the site at multiple locations. The fault strand was manifest within the subsurface generally as a zone of faulting several feet to several tens of feet wide with one or more primary faults and, in areas, several adjacent subsidiary faults within the zone. Some of the subsidiary faults were observed to be antithetic to the primary fault traces. The overall sense of displacement across the fault zone was observed to be in a normal fashion and down to the northwest, as mapped by Solomon (2010, 2010). On the northeast portion of the subject site, the fault strand appears to branch into two distinct traces which extend off-site to the northeast.
