### NOTICE OF INTENTION TO COMMENCE LARGE MINING OPERATIONS

### **Geotechnical study**

## GEOLOGIC HAZARDS INVESTIGATION

Subject: Geologic Hazards Investigation  
Santaquin Heights  
Approximately 650 North State Road 198  
Santaquin, Utah  
CMT Project Number: 12330

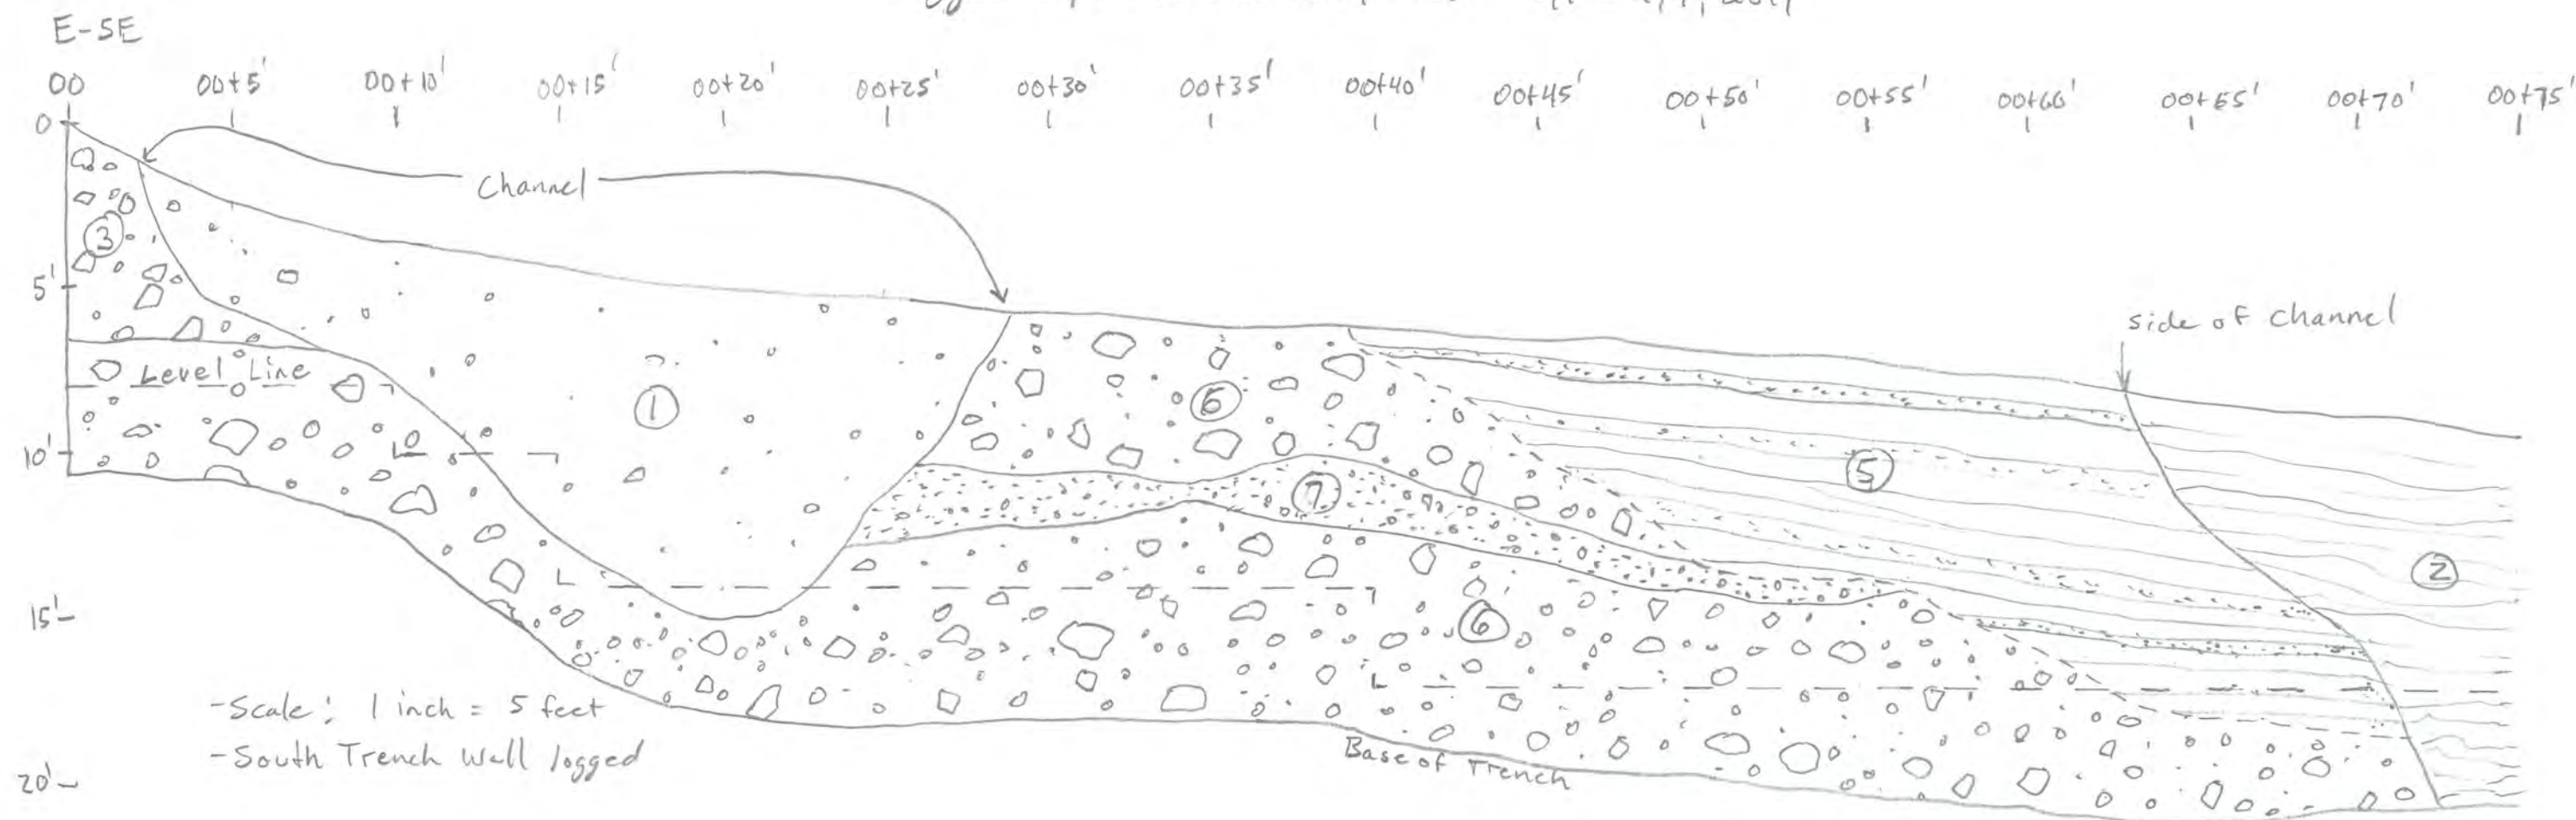
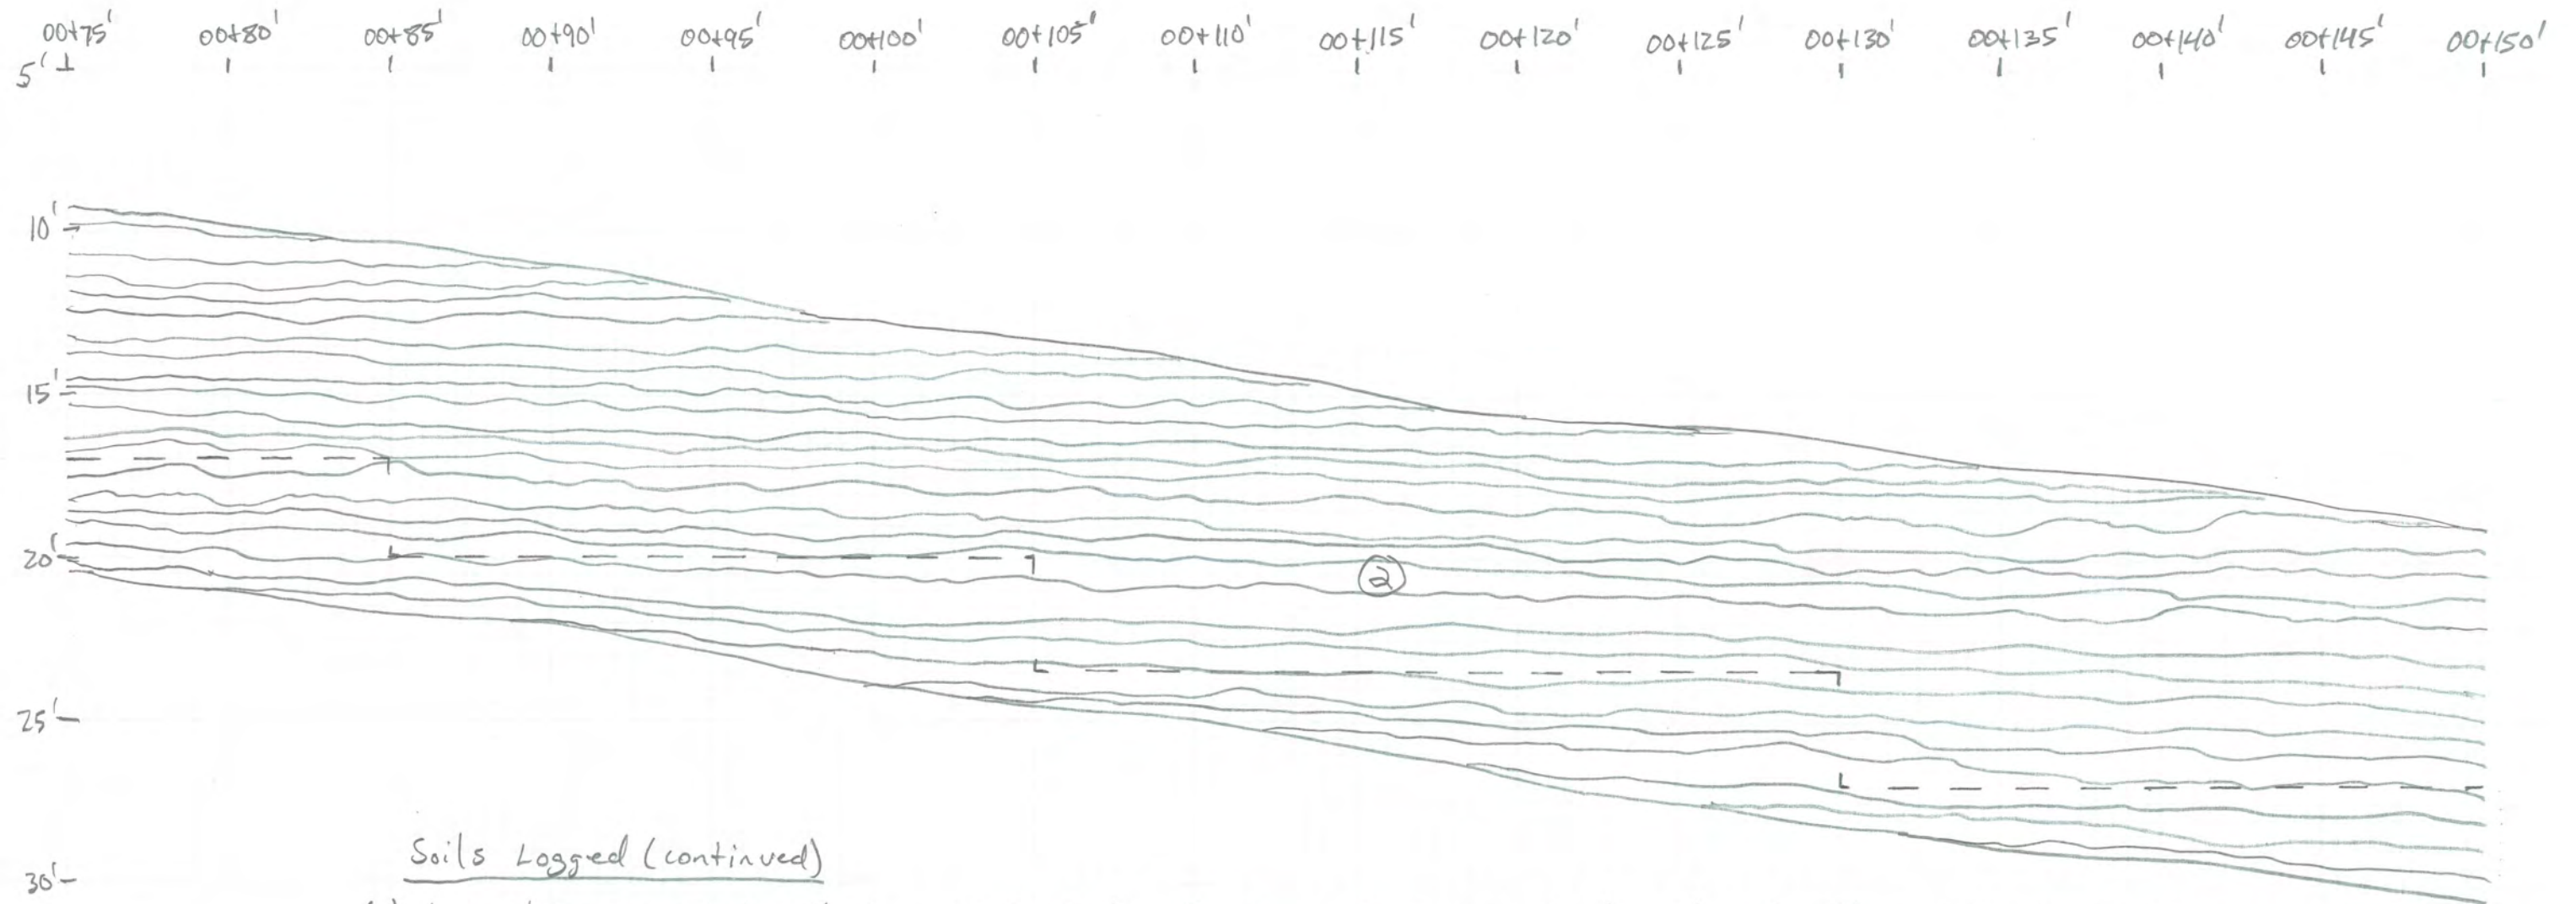
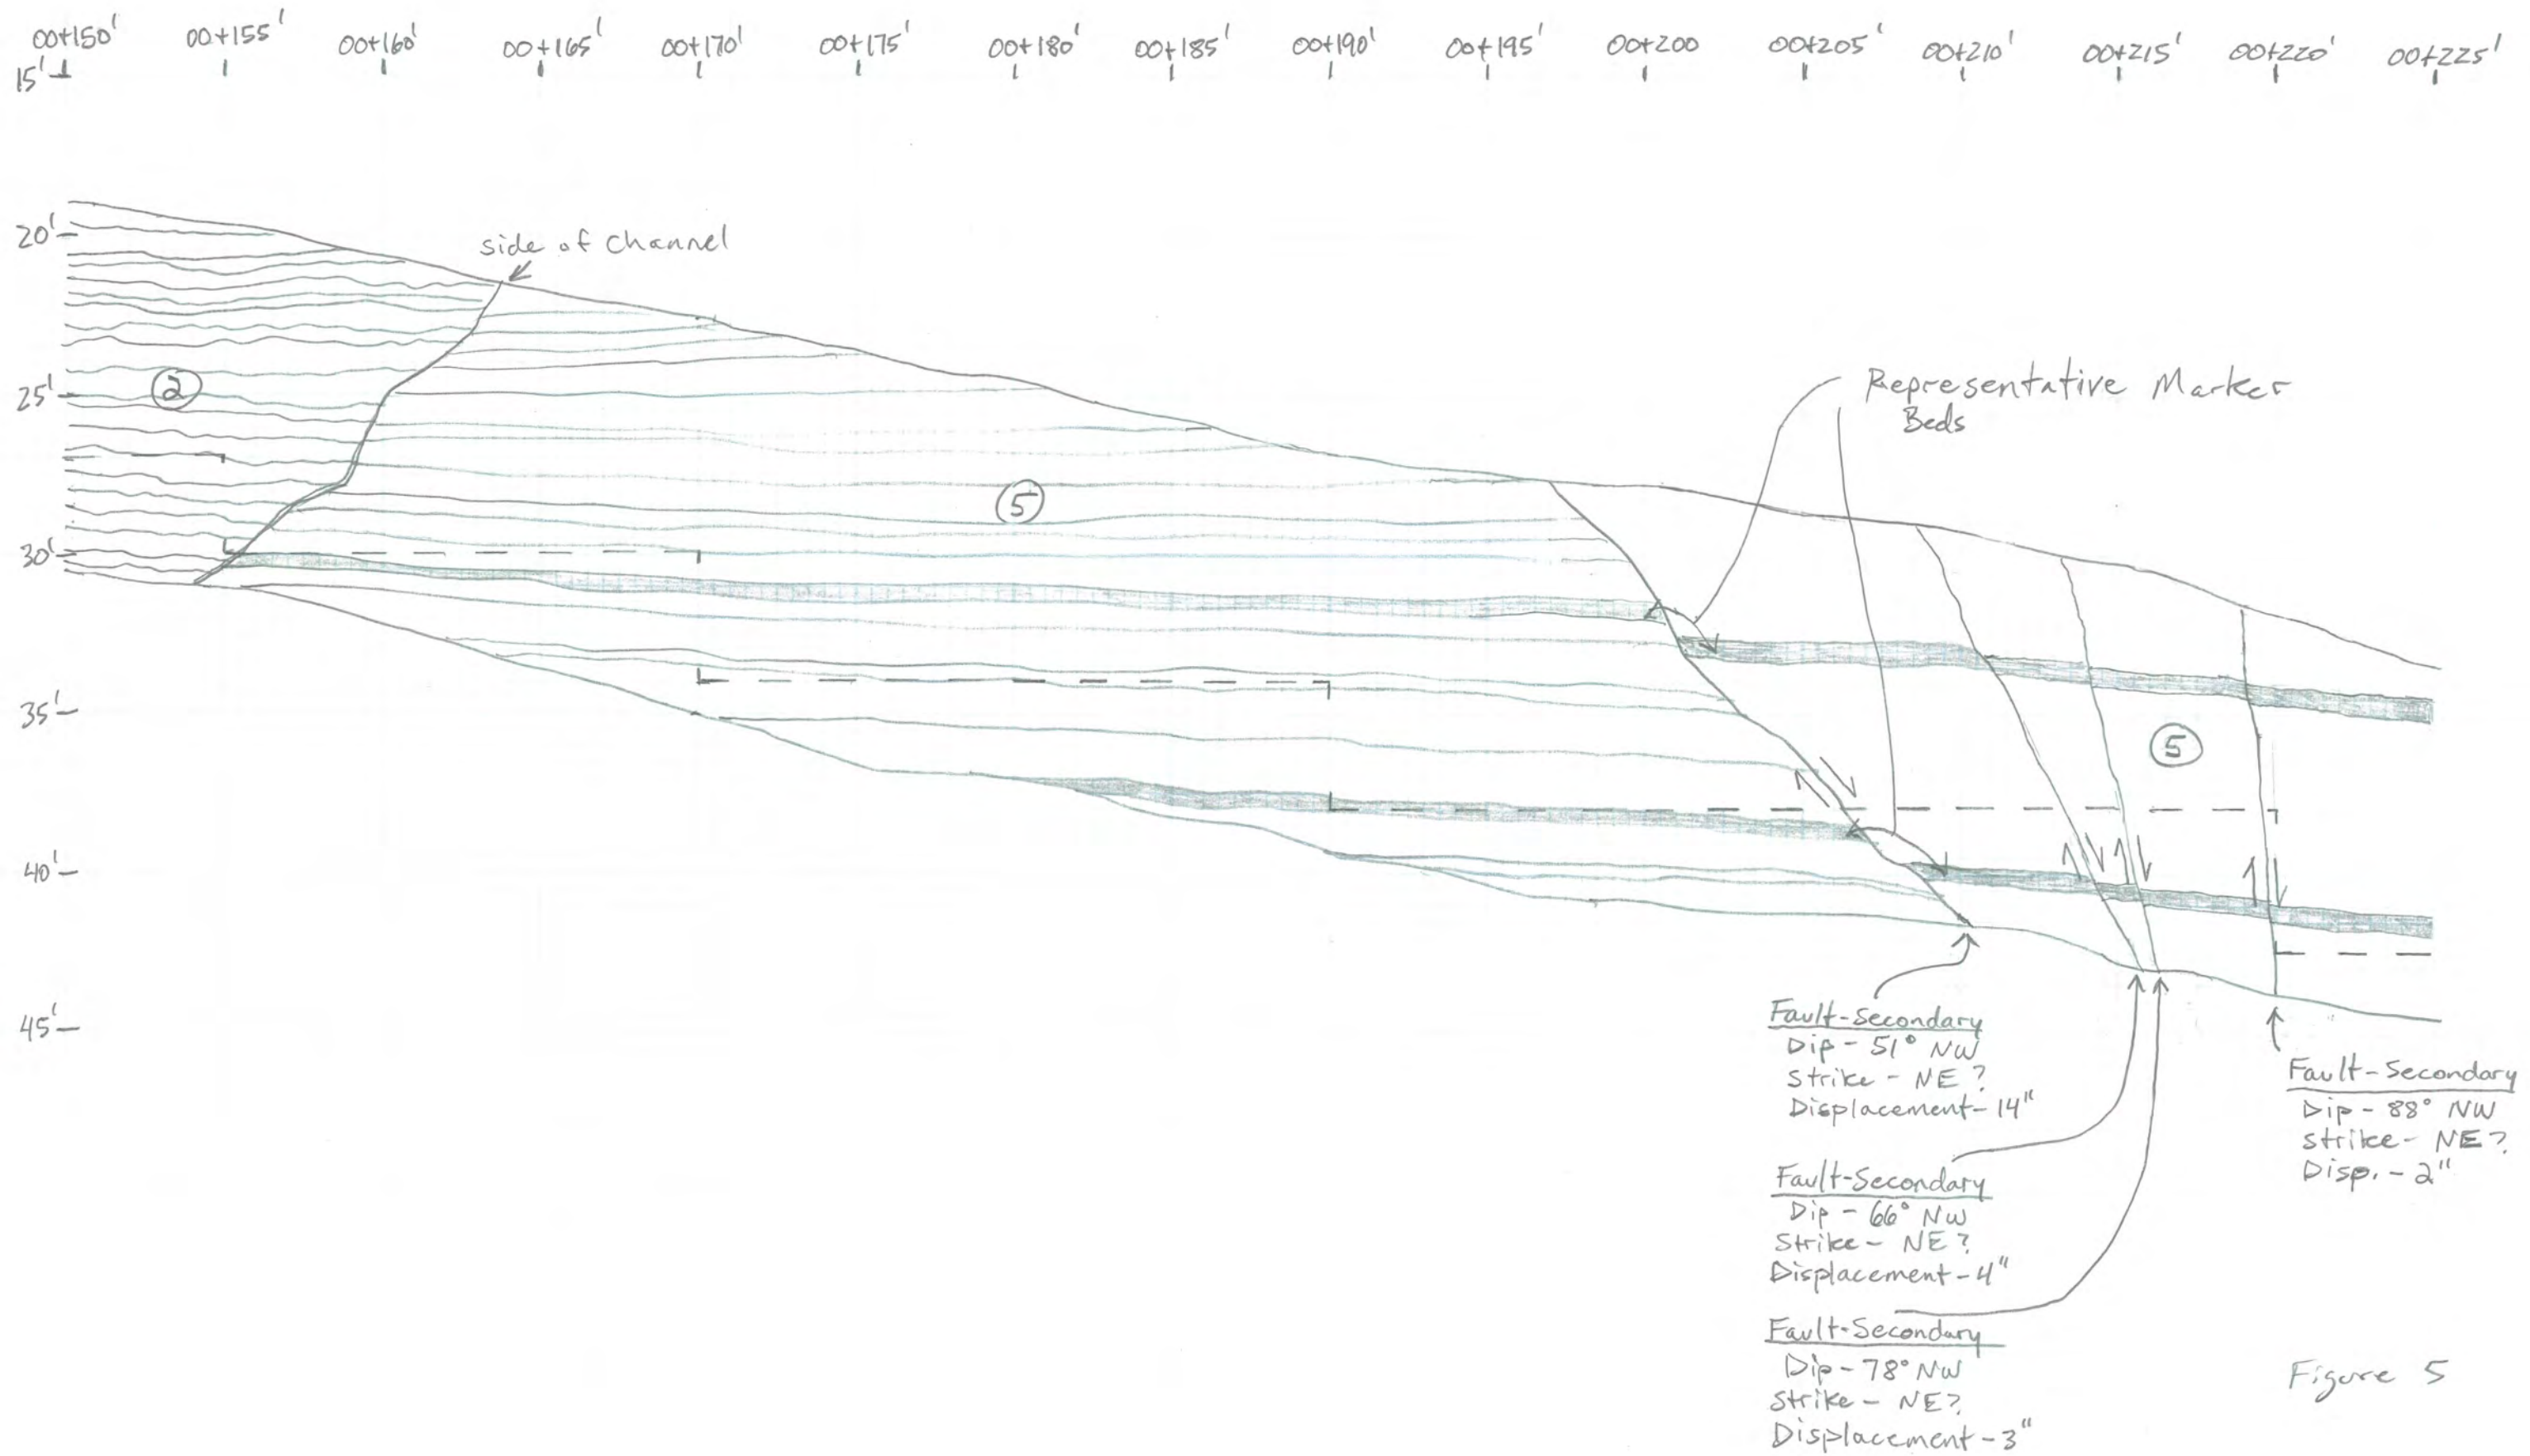
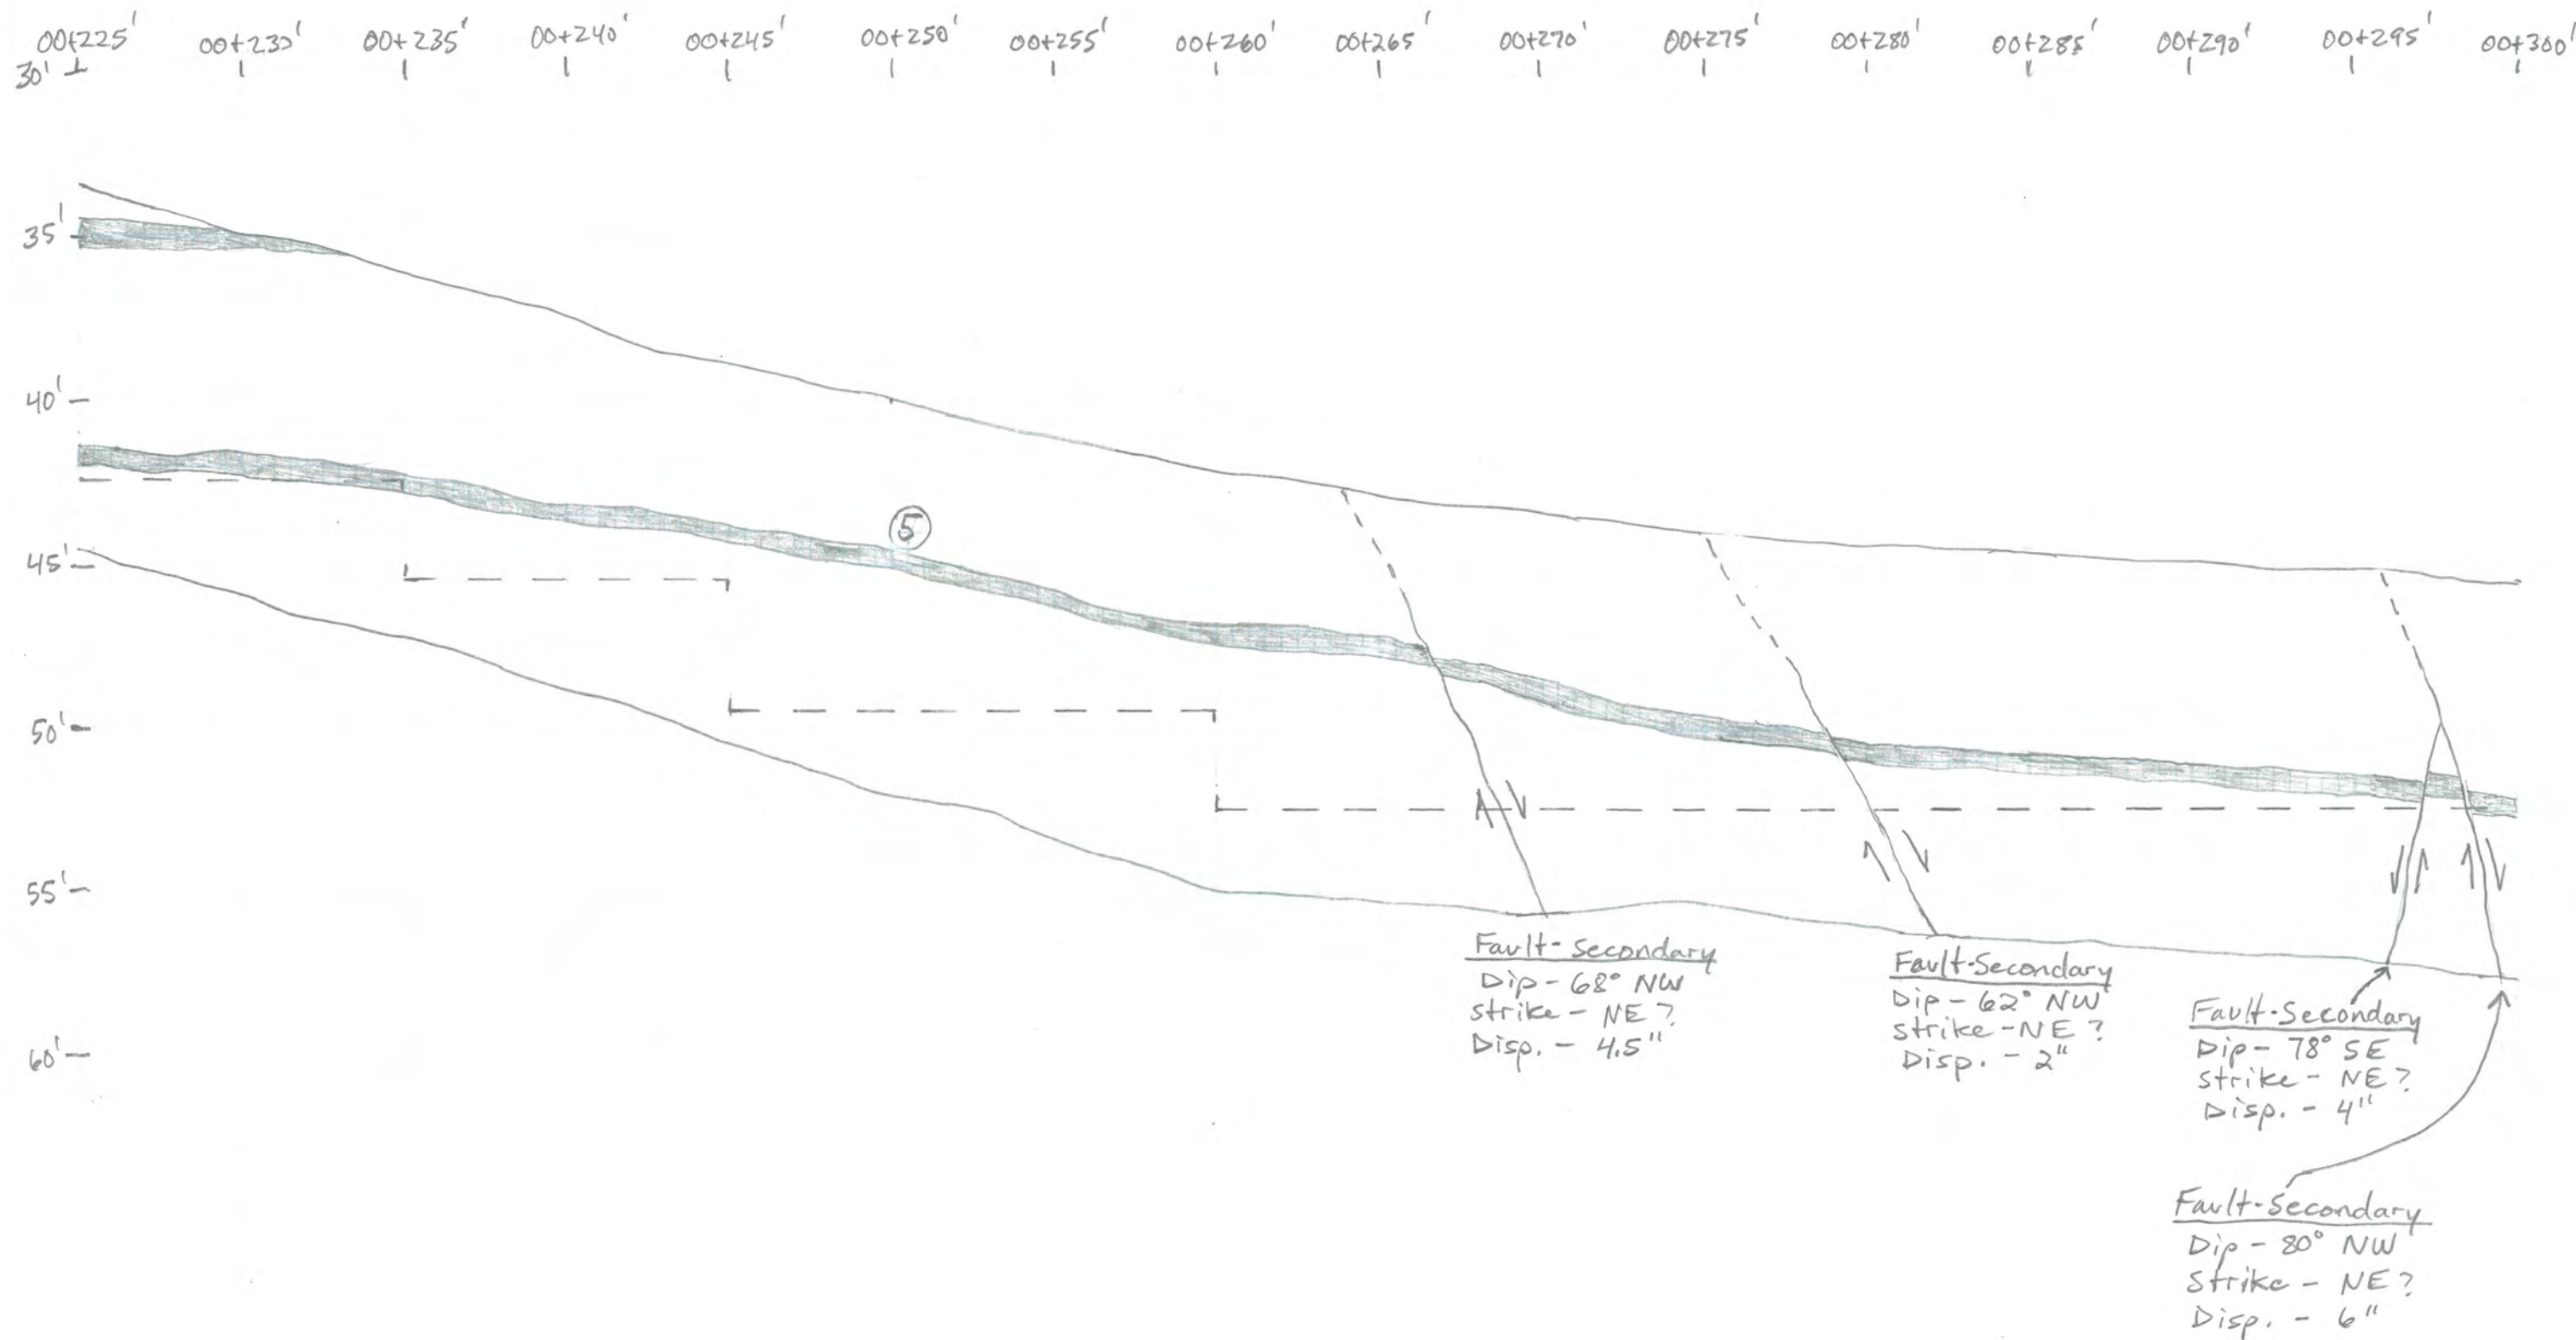
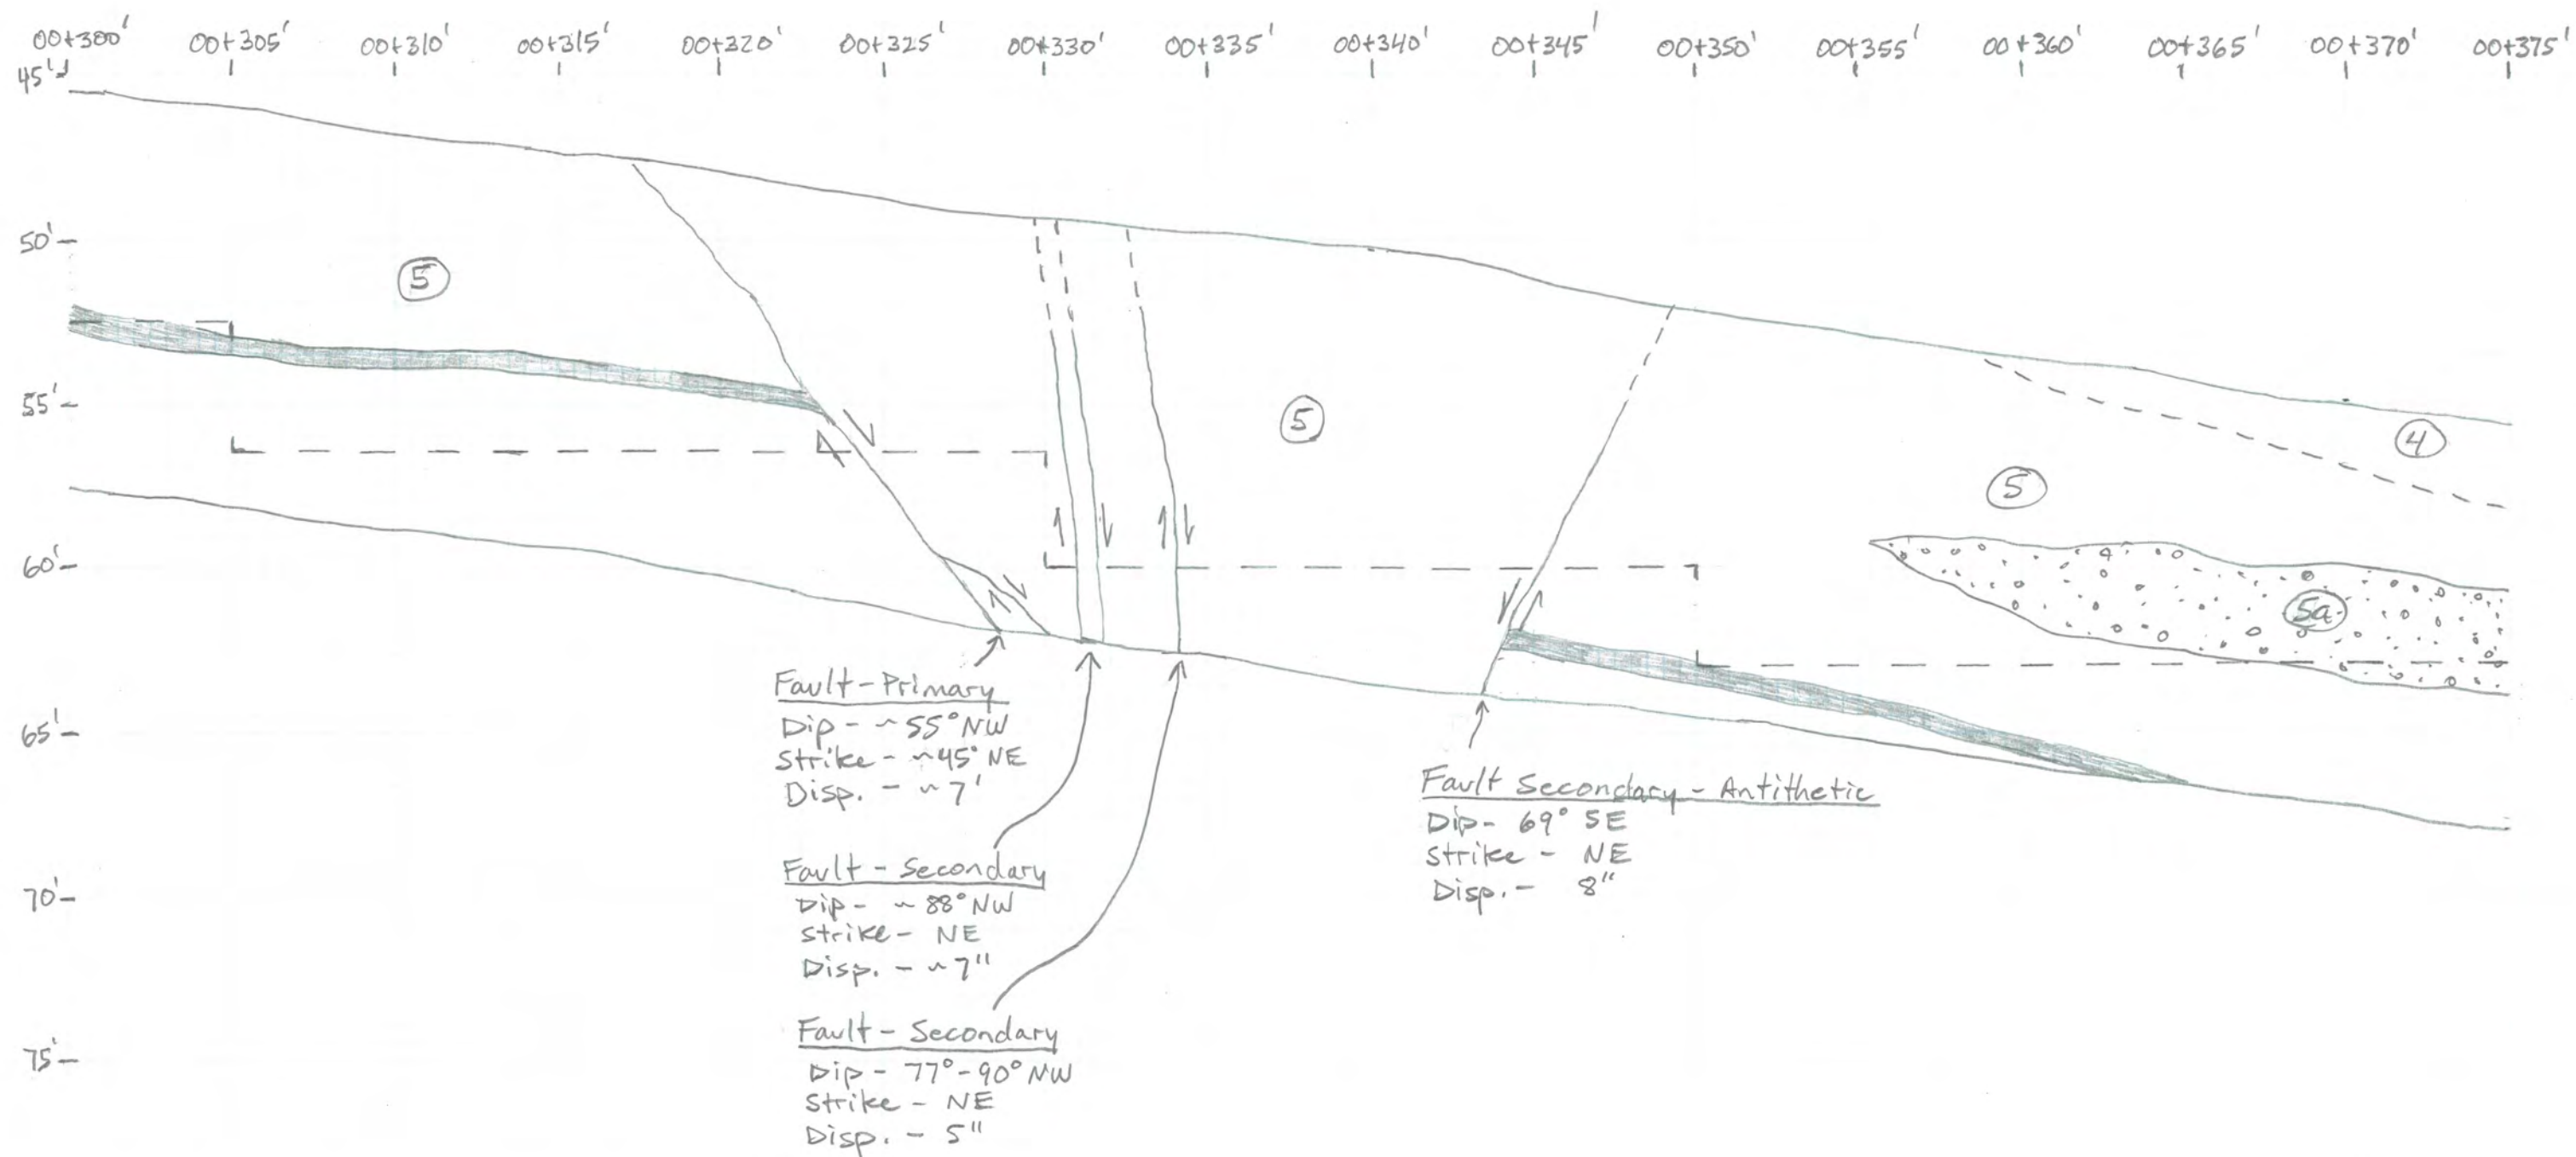
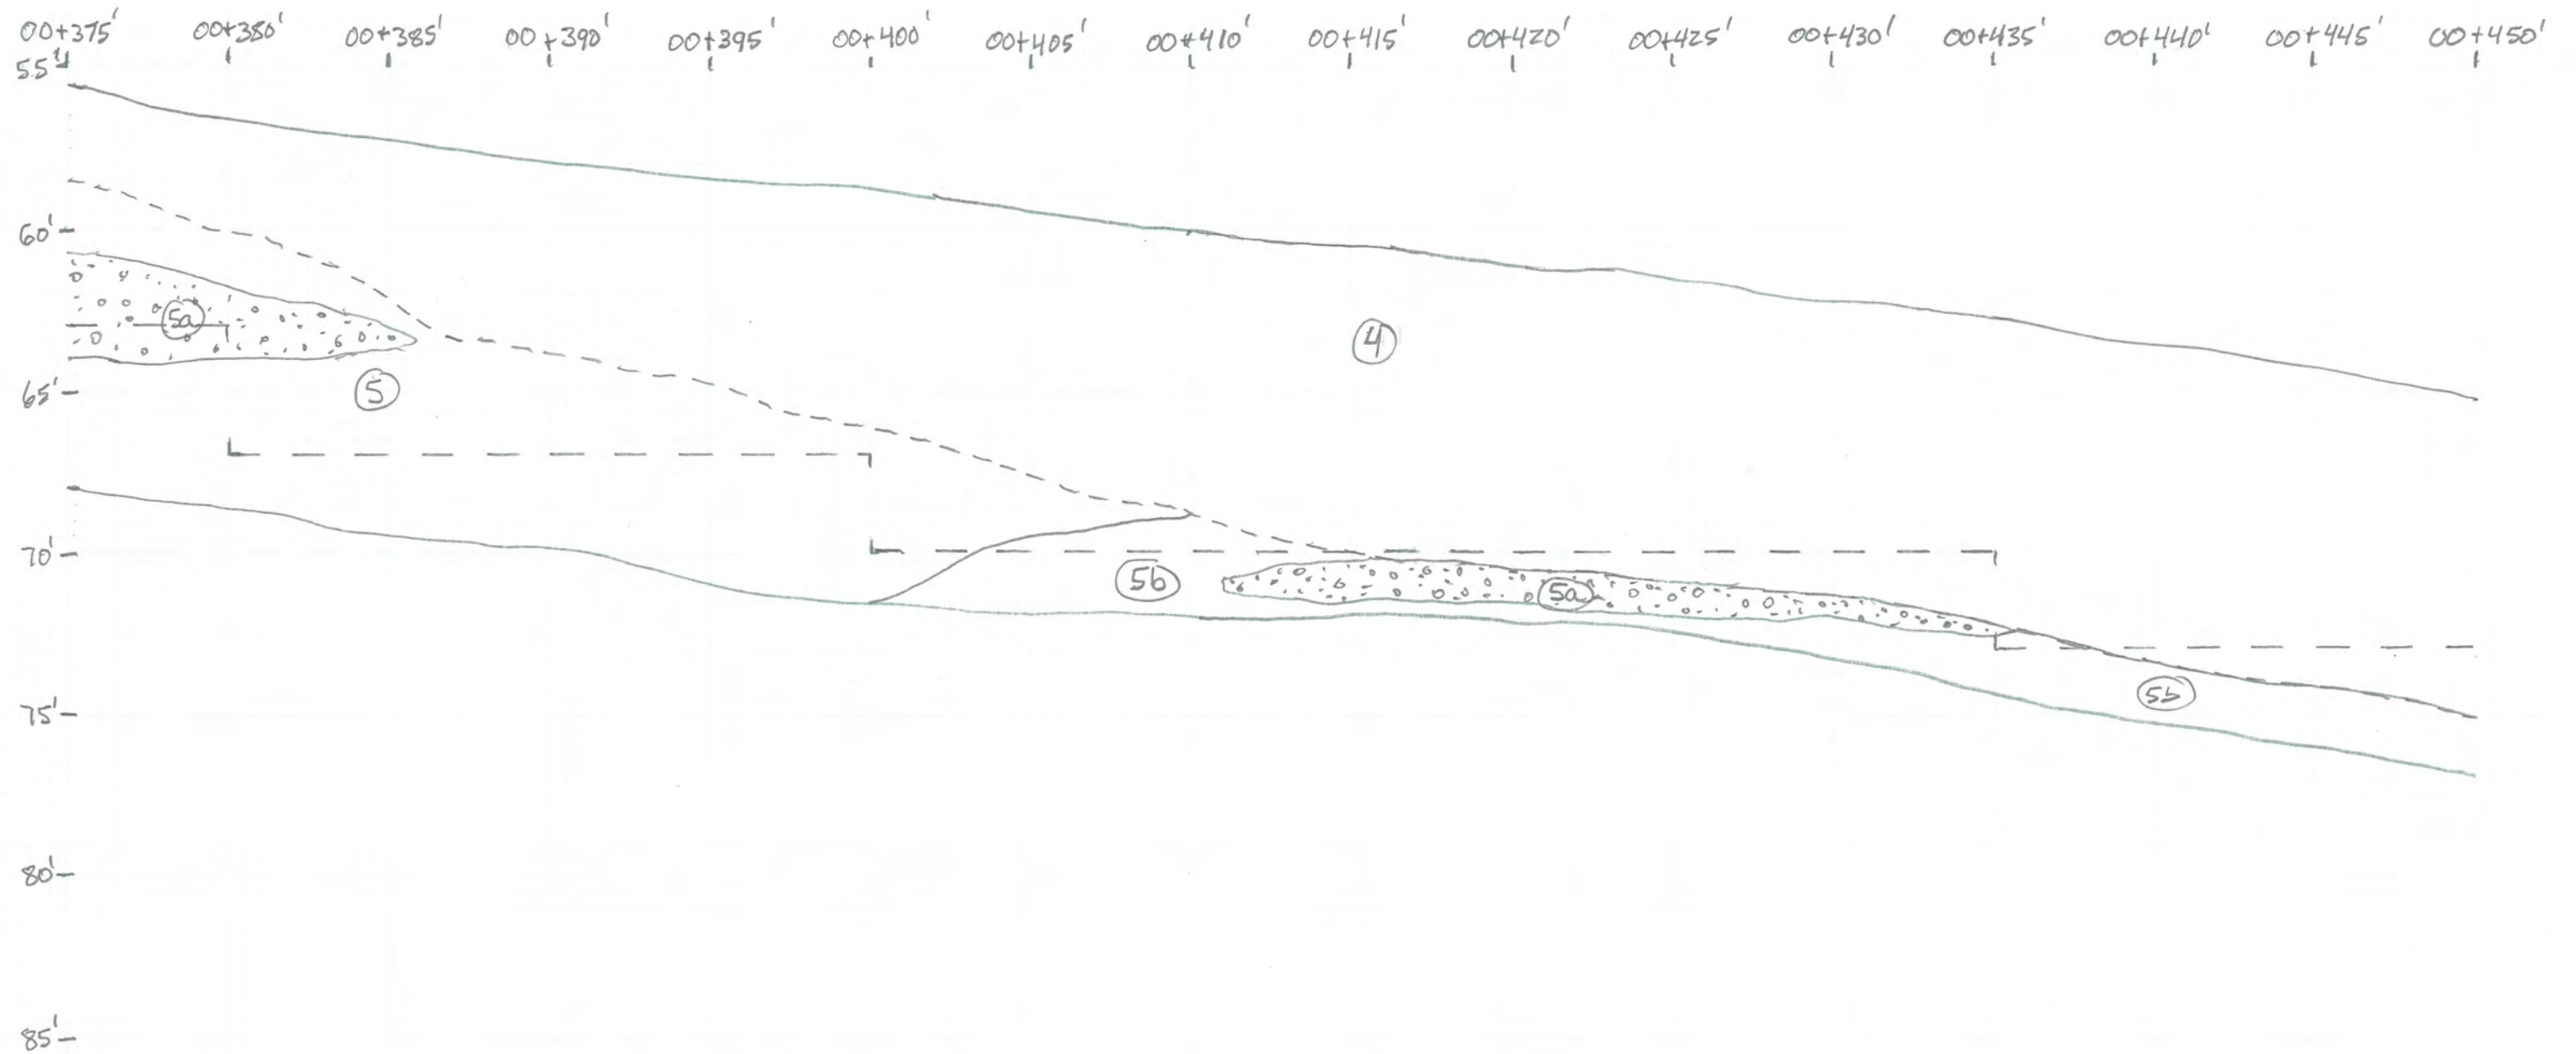
Figure 5

Trench Log - Trench ET-1, Santaquin Development, Santaquin, UT  
Logged By: Mark Larsen, P.G. 2/1 - 2/4, 2019

- 1) Channel Fill - Massive silty sand w/ gravel, pebble to cobble-sized clasts, light-brown to brown.
- 2) Channel Fill - Infilled w/ younger lacustrine sediments. Poorly graded sand and silty sand w/ some gravel. Thin, convoluted bedding, light-brown to brown.
- 3) Colluvium - Some intermixed or entrained lacustrine gravels, pebble to boulder-size gravels, angular to subrounded, massive, gray.
- 4) Fan Alluvium - Clayey to silty gravel w/ sand, mostly pebble-sized angular clasts, brown. Likely deposited in 3-4 events.
- 5) Lacustrine Deposits - Bedded gravels and sands of Bonneville Lake cycle, pebble to cobble-sized, rounded clasts, grayish-brown.
  - 5a.) Lenses of poorly-graded sand w/ pebble gravel.
  - 5b.) Lacustrine silt.
  - 5c.) Lacustrine sand.

- 6.) Lacustrine gravel & colluvium, Undivided - Poorly graded gravel w/ sand and silt, pebble to boulder-sized, subangular to rounded clasts, grayish-brown.
- 7.) Lacustrine gravels - Poorly graded gravels w/ sand, pebble-sized clasts, grayish-brown.

The maximum net vertical displacement across the fault zone at the subject site was observed and measured to be in excess of 8 feet (**Figures 5 through 12**). As previously discussed in **Section 4.6**, the UGS (DuRoss and others, 2008) observed up to 9 feet of displacement in their trenches just west-southwest of the subject site. To avoid structural failure in habitable structures and critical infrastructure during a future ground-rupturing earthquake event, the only currently accepted form of mitigation is to avoid placing such structures and infrastructure across or adjacent to identified active fault traces, such as those observed and mapped at the subject site. Current guidelines and our recommendations for appropriate building setbacks from the mapped faulting at the subject site are discussed in Section 5.0.
