### NOTICE OF INTENTION TO COMMENCE LARGE MINING OPERATIONS

### **Geotechnical study**

## GEOLOGIC HAZARDS INVESTIGATION

Subject: Geologic Hazards Investigation  
Santaquin Heights  
Approximately 650 North State Road 198  
Santaquin, Utah  
CMT Project Number: 12330

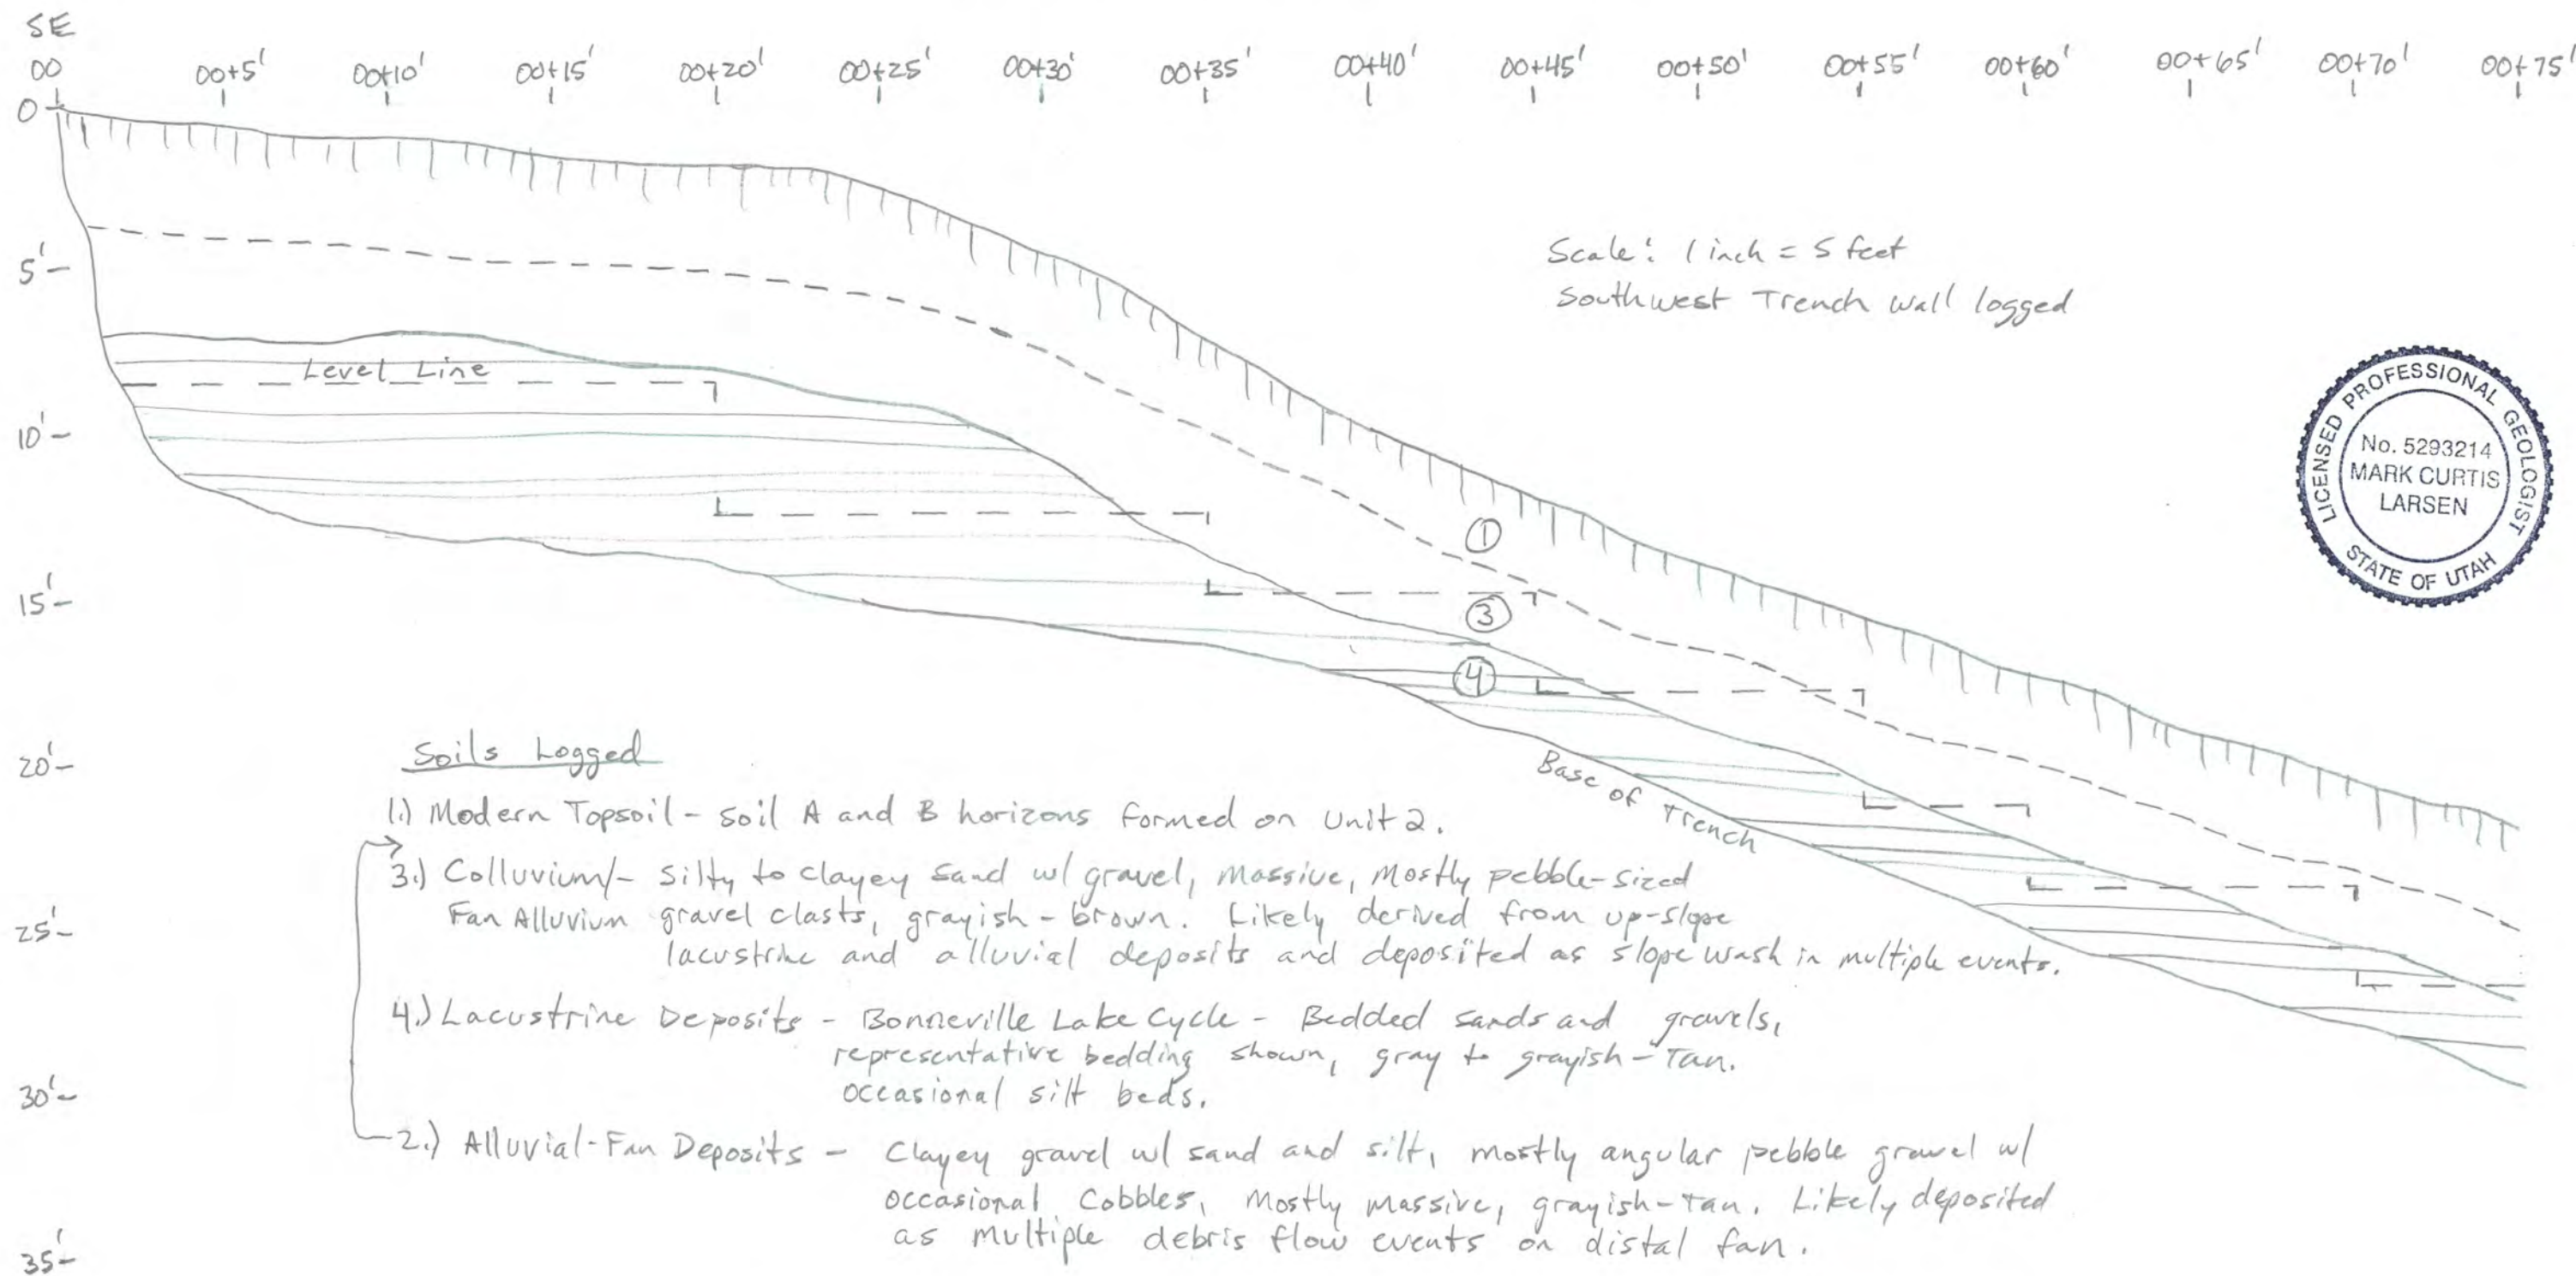
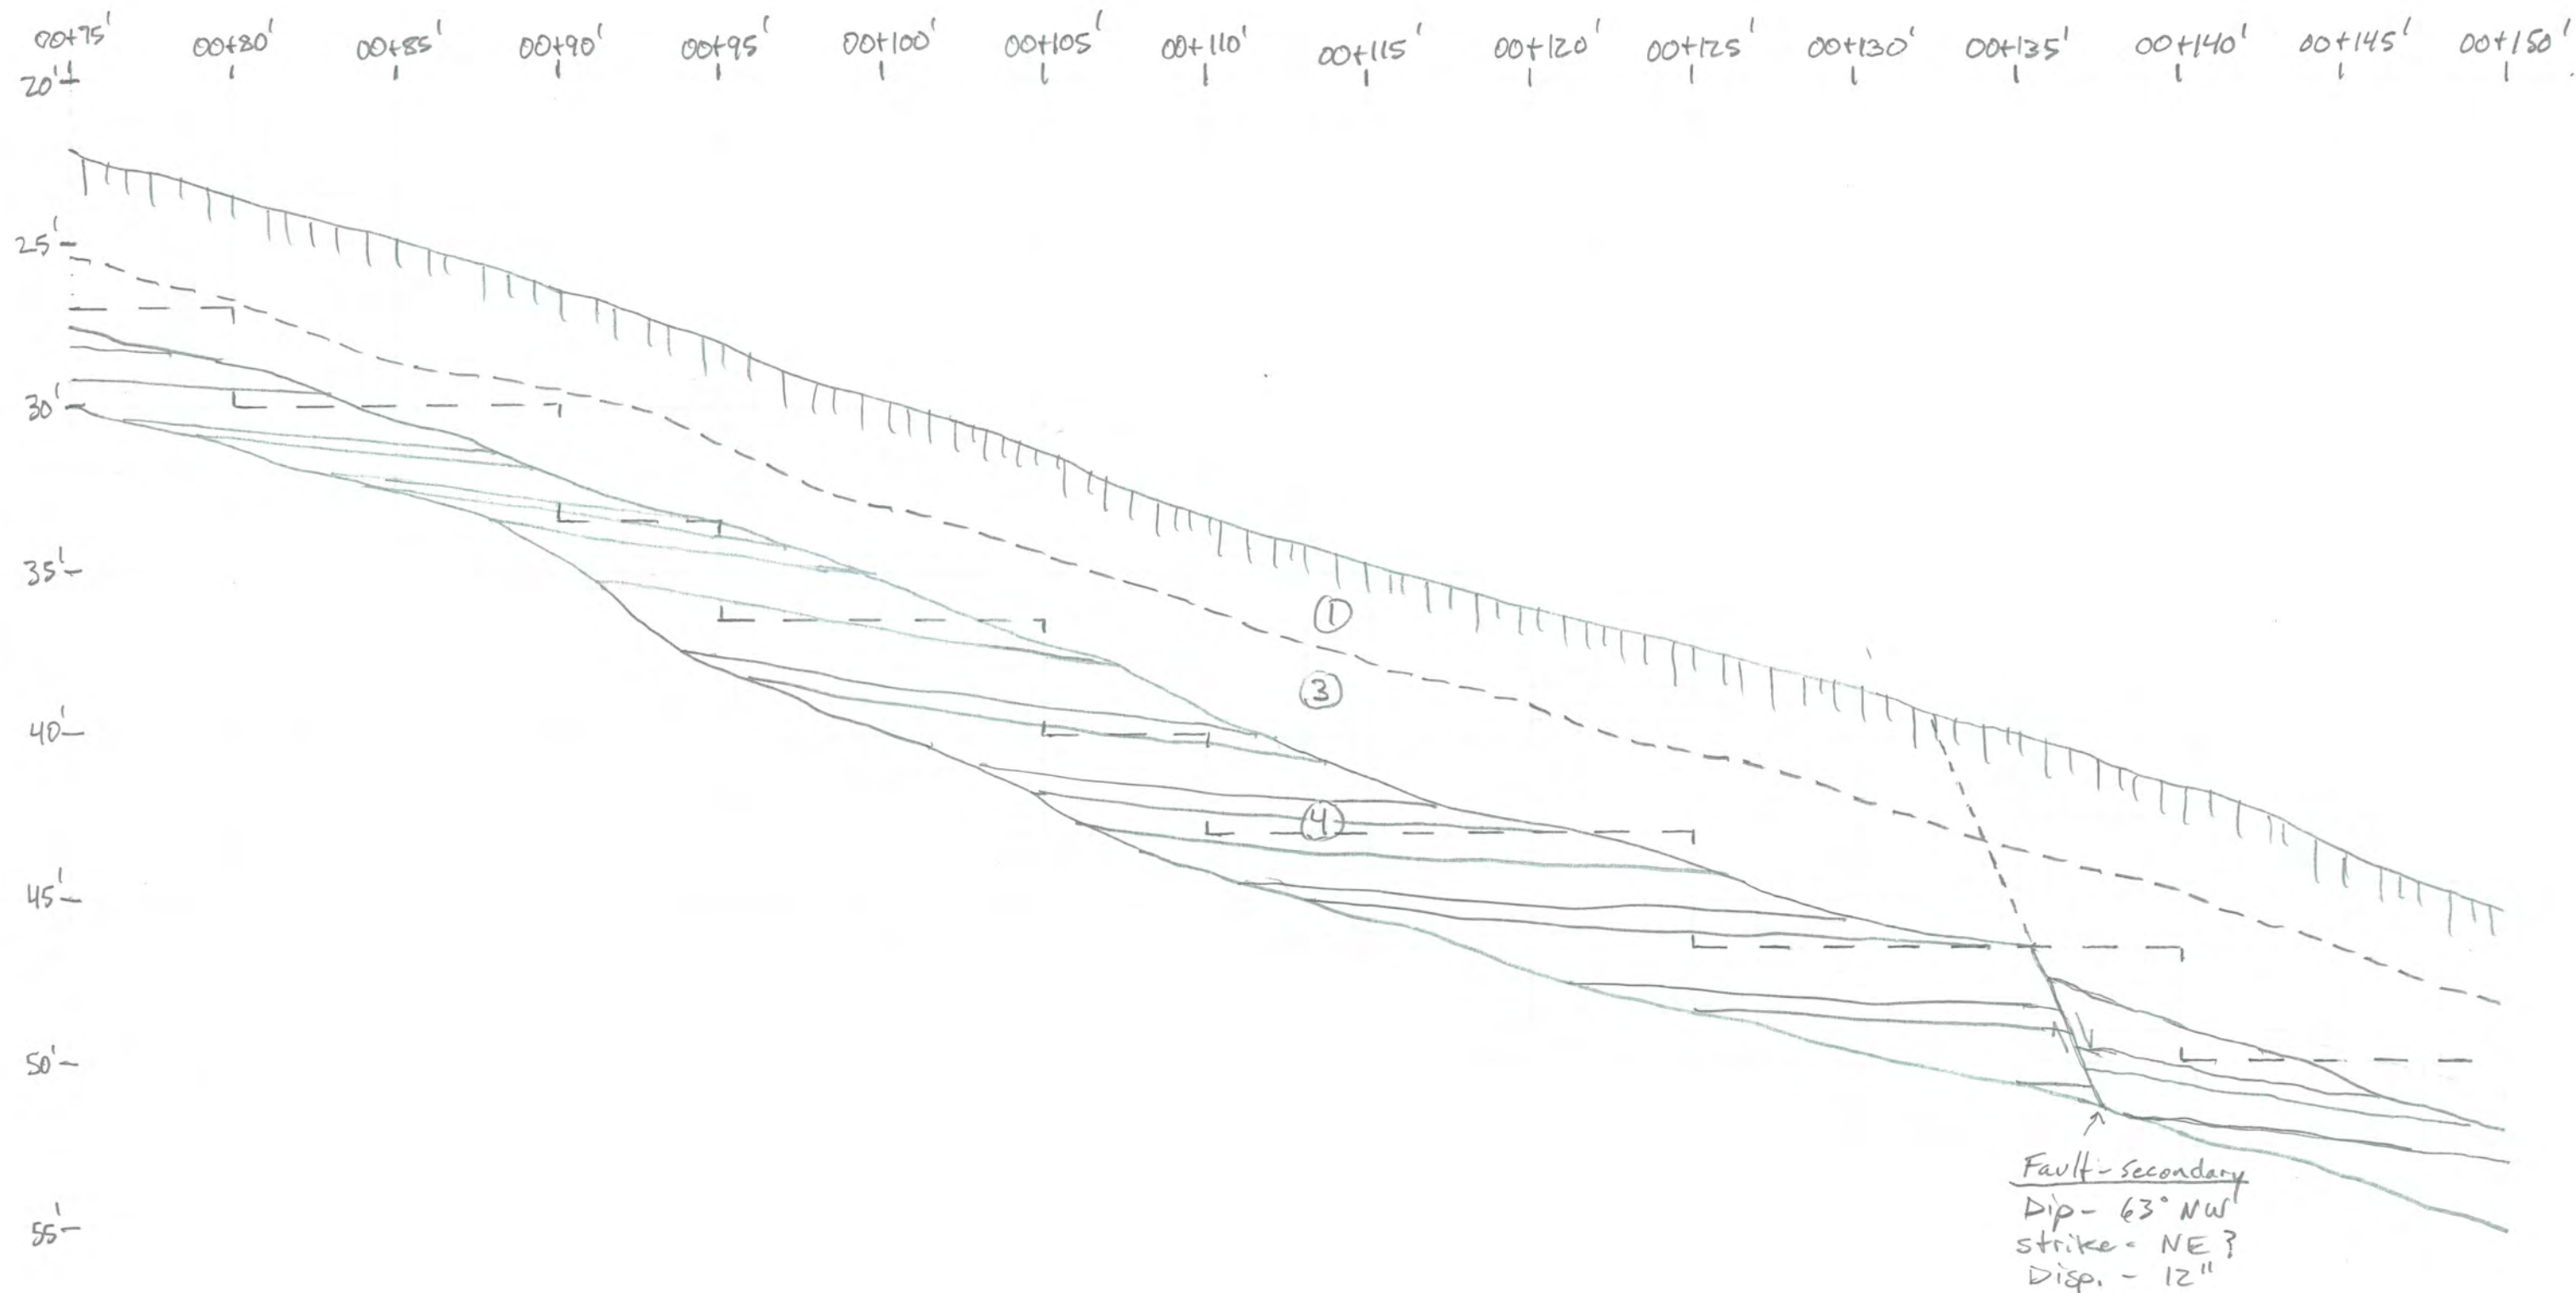
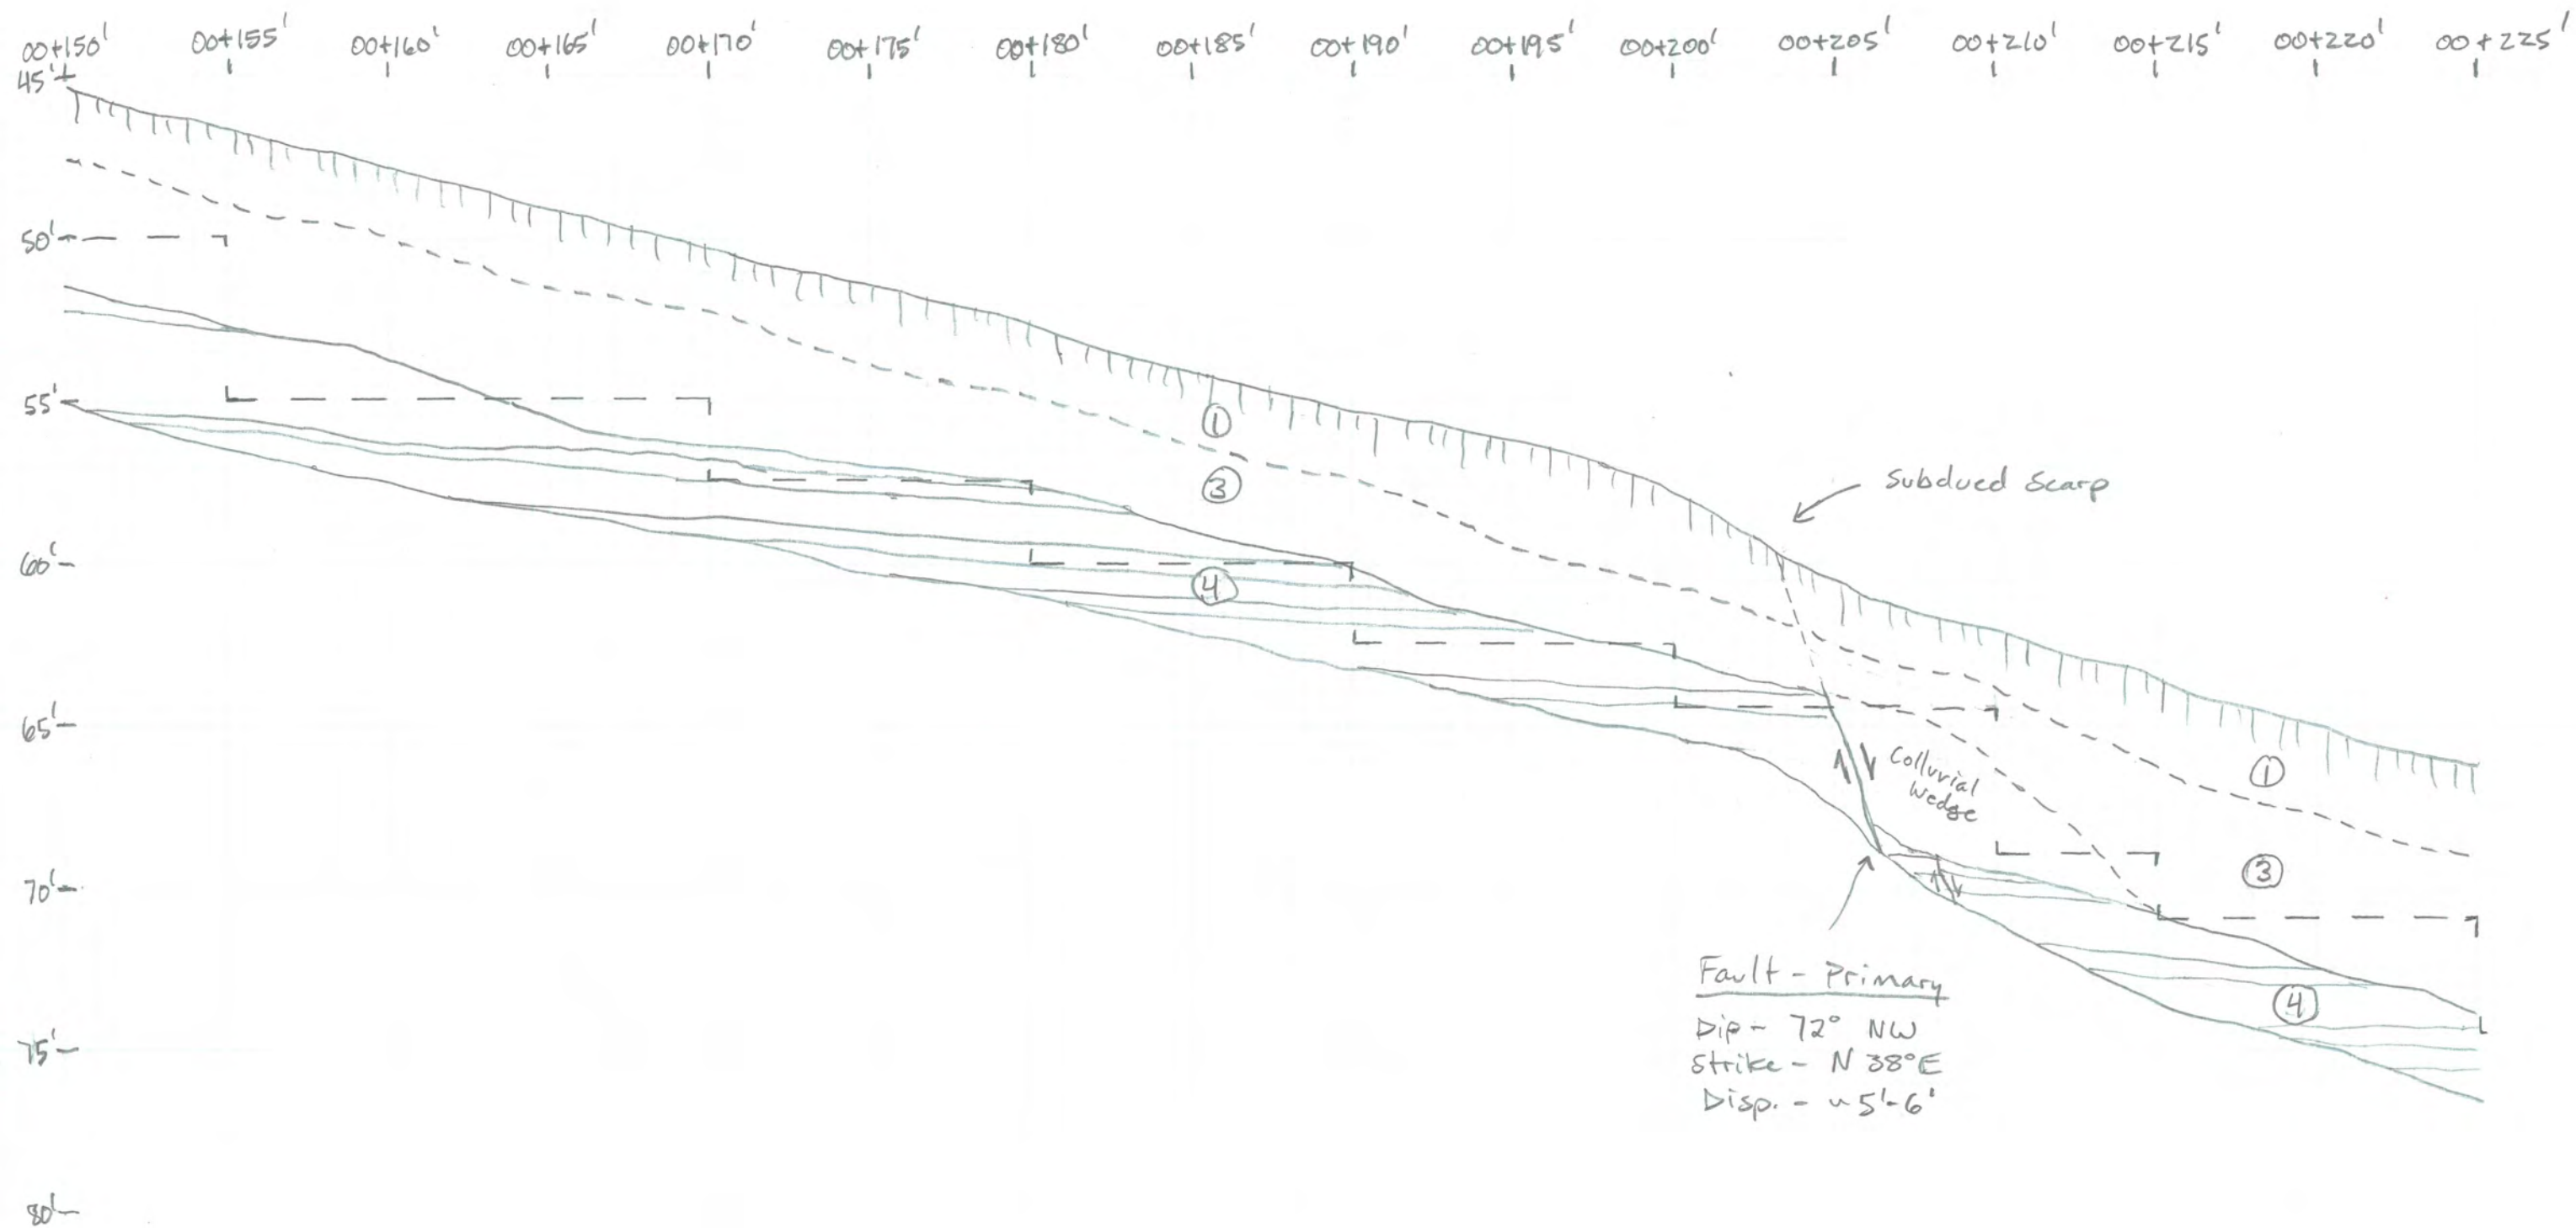
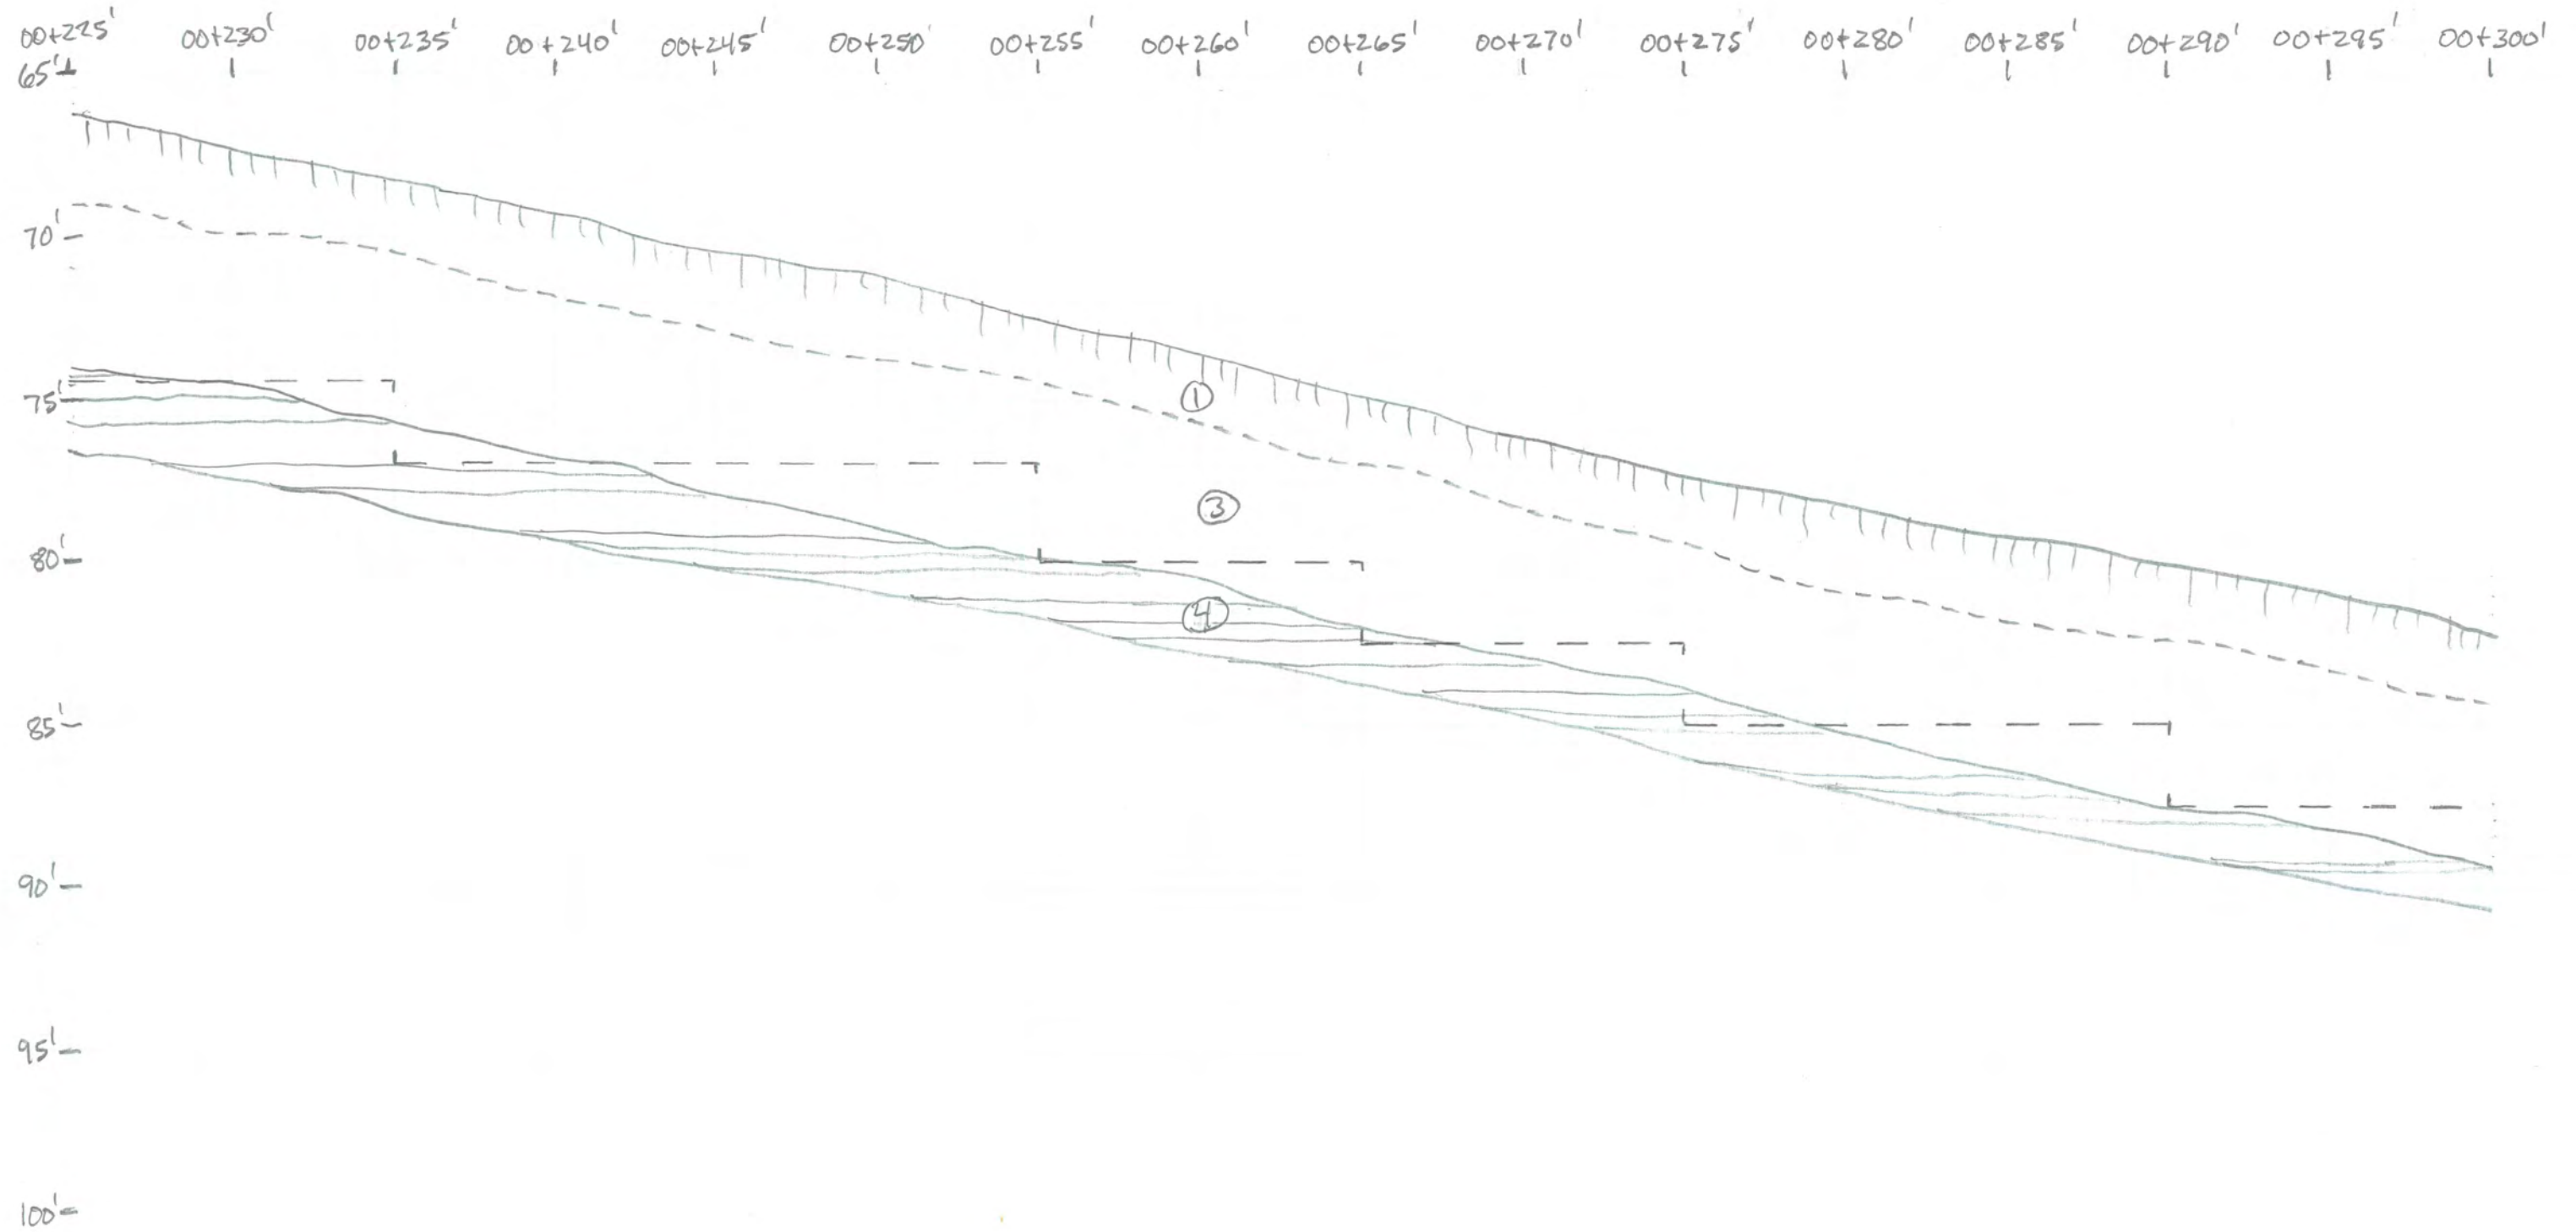
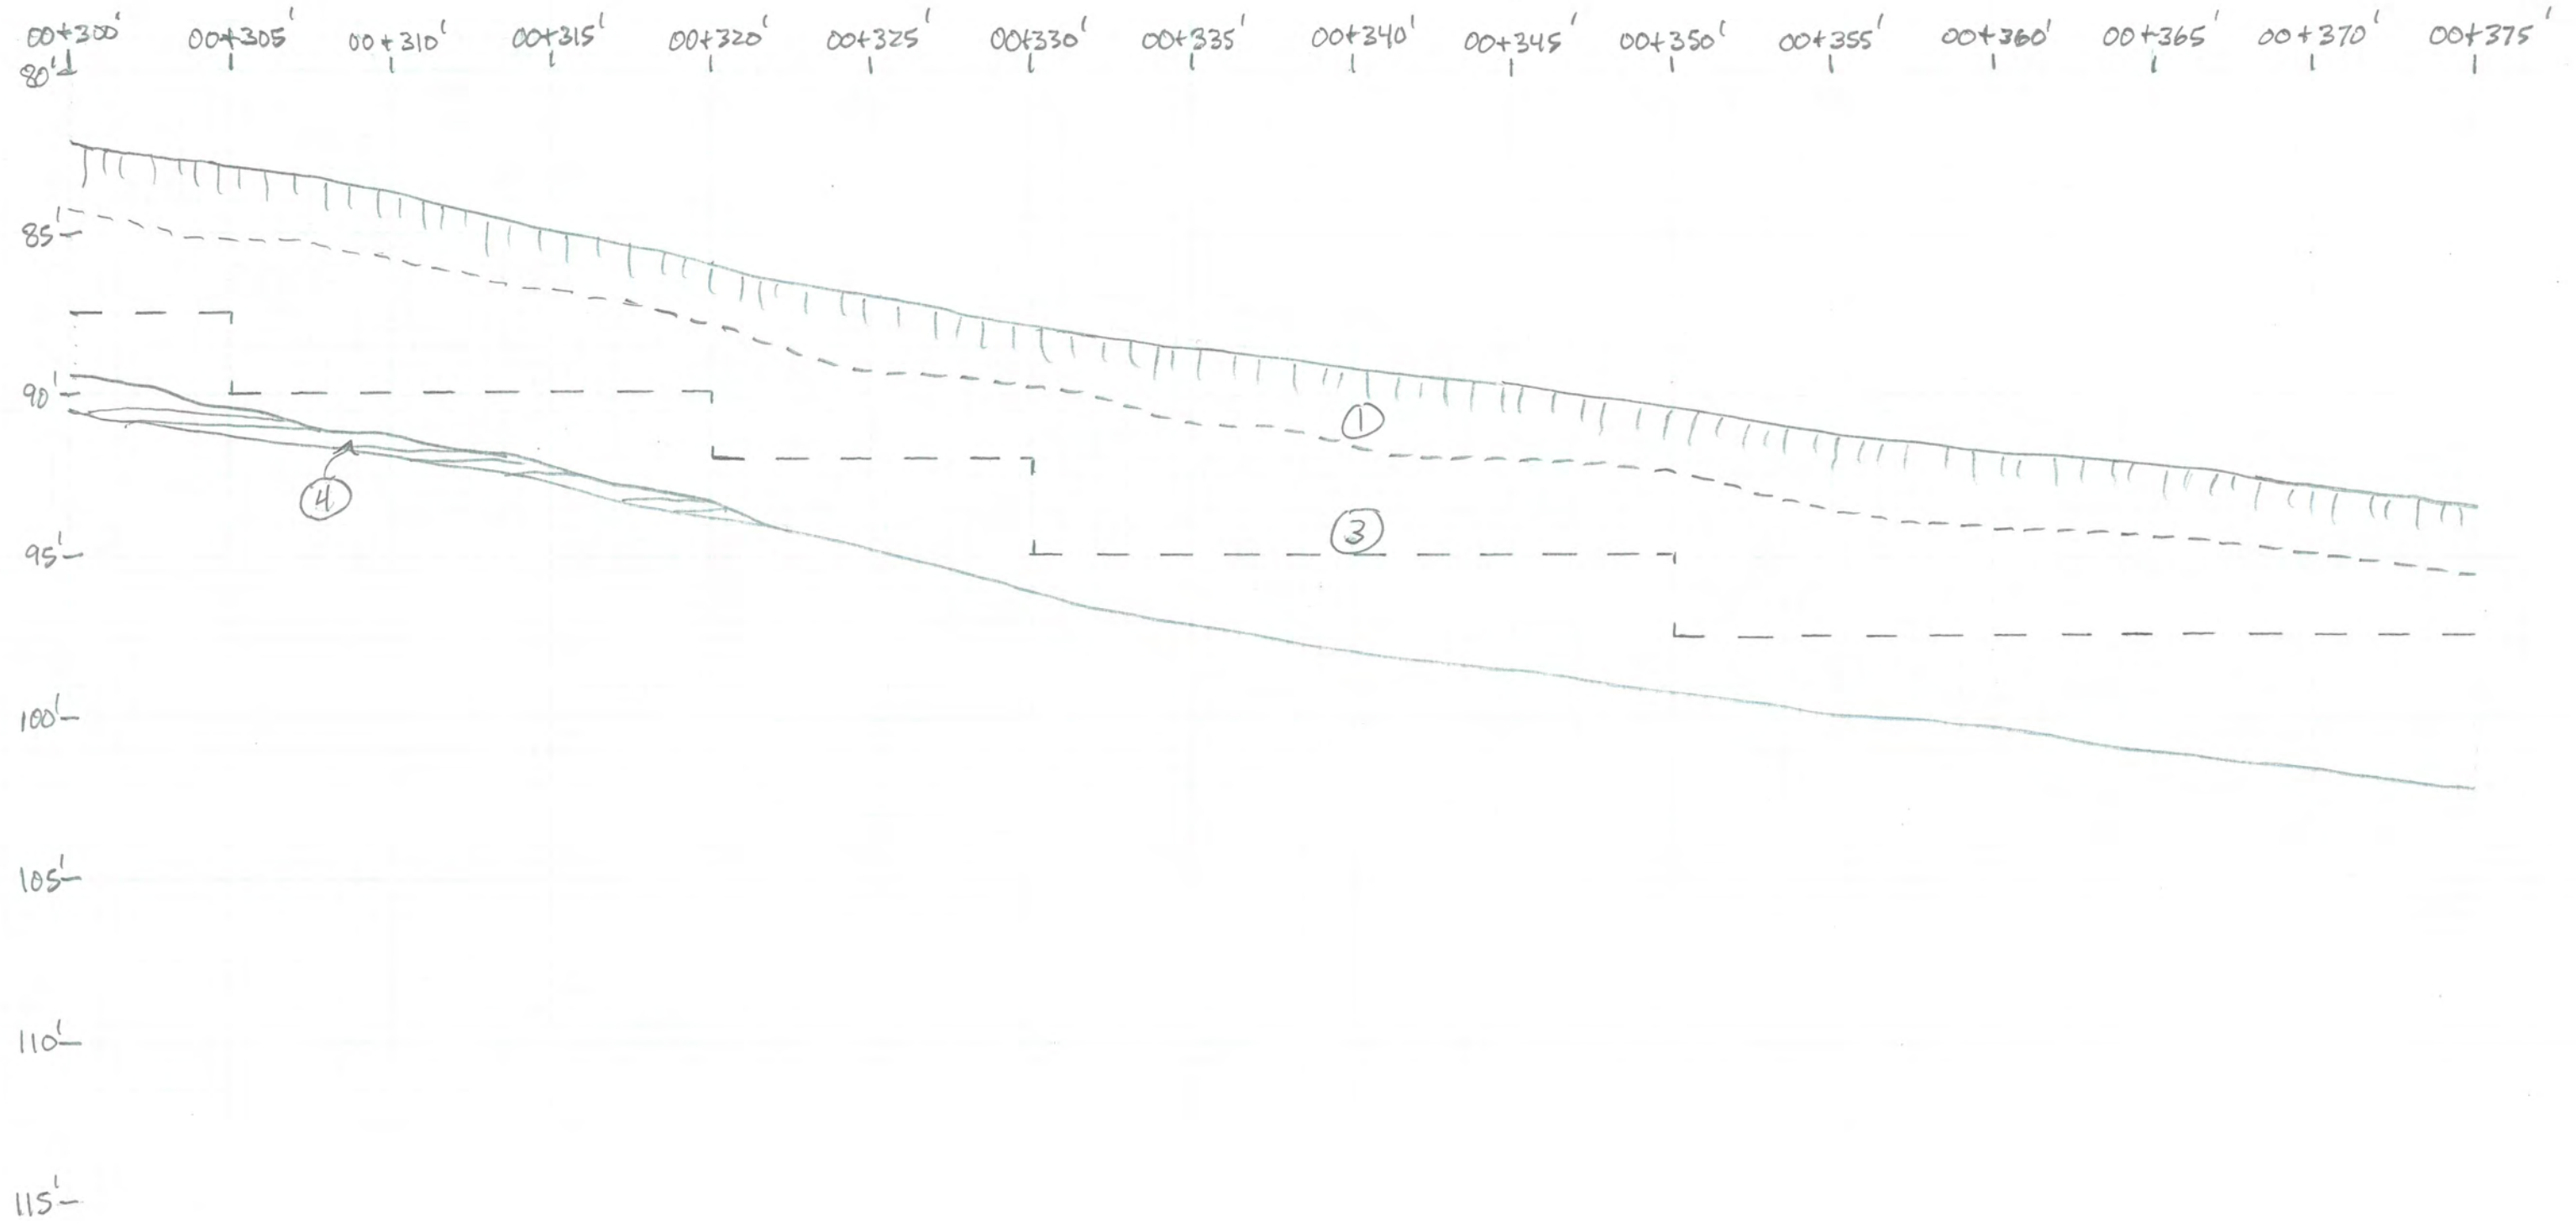
Figure 6

Trench Log - Trench ET-2 Santaquin Development, Santaquin, UT  
Logged By: Mark Larsen, P.G., 2/9/19

The maximum net vertical displacement across the fault zone at the subject site was observed and measured to be in excess of 8 feet (**Figures 5 through 12**). As previously discussed in **Section 4.6**, the UGS (DuRoss and others, 2008) observed up to 9 feet of displacement in their trenches just west-southwest of the subject site. To avoid structural failure in habitable structures and critical infrastructure during a future ground-rupturing earthquake event, the only currently accepted form of mitigation is to avoid placing such structures and infrastructure across or adjacent to identified active fault traces, such as those observed and mapped at the subject site. Current guidelines and our recommendations for appropriate building setbacks from the mapped faulting at the subject site are discussed in Section 5.0.
