### NOTICE OF INTENTION TO COMMENCE LARGE MINING OPERATIONS

### **Geotechnical study**

## GEOLOGIC HAZARDS INVESTIGATION

Subject: Geologic Hazards Investigation  
Santaquin Heights  
Approximately 650 North State Road 198  
Santaquin, Utah  
CMT Project Number: 12330

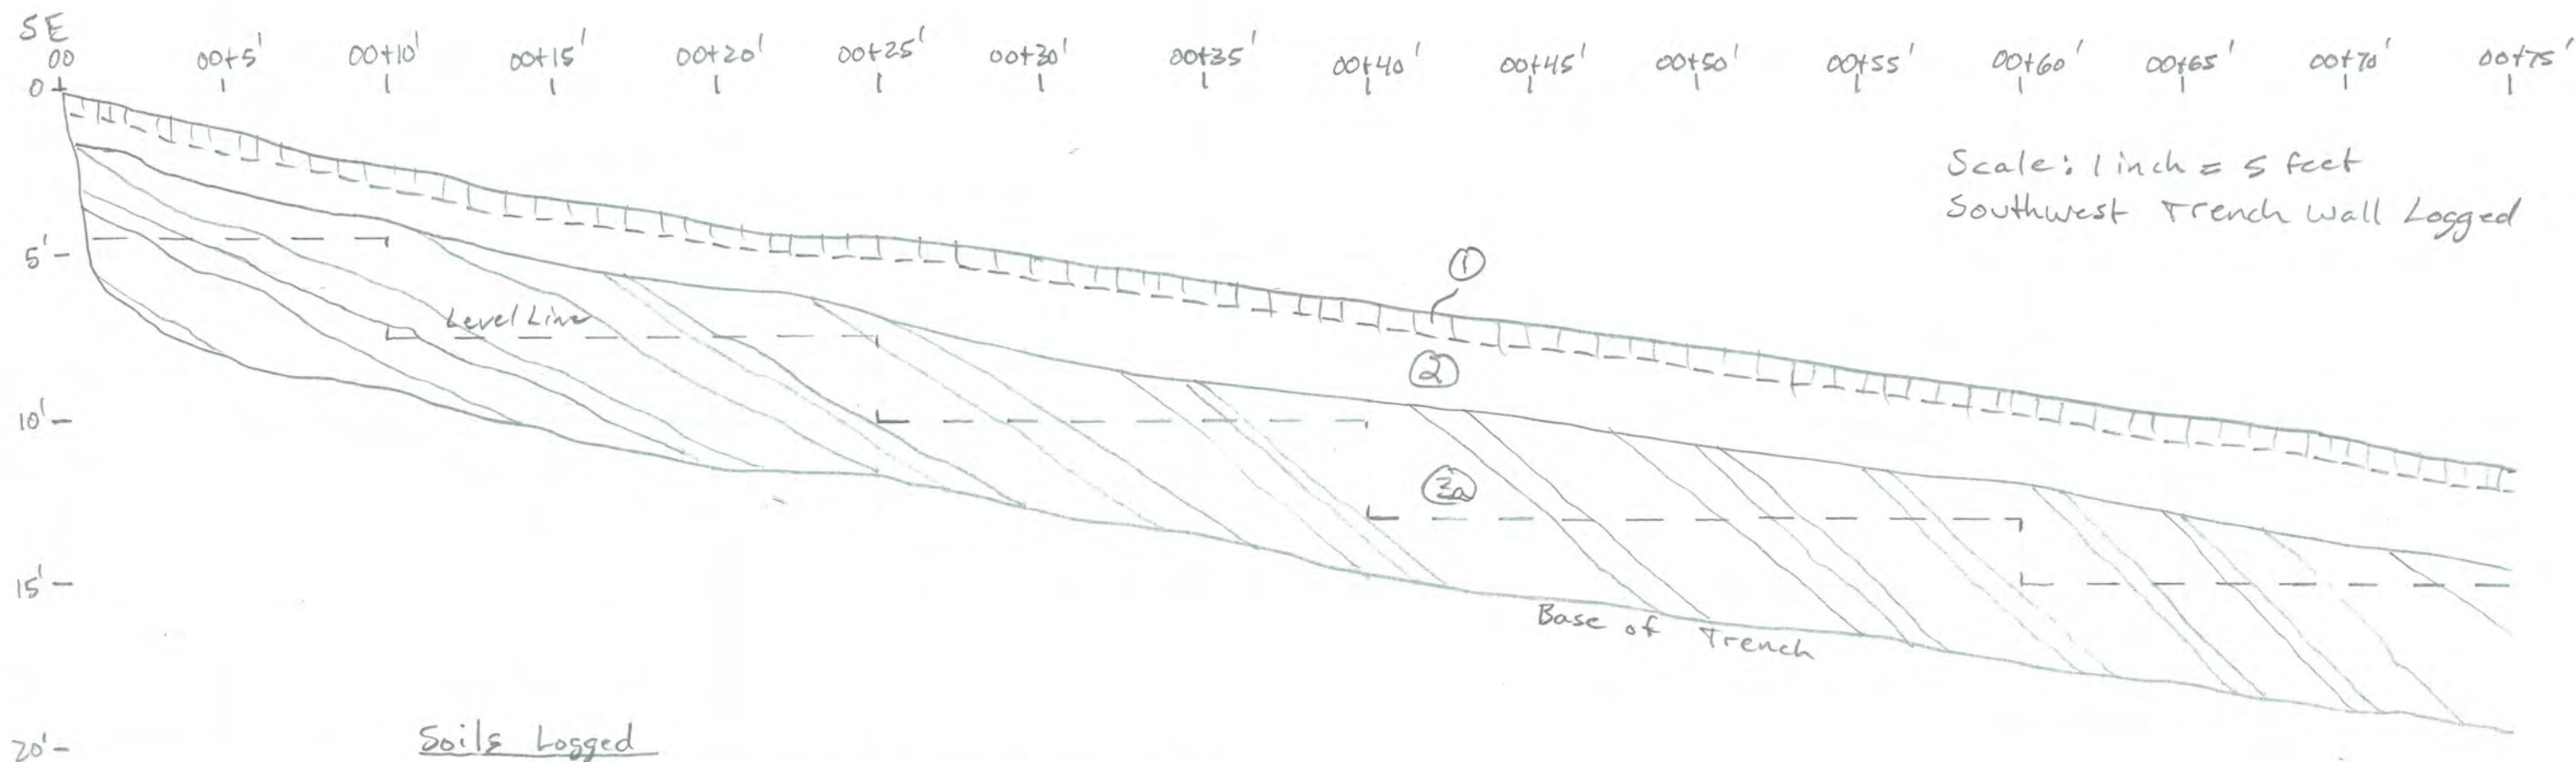
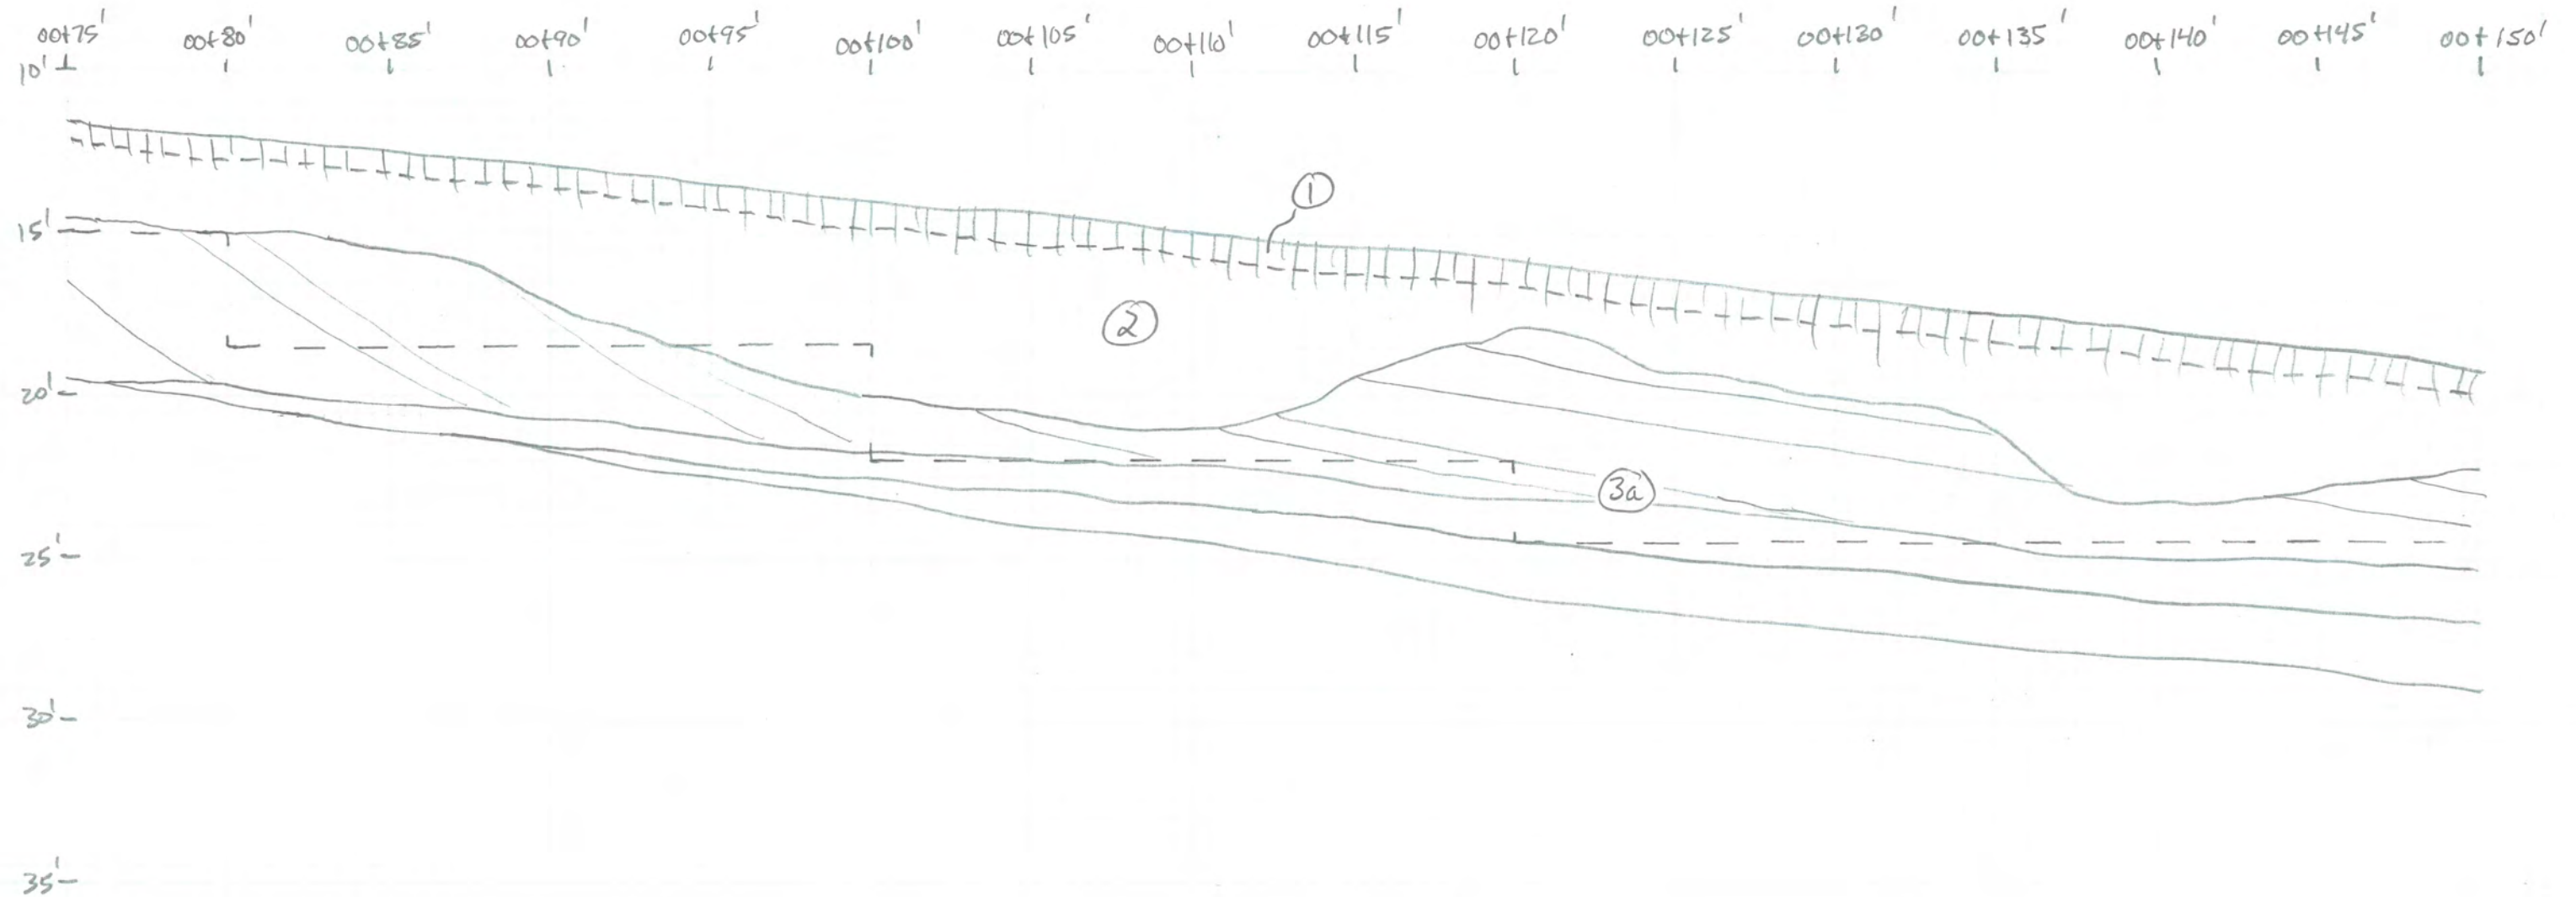
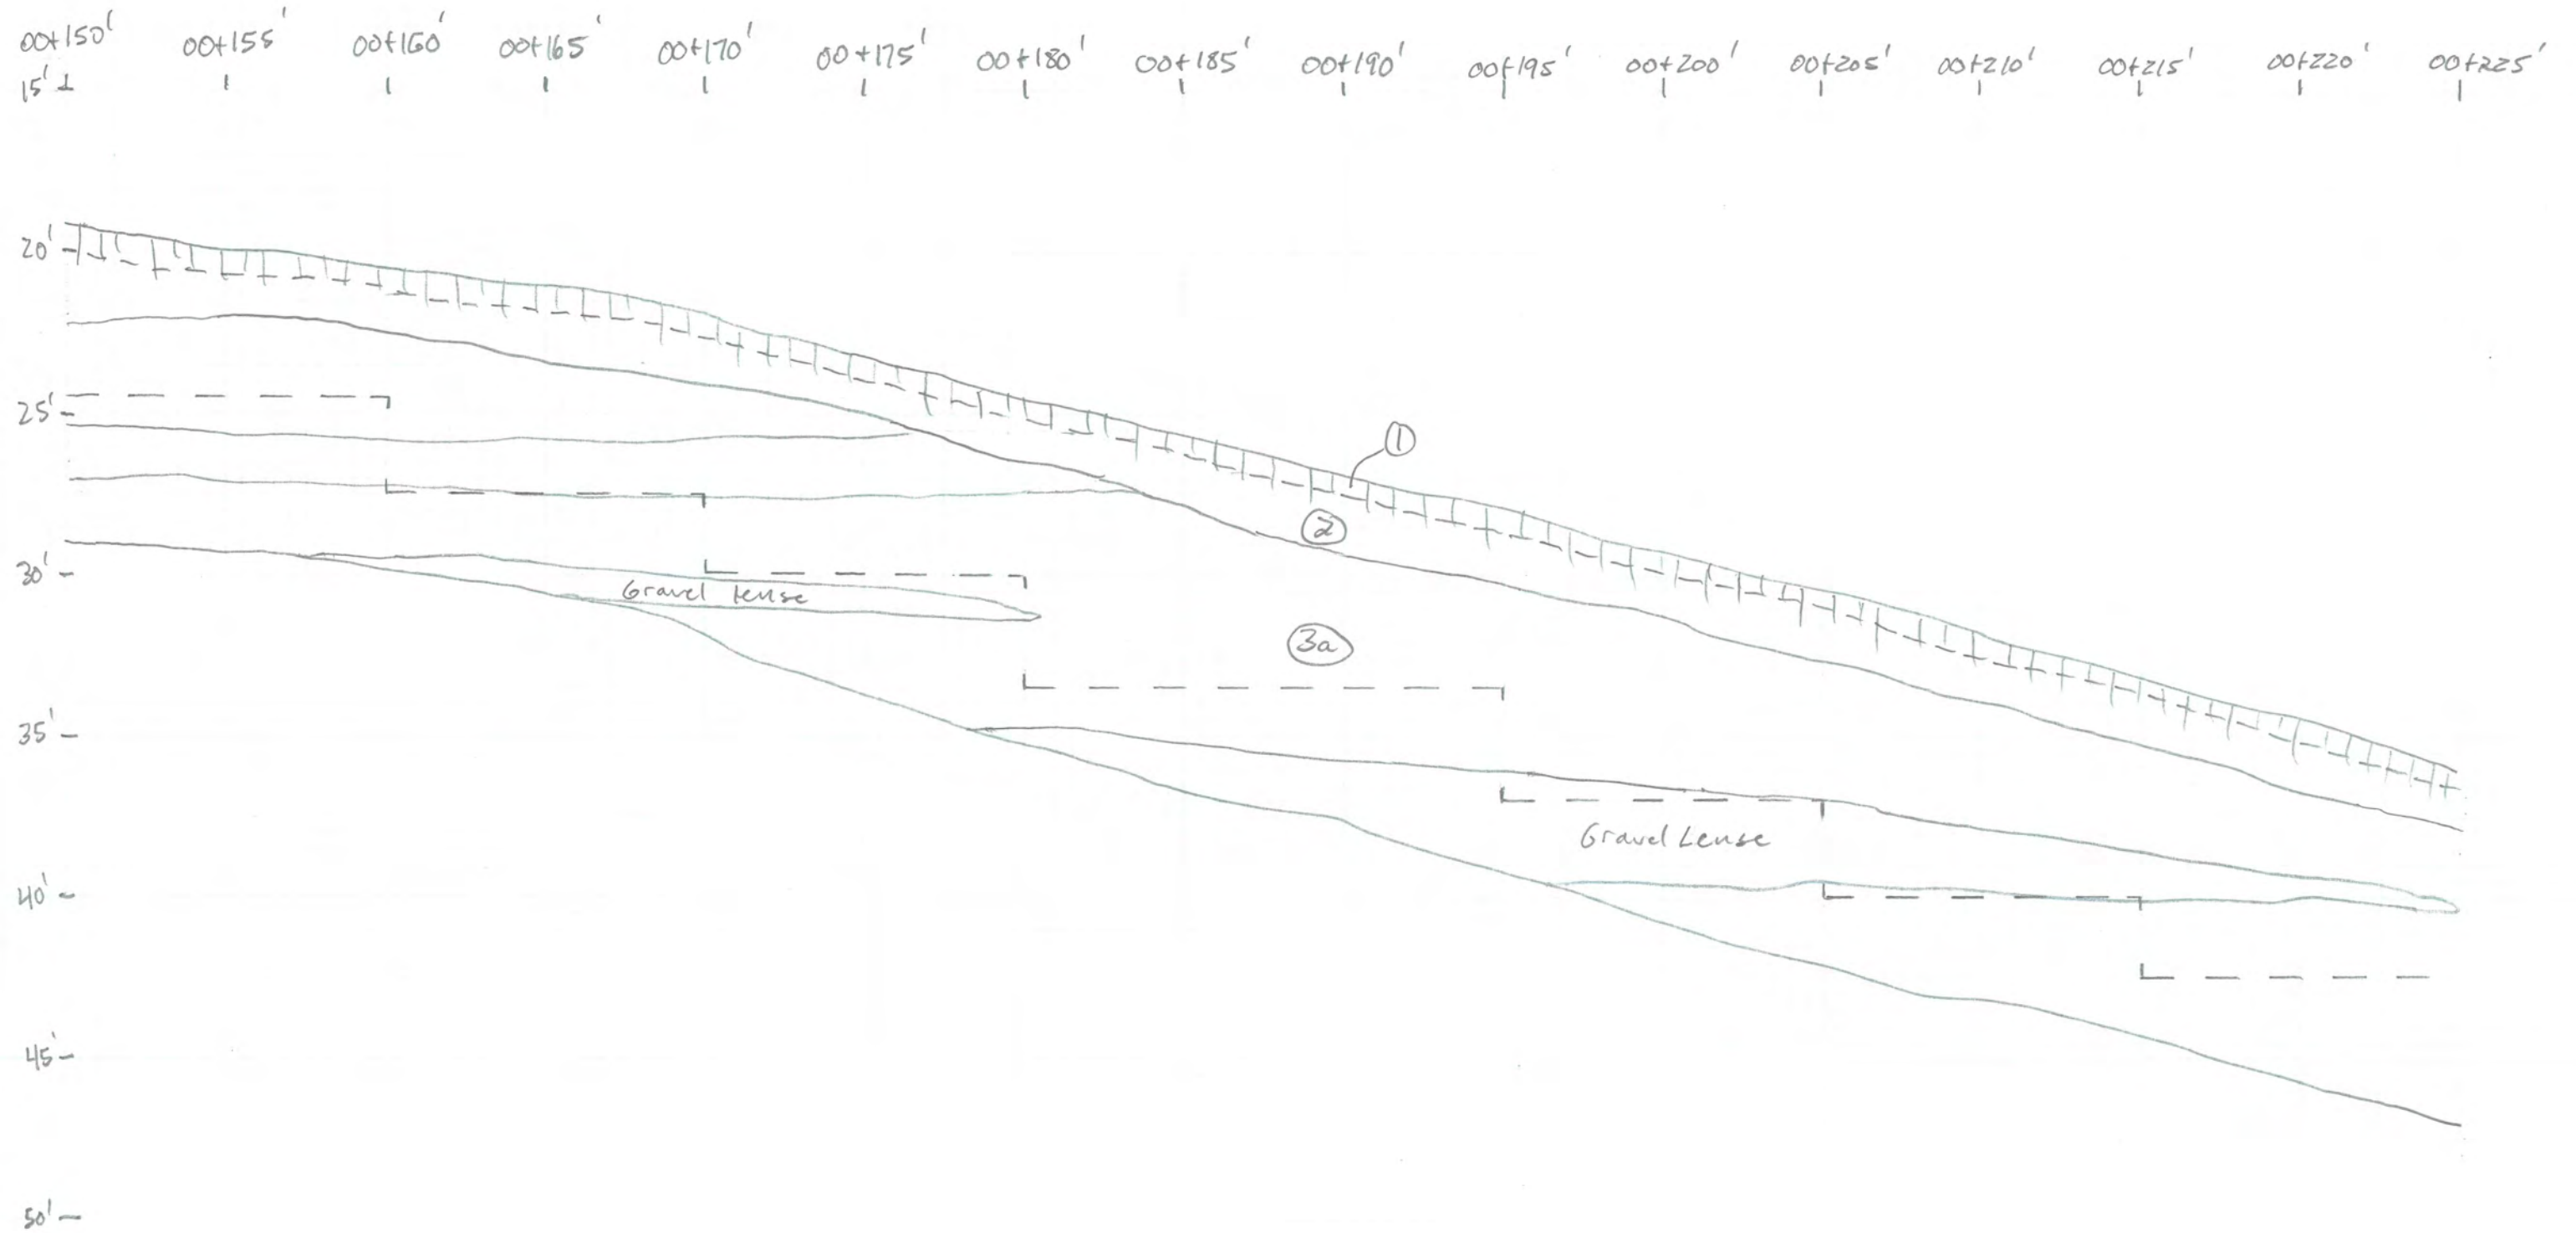
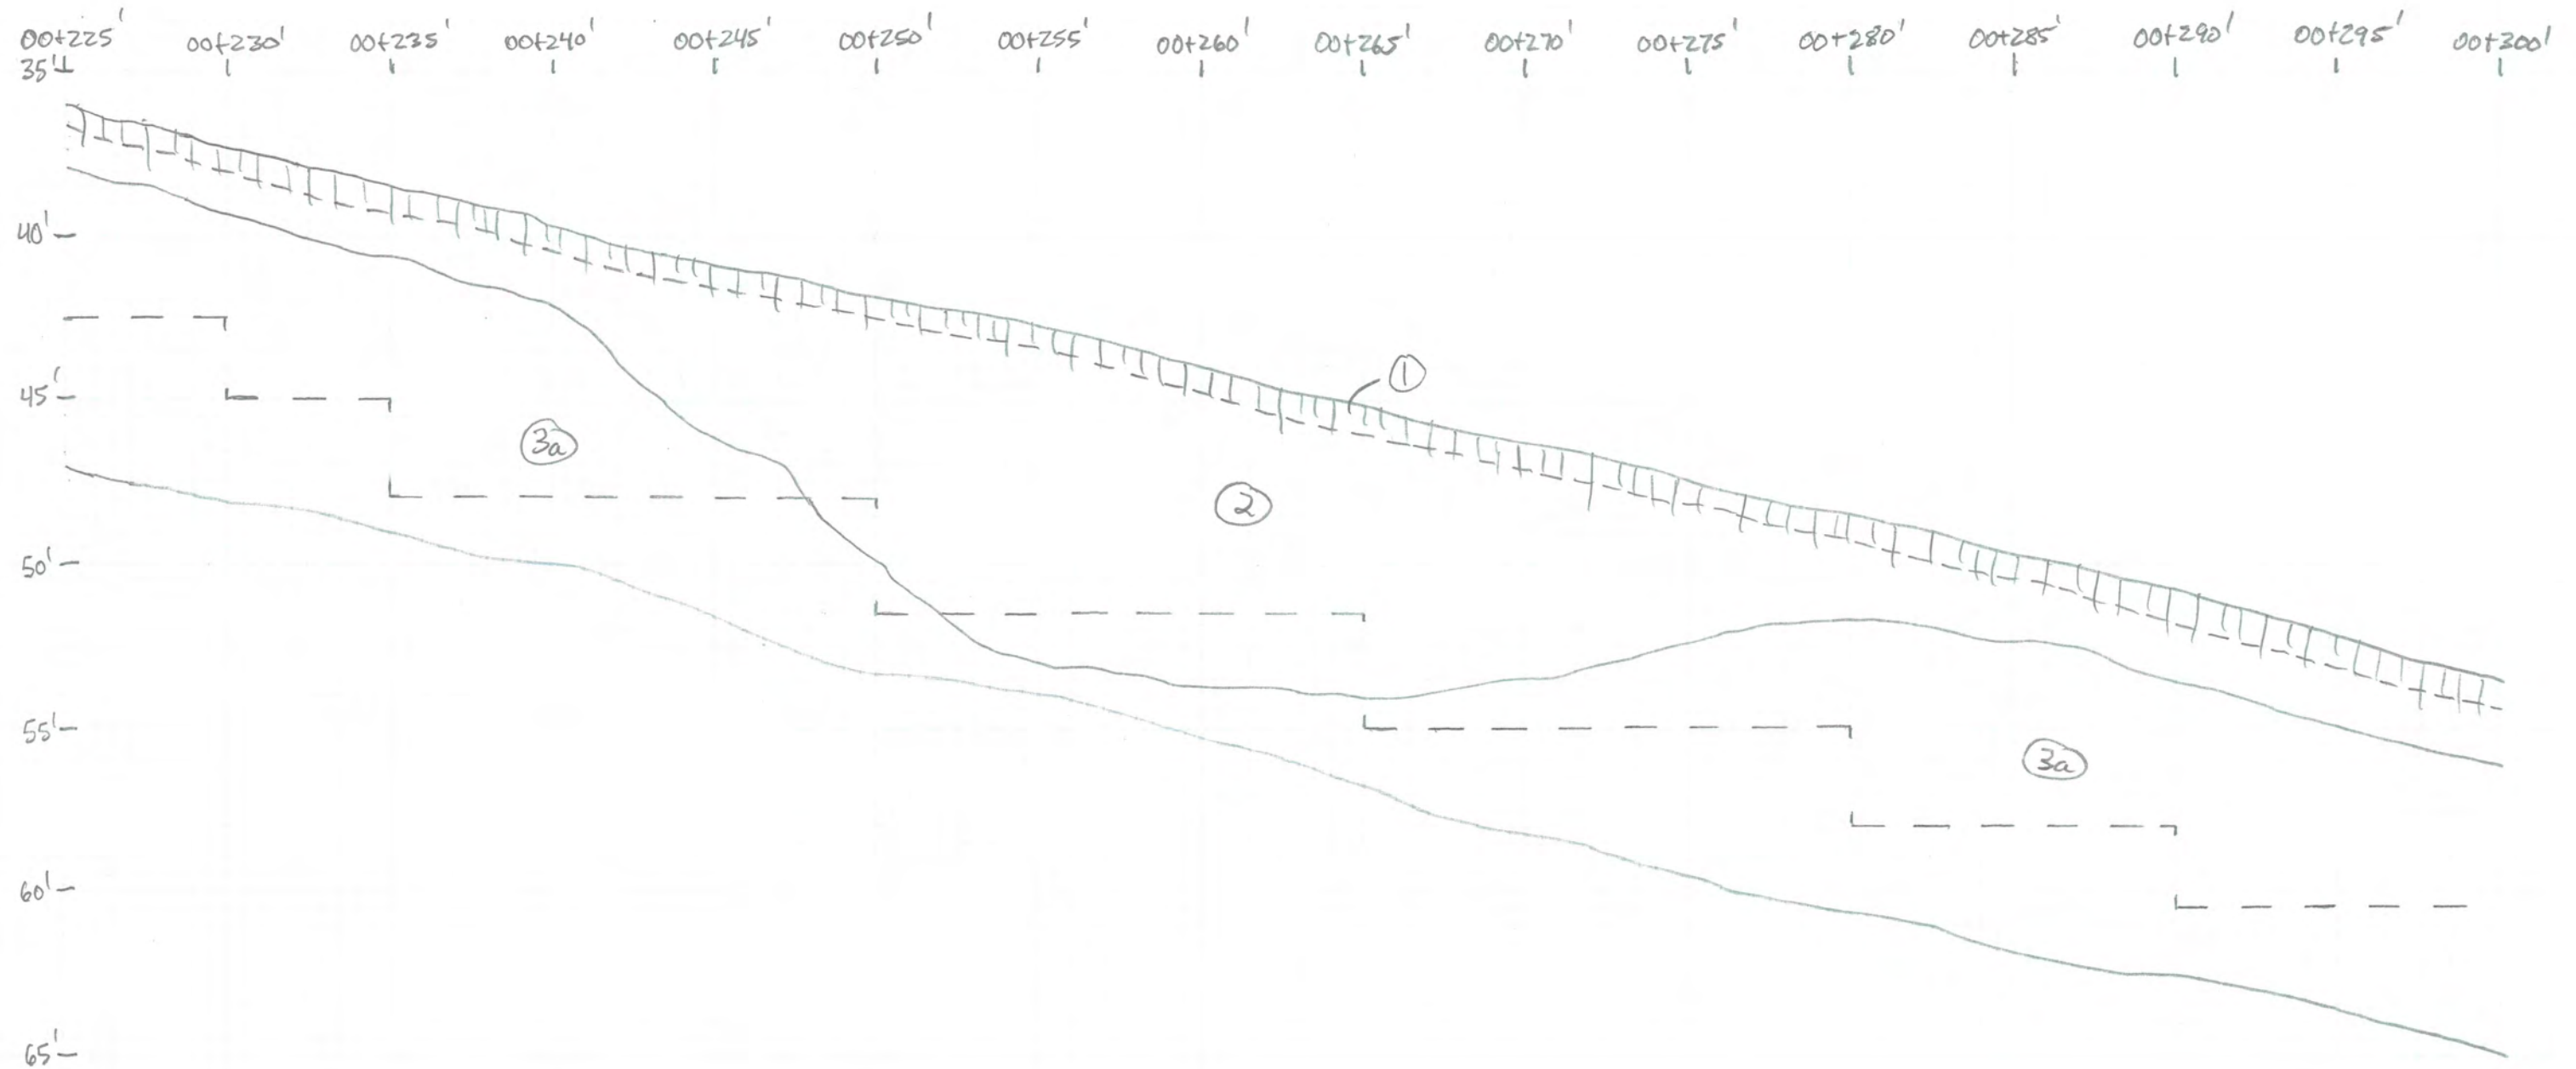
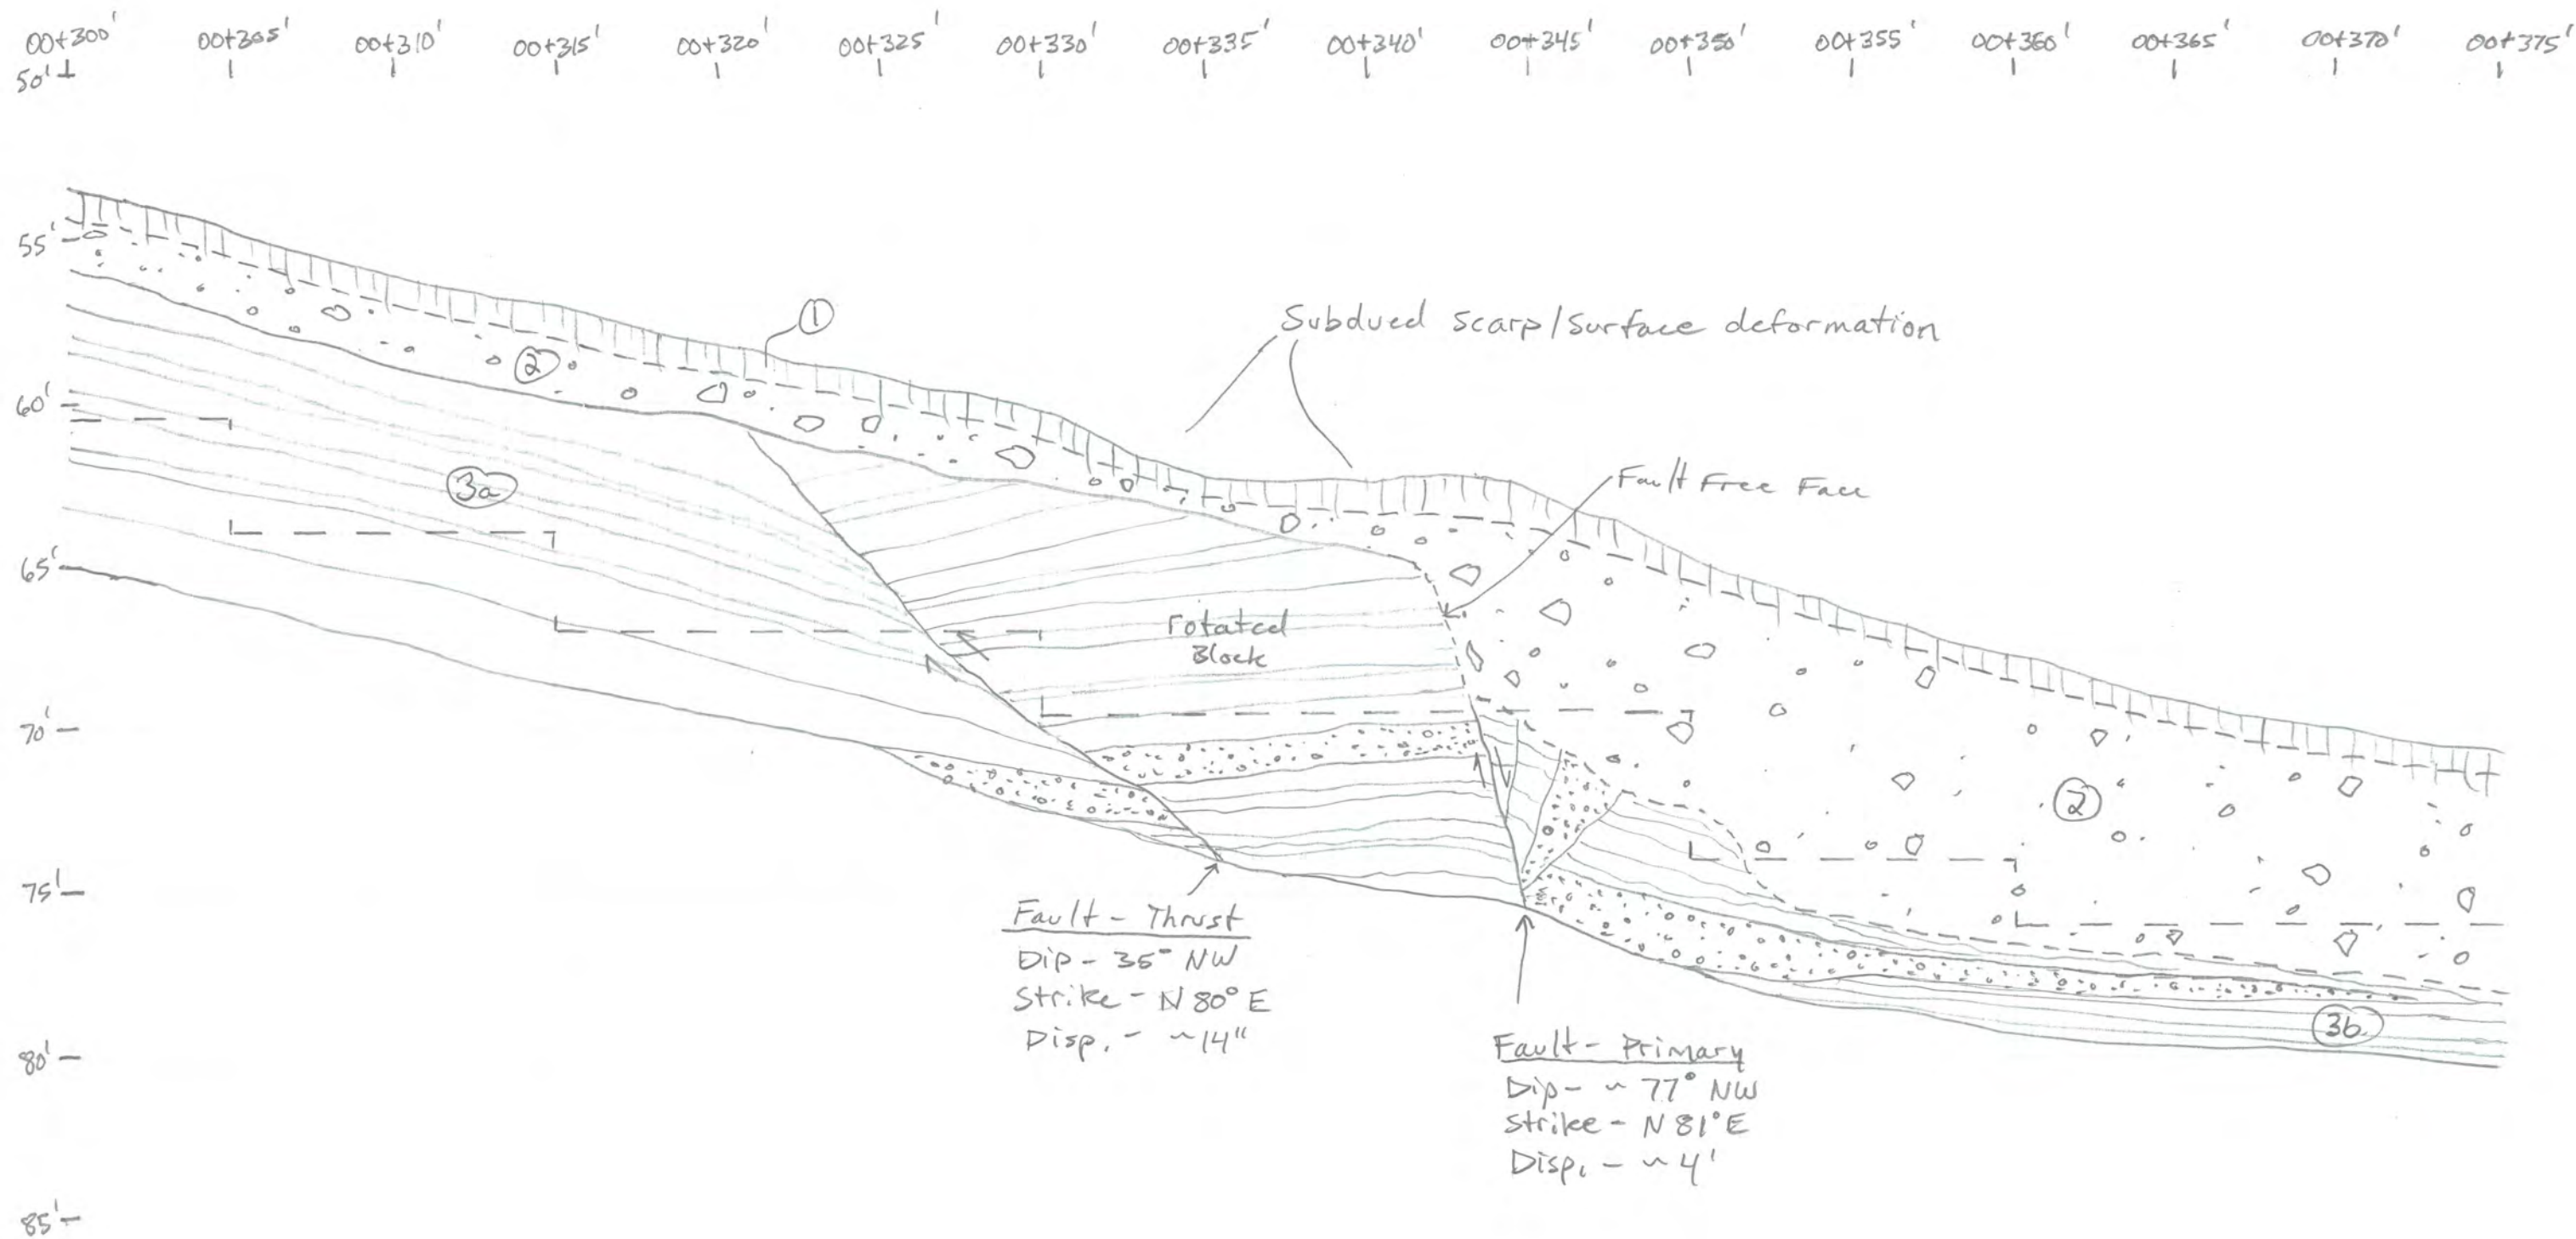
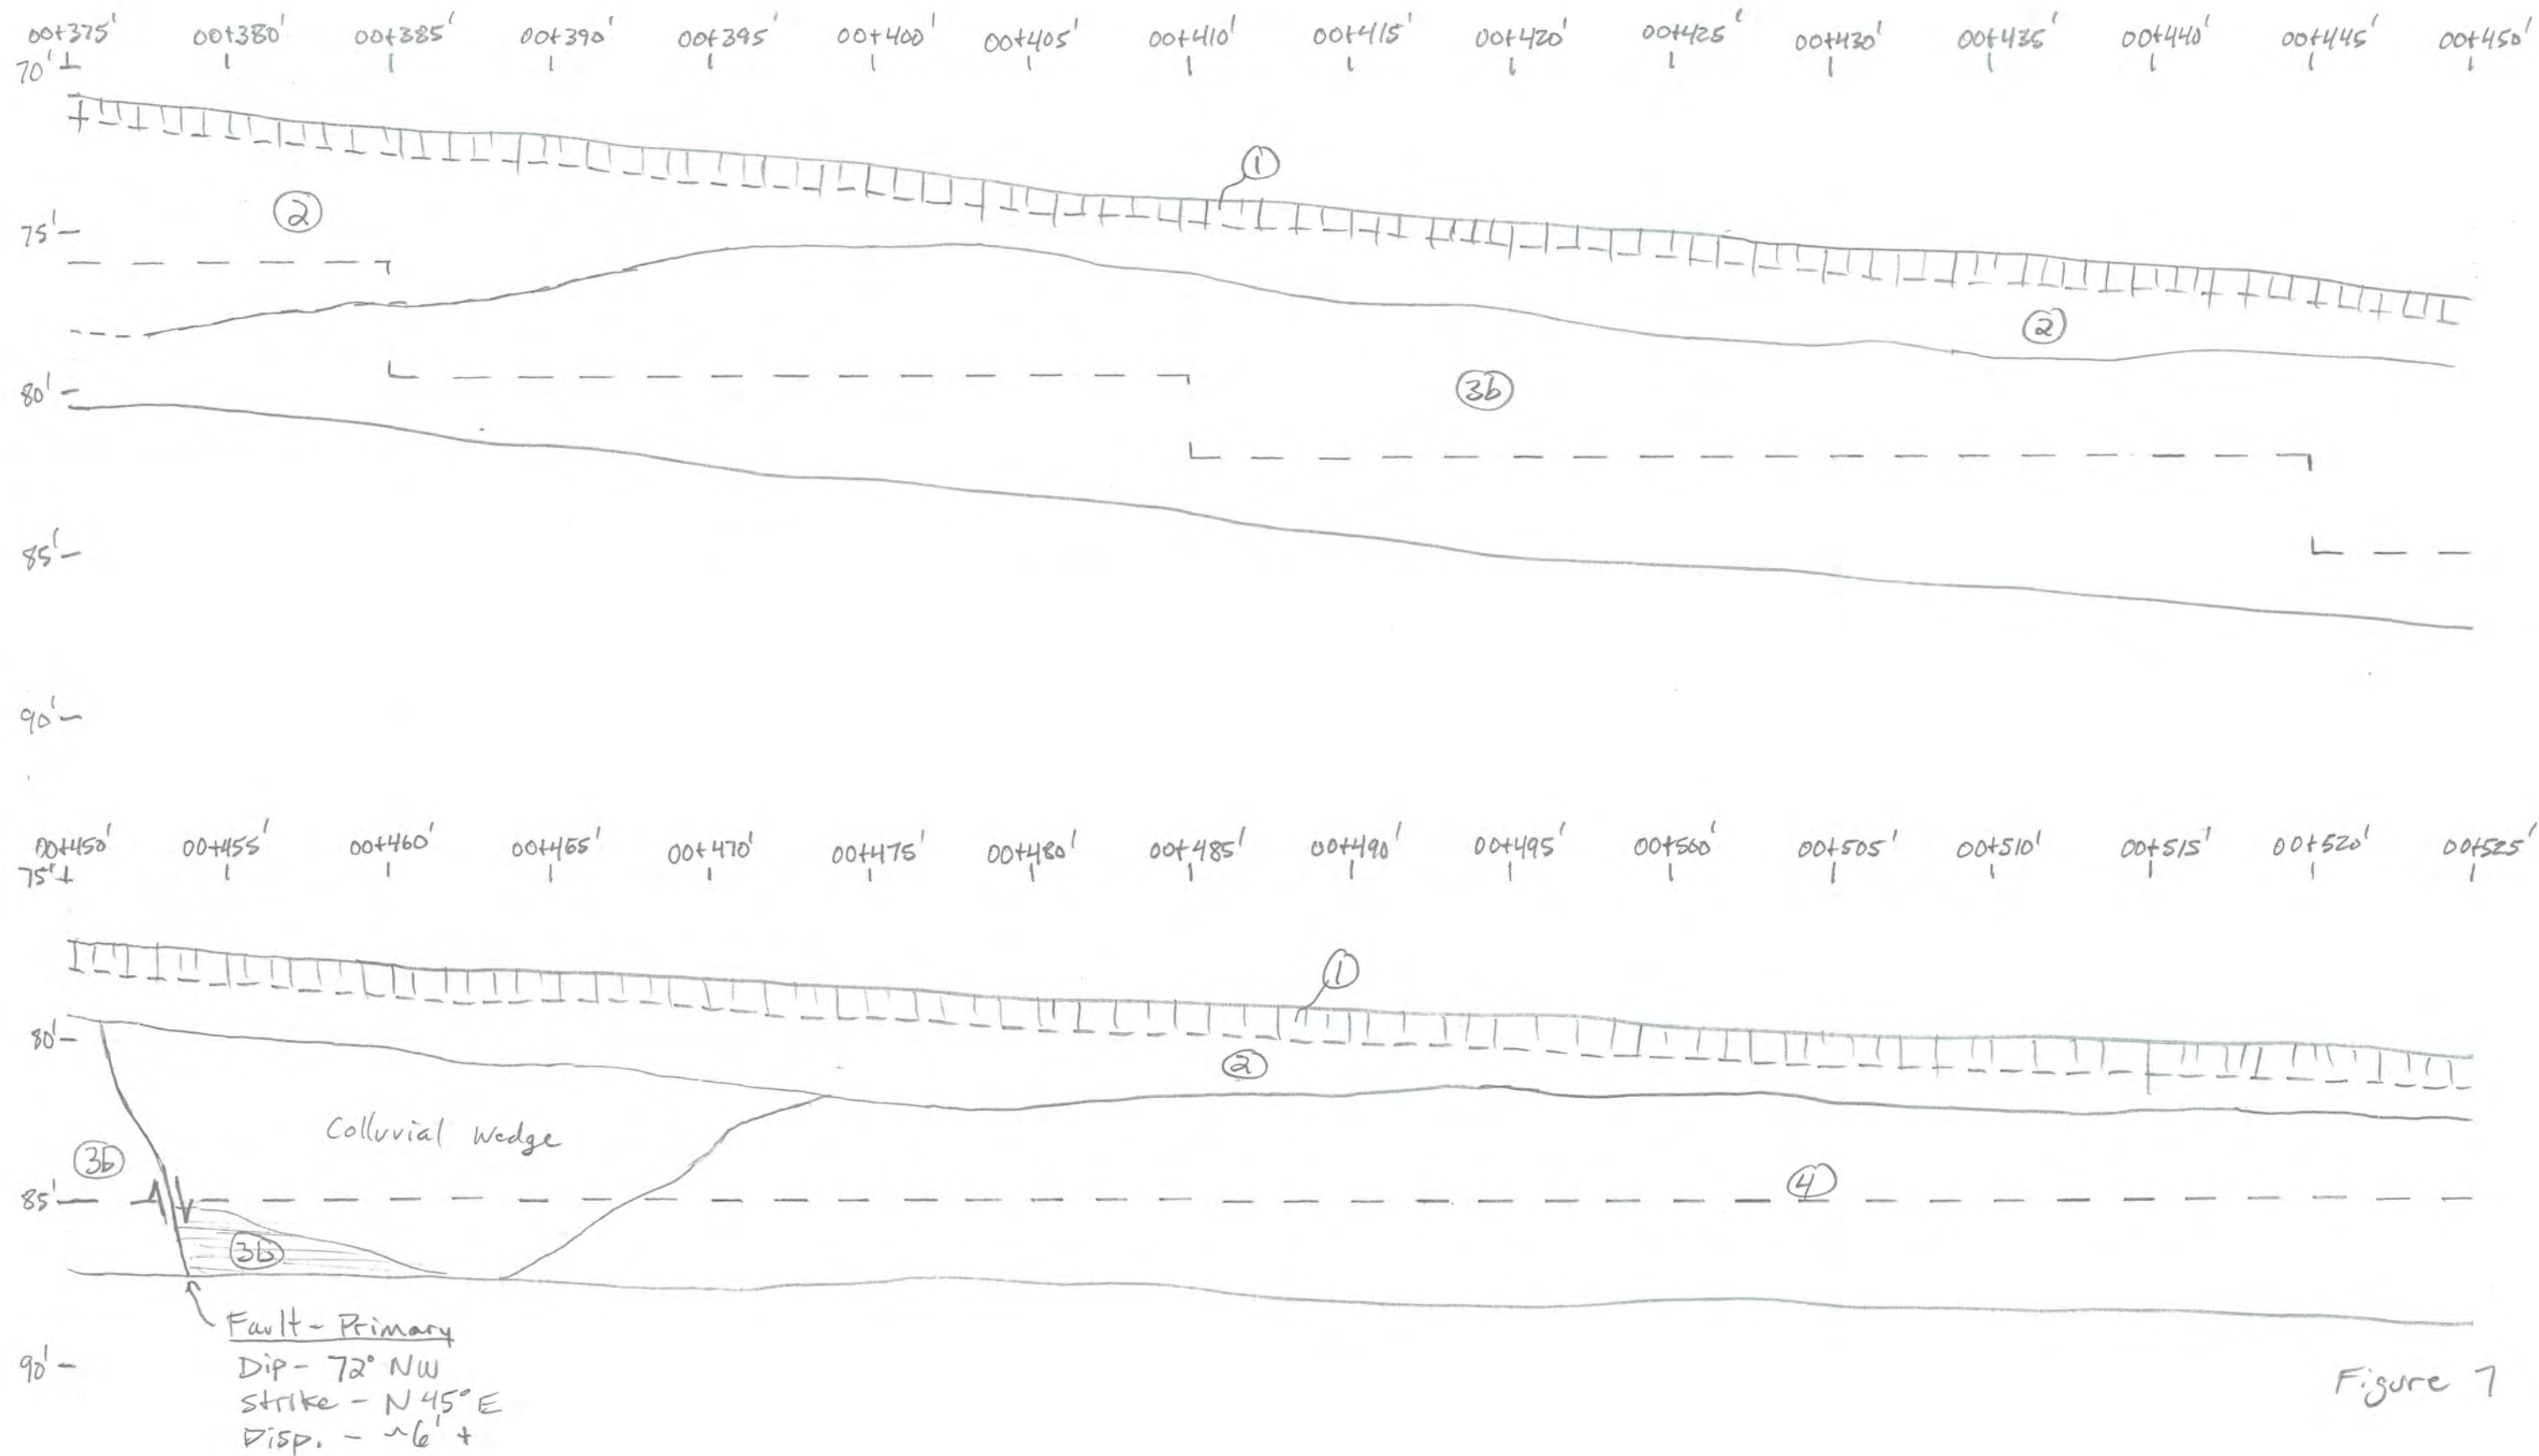
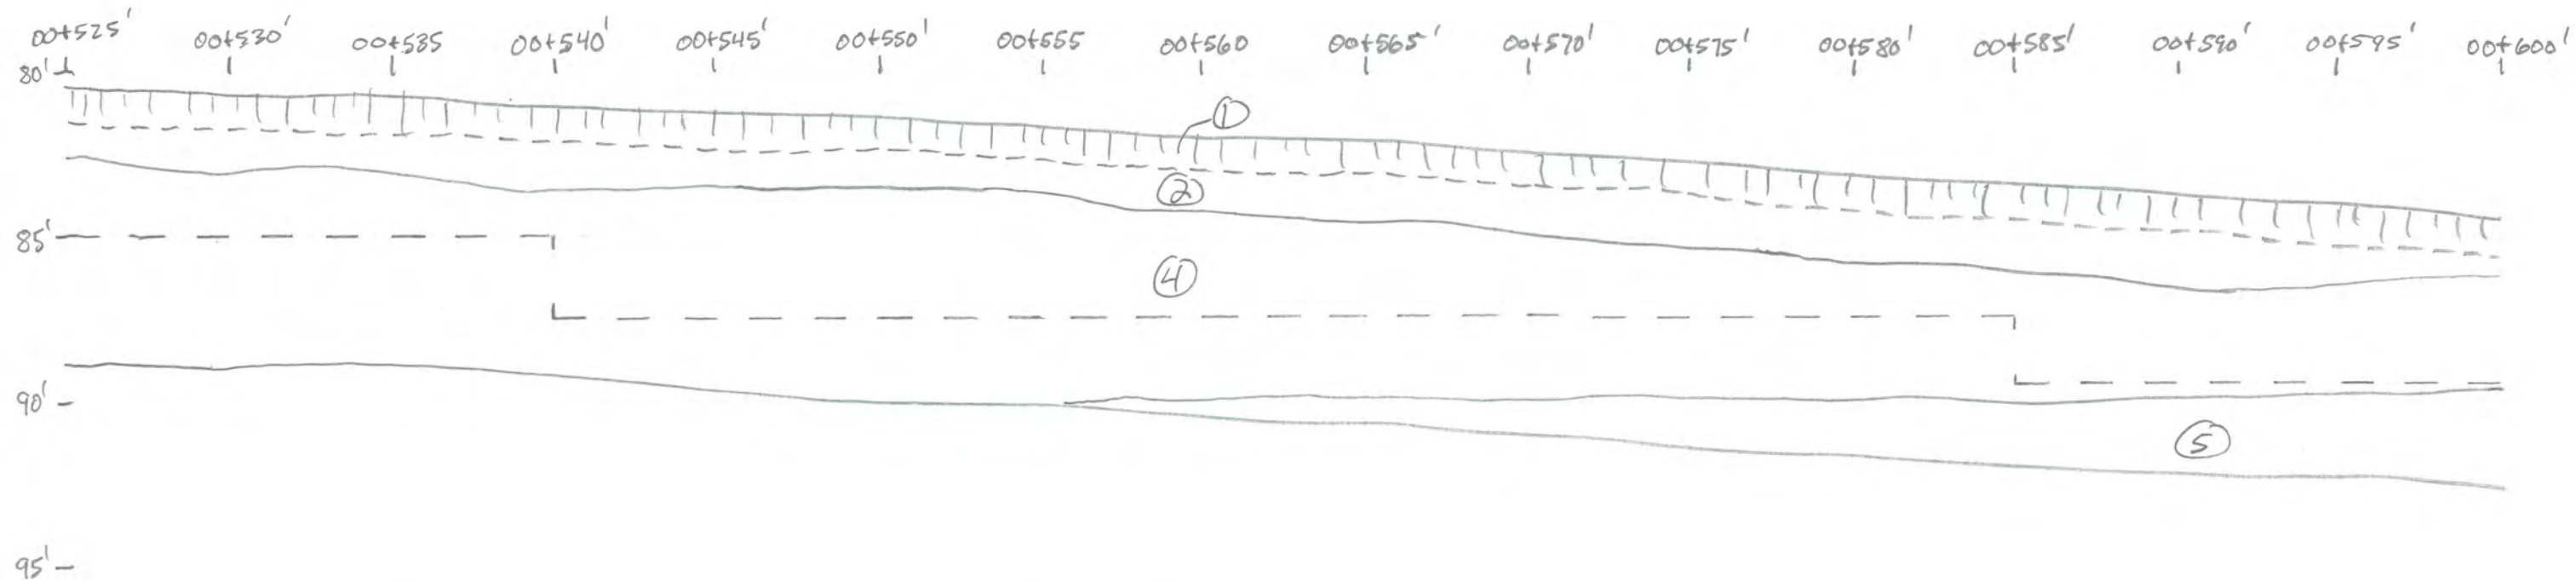
Figure 7

Trench Log - Trench ET-3, Santaquin Development, Santaquin, UT  
Logged By: Mark Larsen, P.G. 2/19 - 2/20, 2019

- 1.) Modern Topsoil - Soil A horizon formed Unit 2.
- 2.) Younger Fan - Alluvium & Colluvium, Undivided - Gravelly sand w/ silt, mostly massive, pebble to a few cobble-sized clasts, brown.
- 3a.) Lacustrine Sands and Gravels - Bonneville Lake Cycle - Bedded sands and gravels, mostly pebble-sized gravels, beds dip steeply in SE portion of trench and flatten to NW. - may show both transgressive and regressive deposits. gray to grayish-tan. Includes some gravel lenses w/ cobbles.
- 3b.) Lacustrine silts and sands - Bonneville Lake Cycle - Thinly-bedded, interbedded fine sands and silts, grayish-tan.
- 4.) Lacustrine silts and clays - Bonneville Lake Cycle - Thinly bedded, interbedded silts and clays w/ some fine sand beds, grayish-tan.
- 5.) Lacustrine Gravels - Bonneville Lake Cycle - Bedded, subrounded to rounded gravels, pebble to small boulder-sized clasts, w/ sand, gray.

185' Gap in Log -  
 no significant  
 features or changes  
 in strata.

The maximum net vertical displacement across the fault zone at the subject site was observed and measured to be in excess of 8 feet (**Figures 5 through 12**). As previously discussed in **Section 4.6**, the UGS (DuRoss and others, 2008) observed up to 9 feet of displacement in their trenches just west-southwest of the subject site. To avoid structural failure in habitable structures and critical infrastructure during a future ground-rupturing earthquake event, the only currently accepted form of mitigation is to avoid placing such structures and infrastructure across or adjacent to identified active fault traces, such as those observed and mapped at the subject site. Current guidelines and our recommendations for appropriate building setbacks from the mapped faulting at the subject site are discussed in Section 5.0.

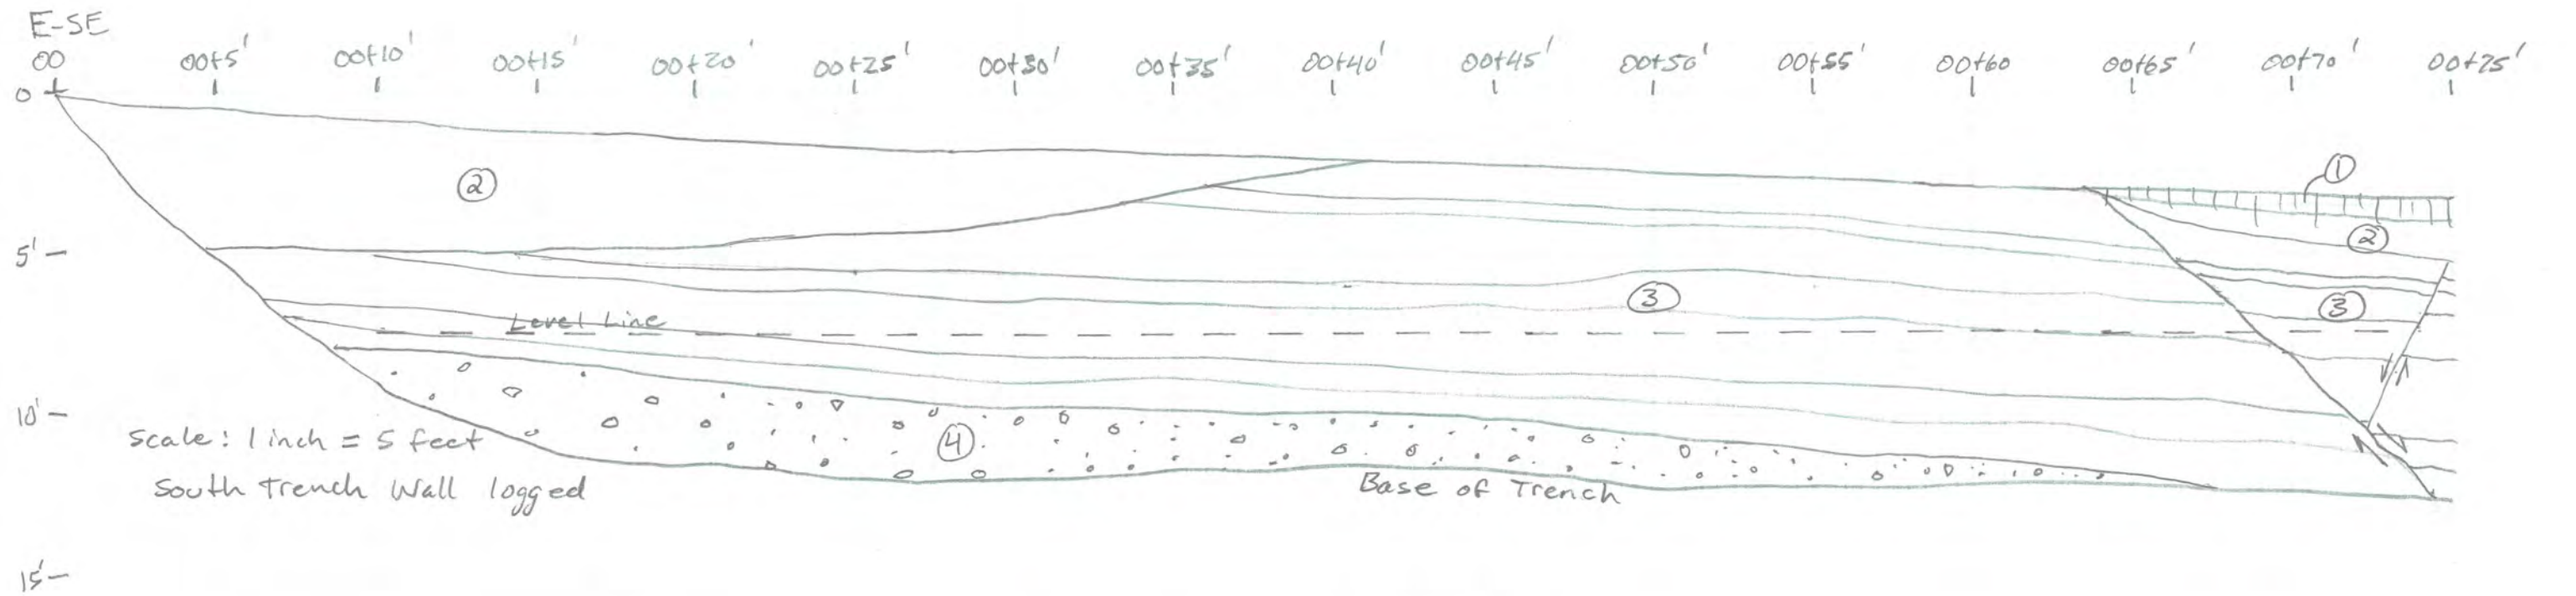
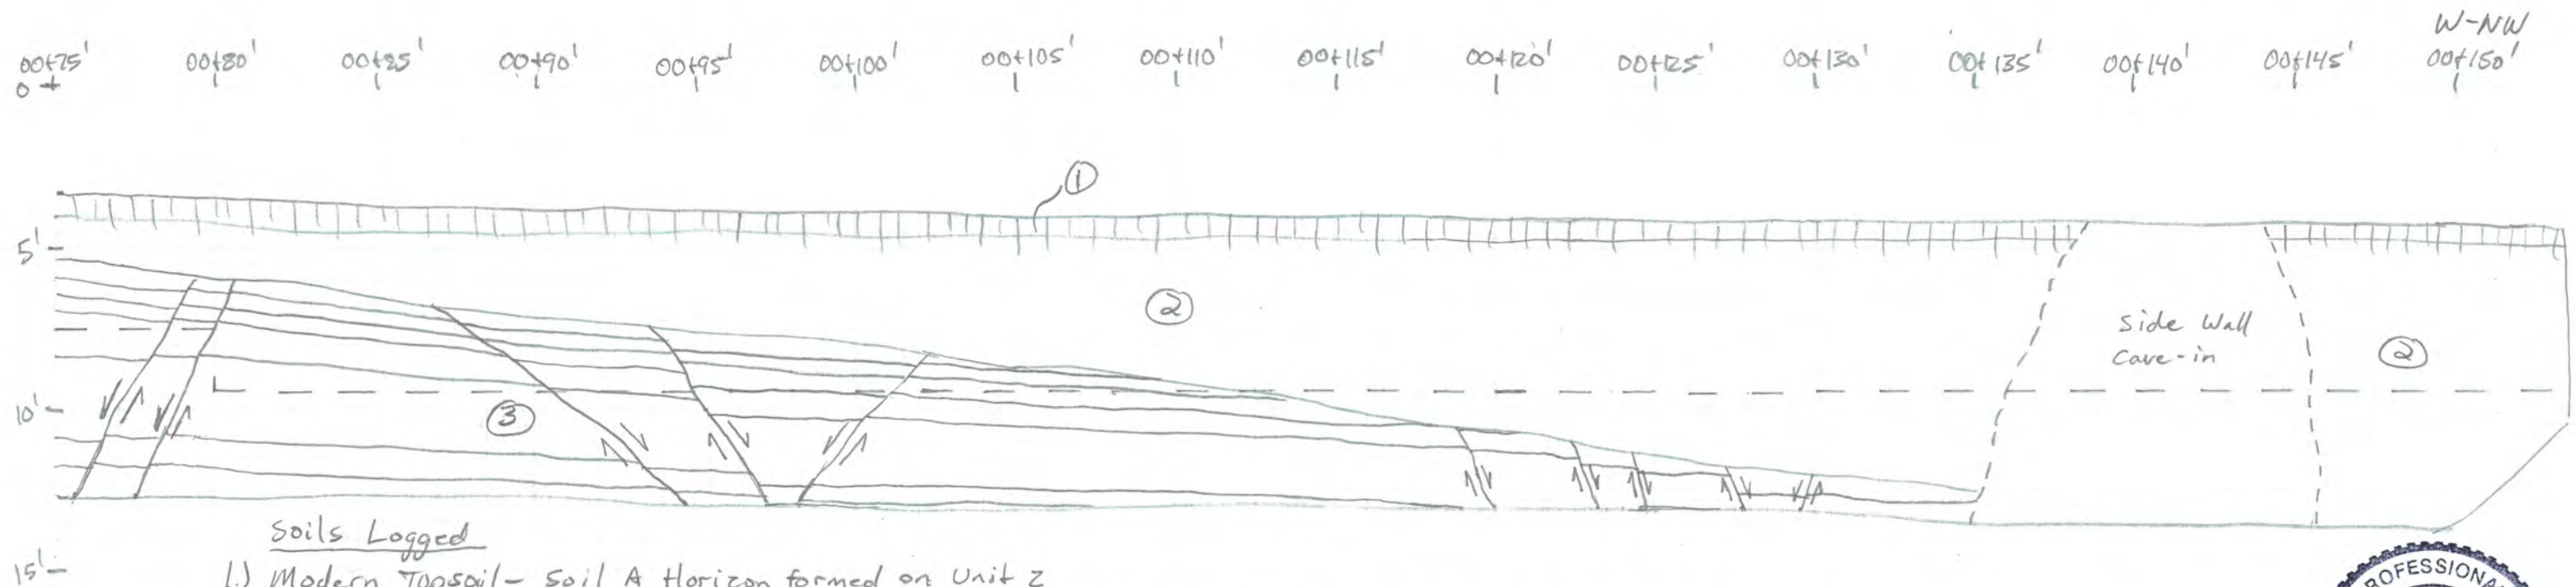
Figure 8

Trench Log - Trench ET-4 Santaquin Development, Santaquin, UT  
logged By: Mark Larsen, P.G. 3/25/19

- 1.) Modern Topsoil - Soil A Horizon formed on Unit 2
- 2.) Channel fills - Sands and silts w/ some gravel - similar to Units 1 & 2 in ET-1, light brown.
- 3.) Lacustrine Deposits - Bonneville Lake Cycle - Bedded gravels and sands, pebble to cobble-sized gravel clasts, rounded to subrounded clasts, gray to grayish-tan.
- 4.) Older Fan-Alluvium - Pre Bonneville Lake Cycle - clayey gravel, angular, pebble-sized clasts, massive, grayish-brown.
