### NOTICE OF INTENTION TO COMMENCE LARGE MINING OPERATIONS

### **Geotechnical study**

## GEOLOGIC HAZARDS INVESTIGATION

Subject: Geologic Hazards Investigation  
Santaquin Heights  
Approximately 650 North State Road 198  
Santaquin, Utah  
CMT Project Number: 12330

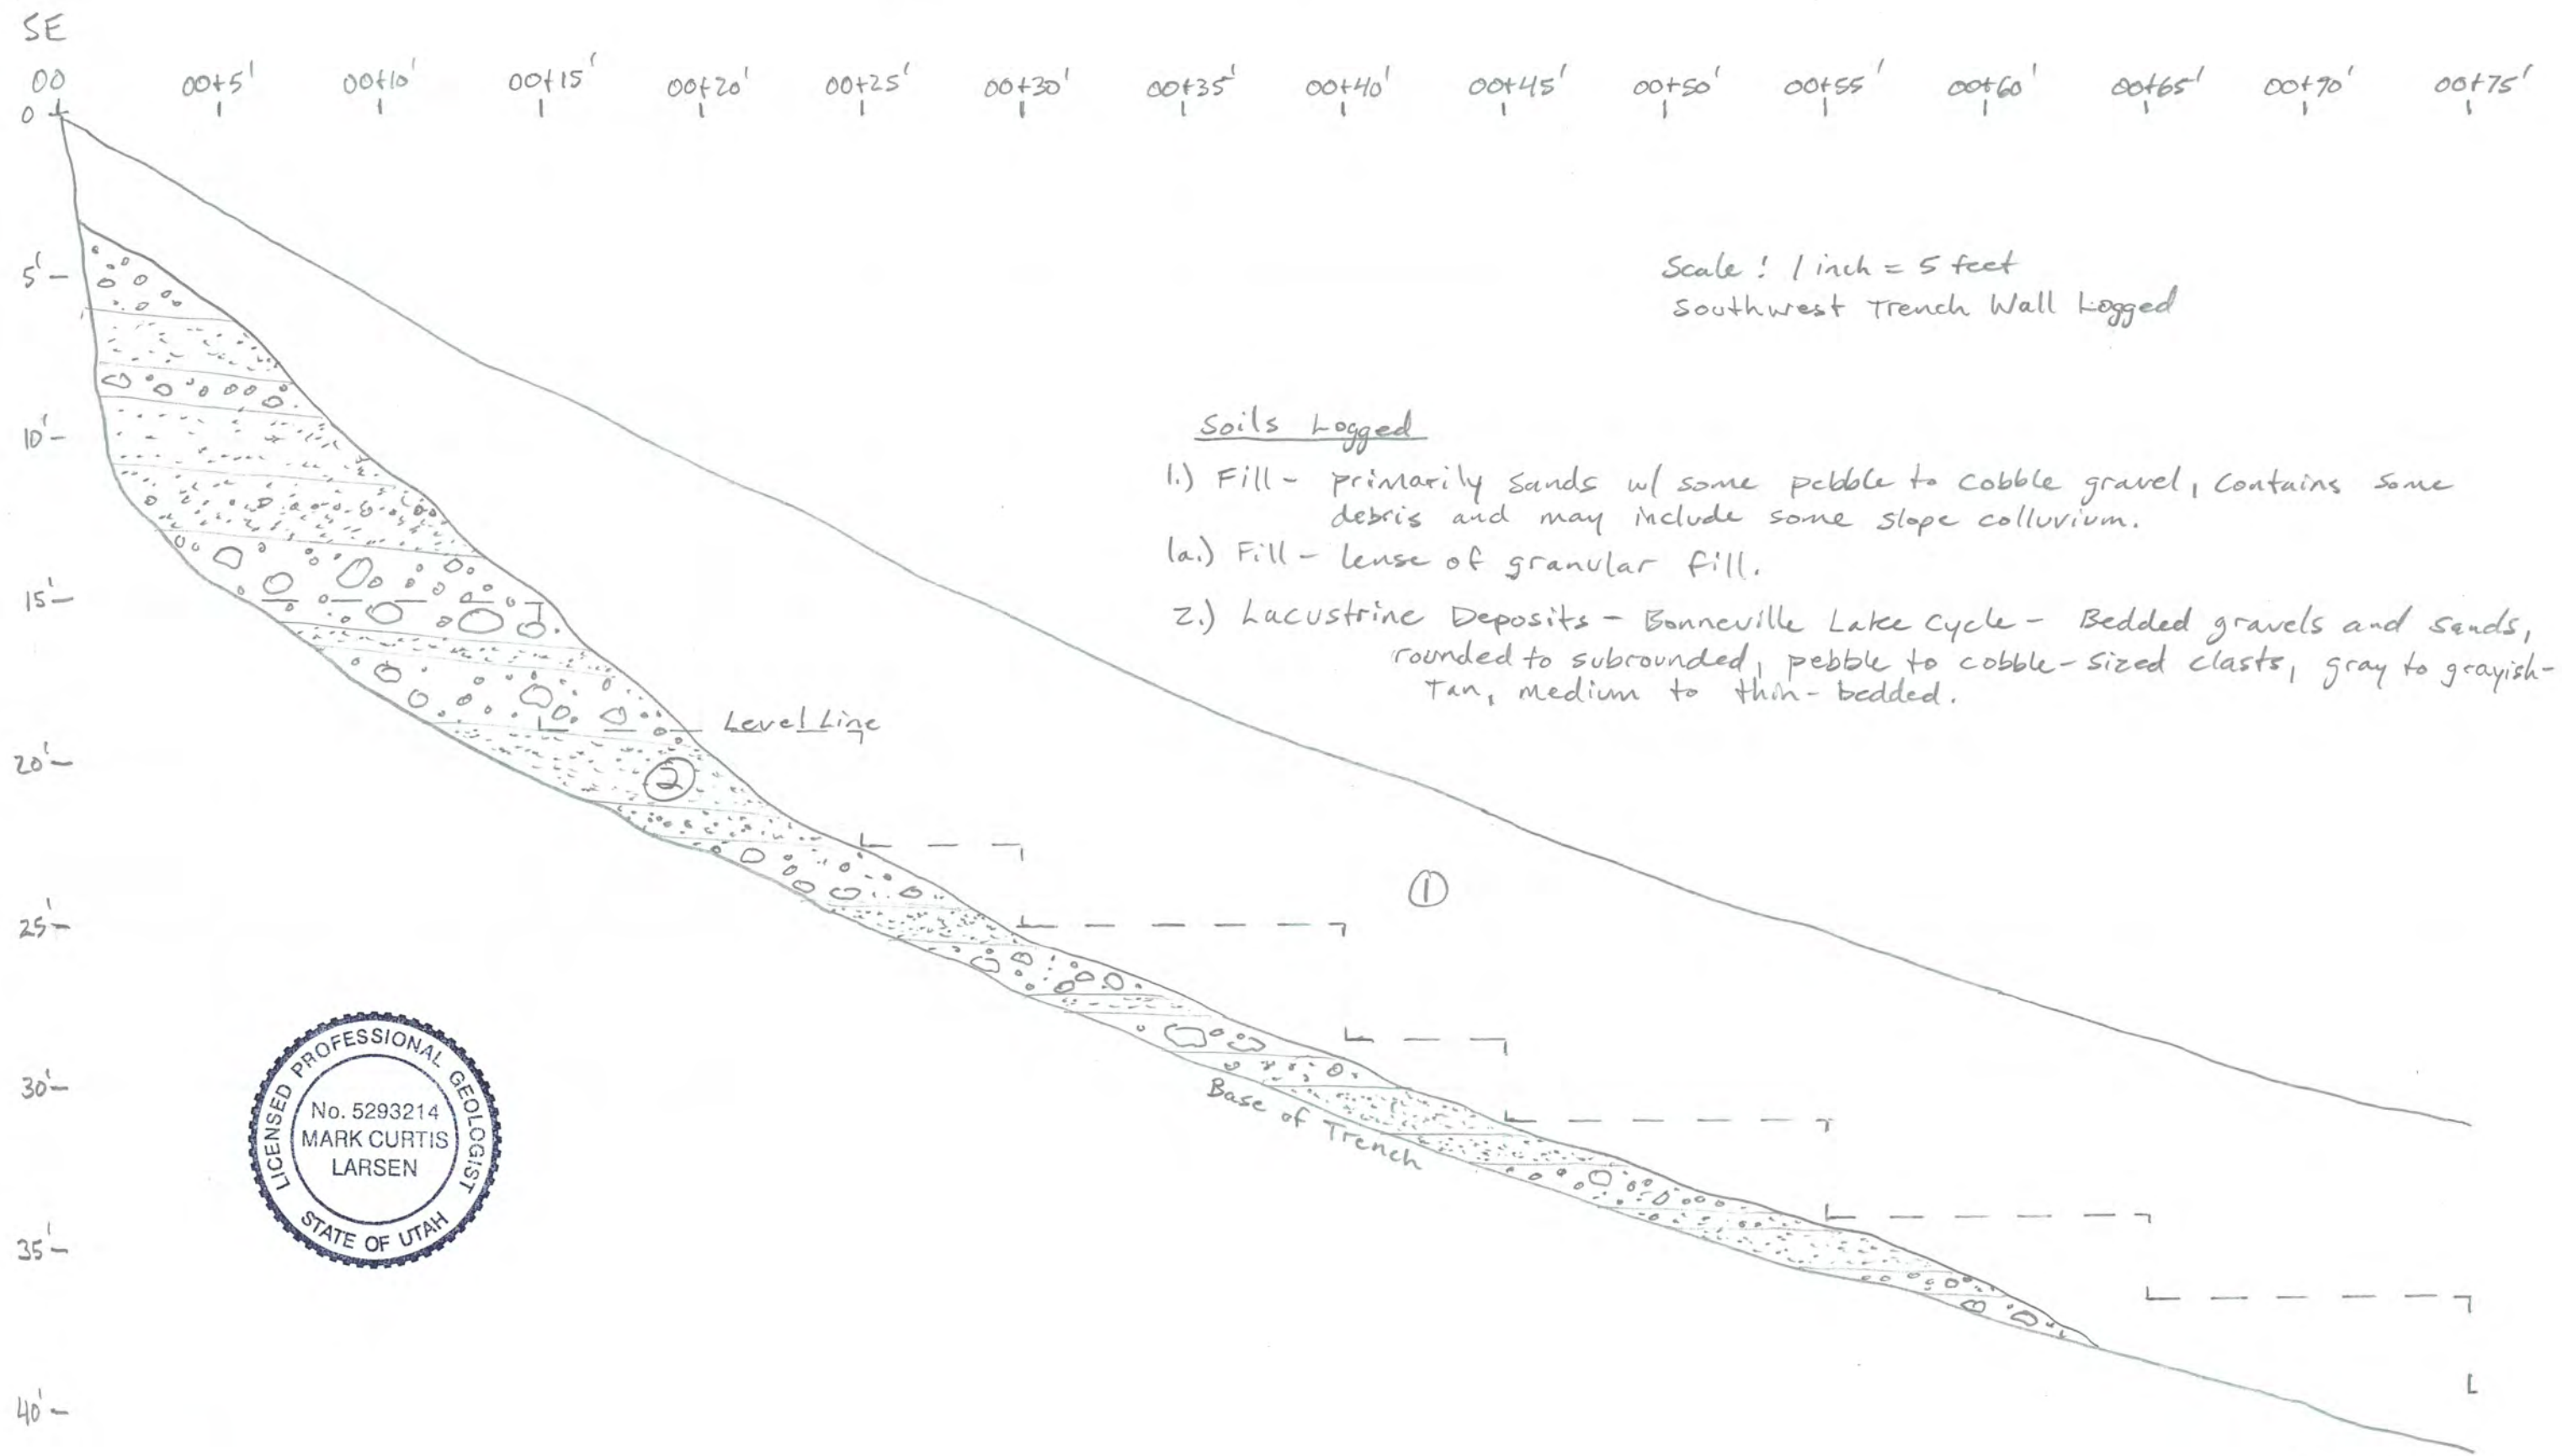
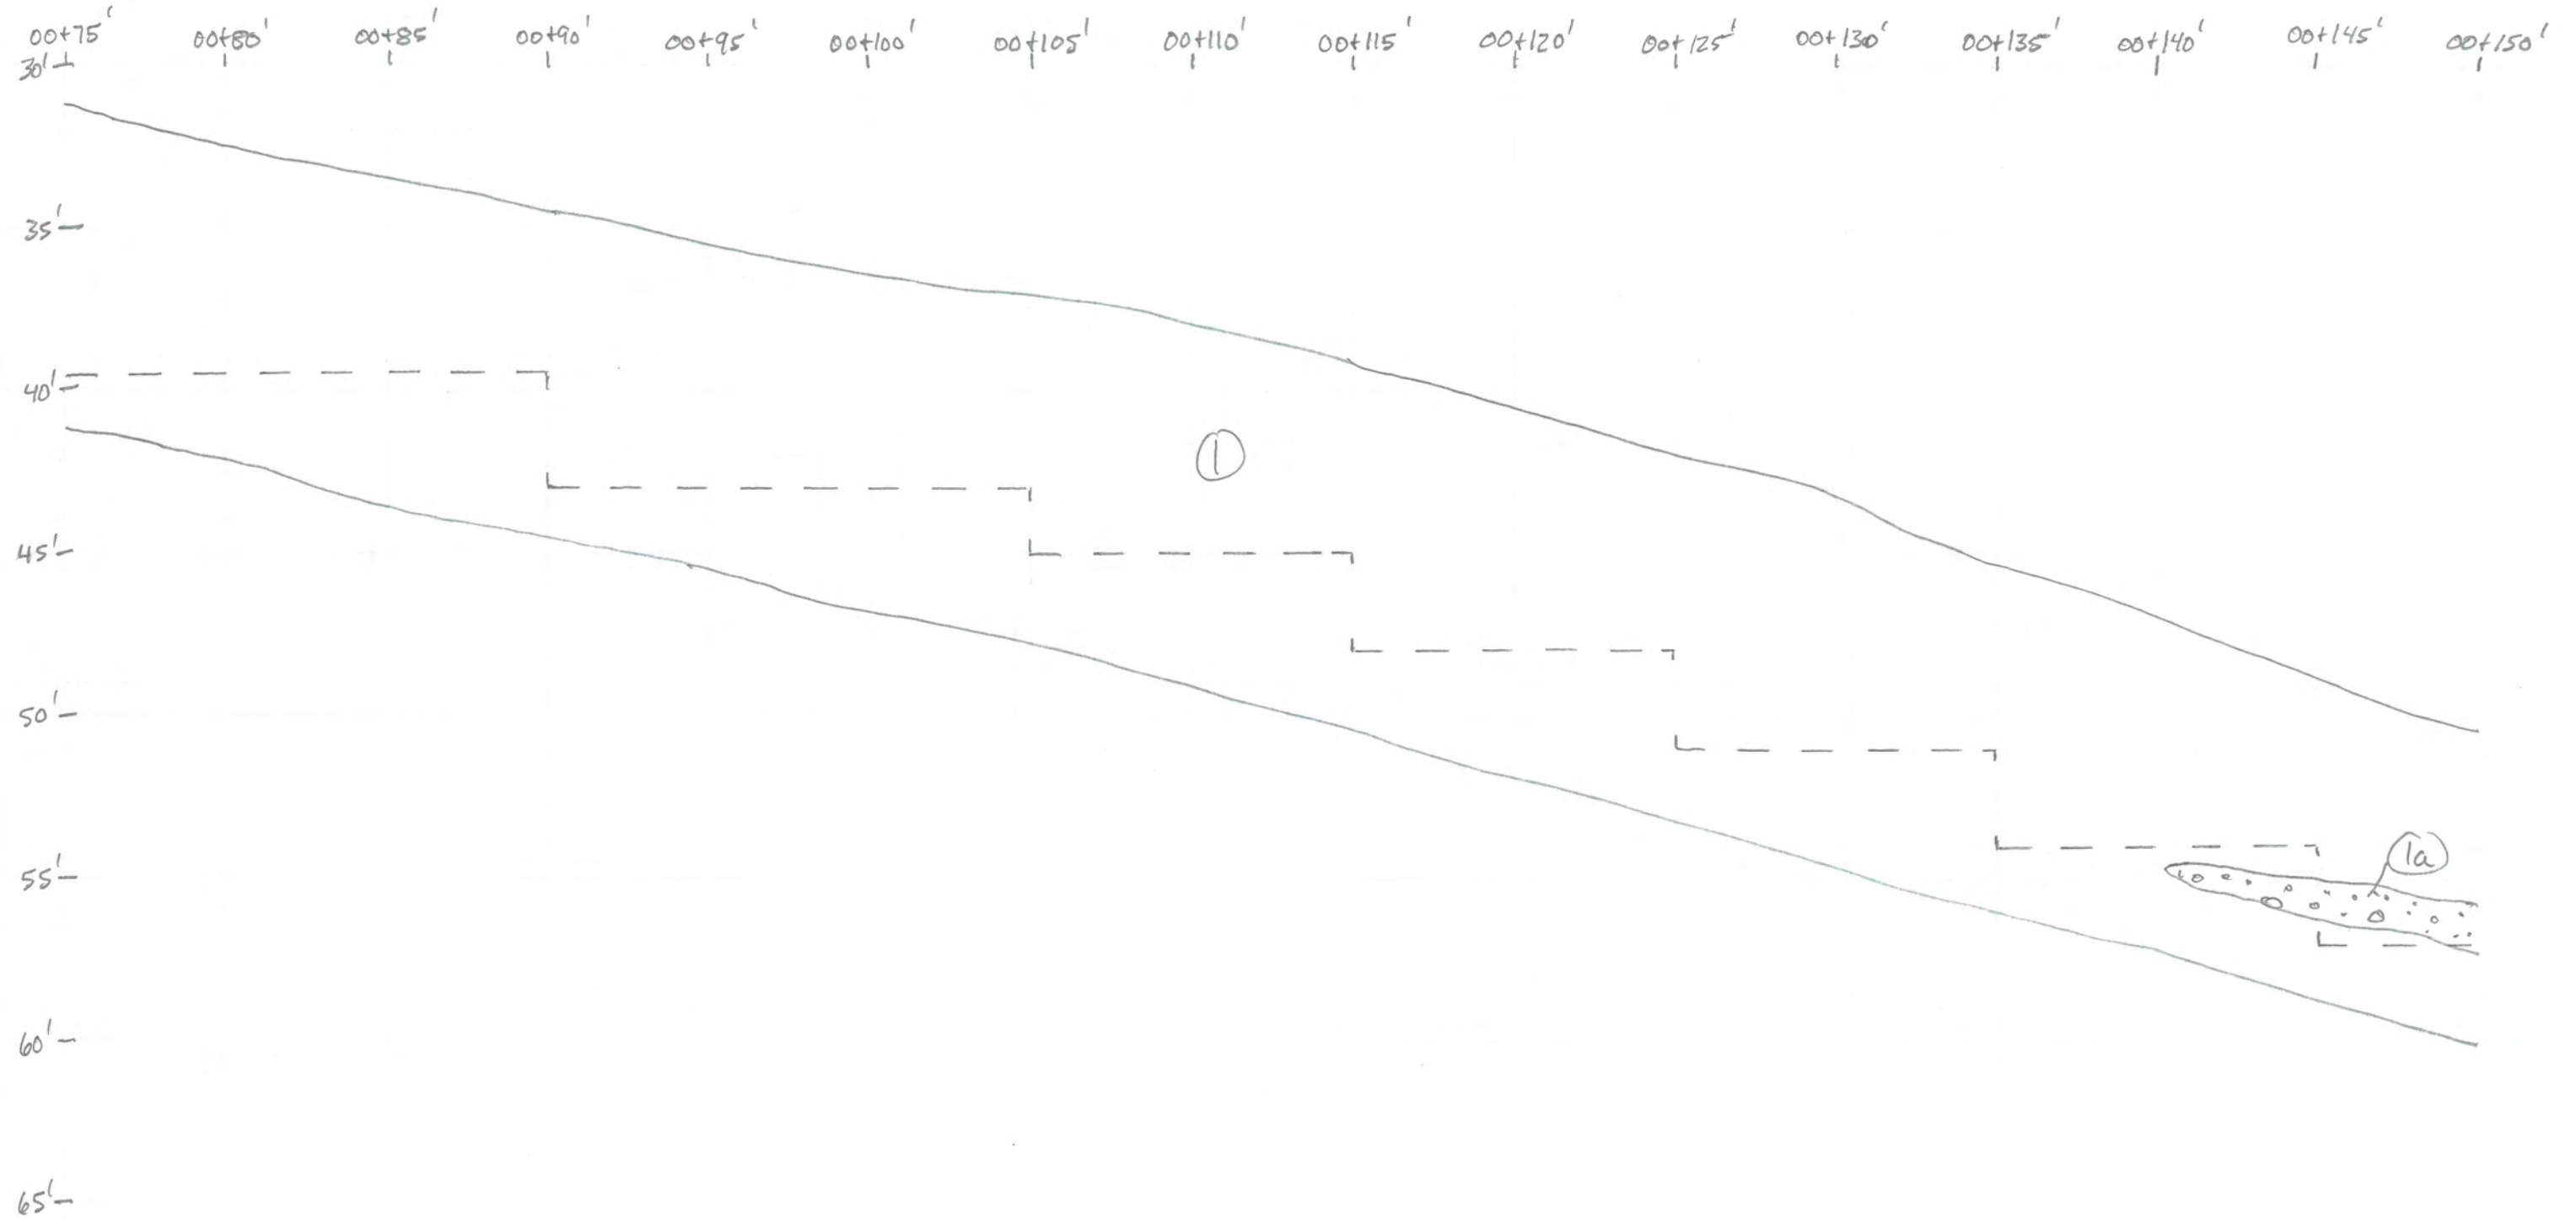
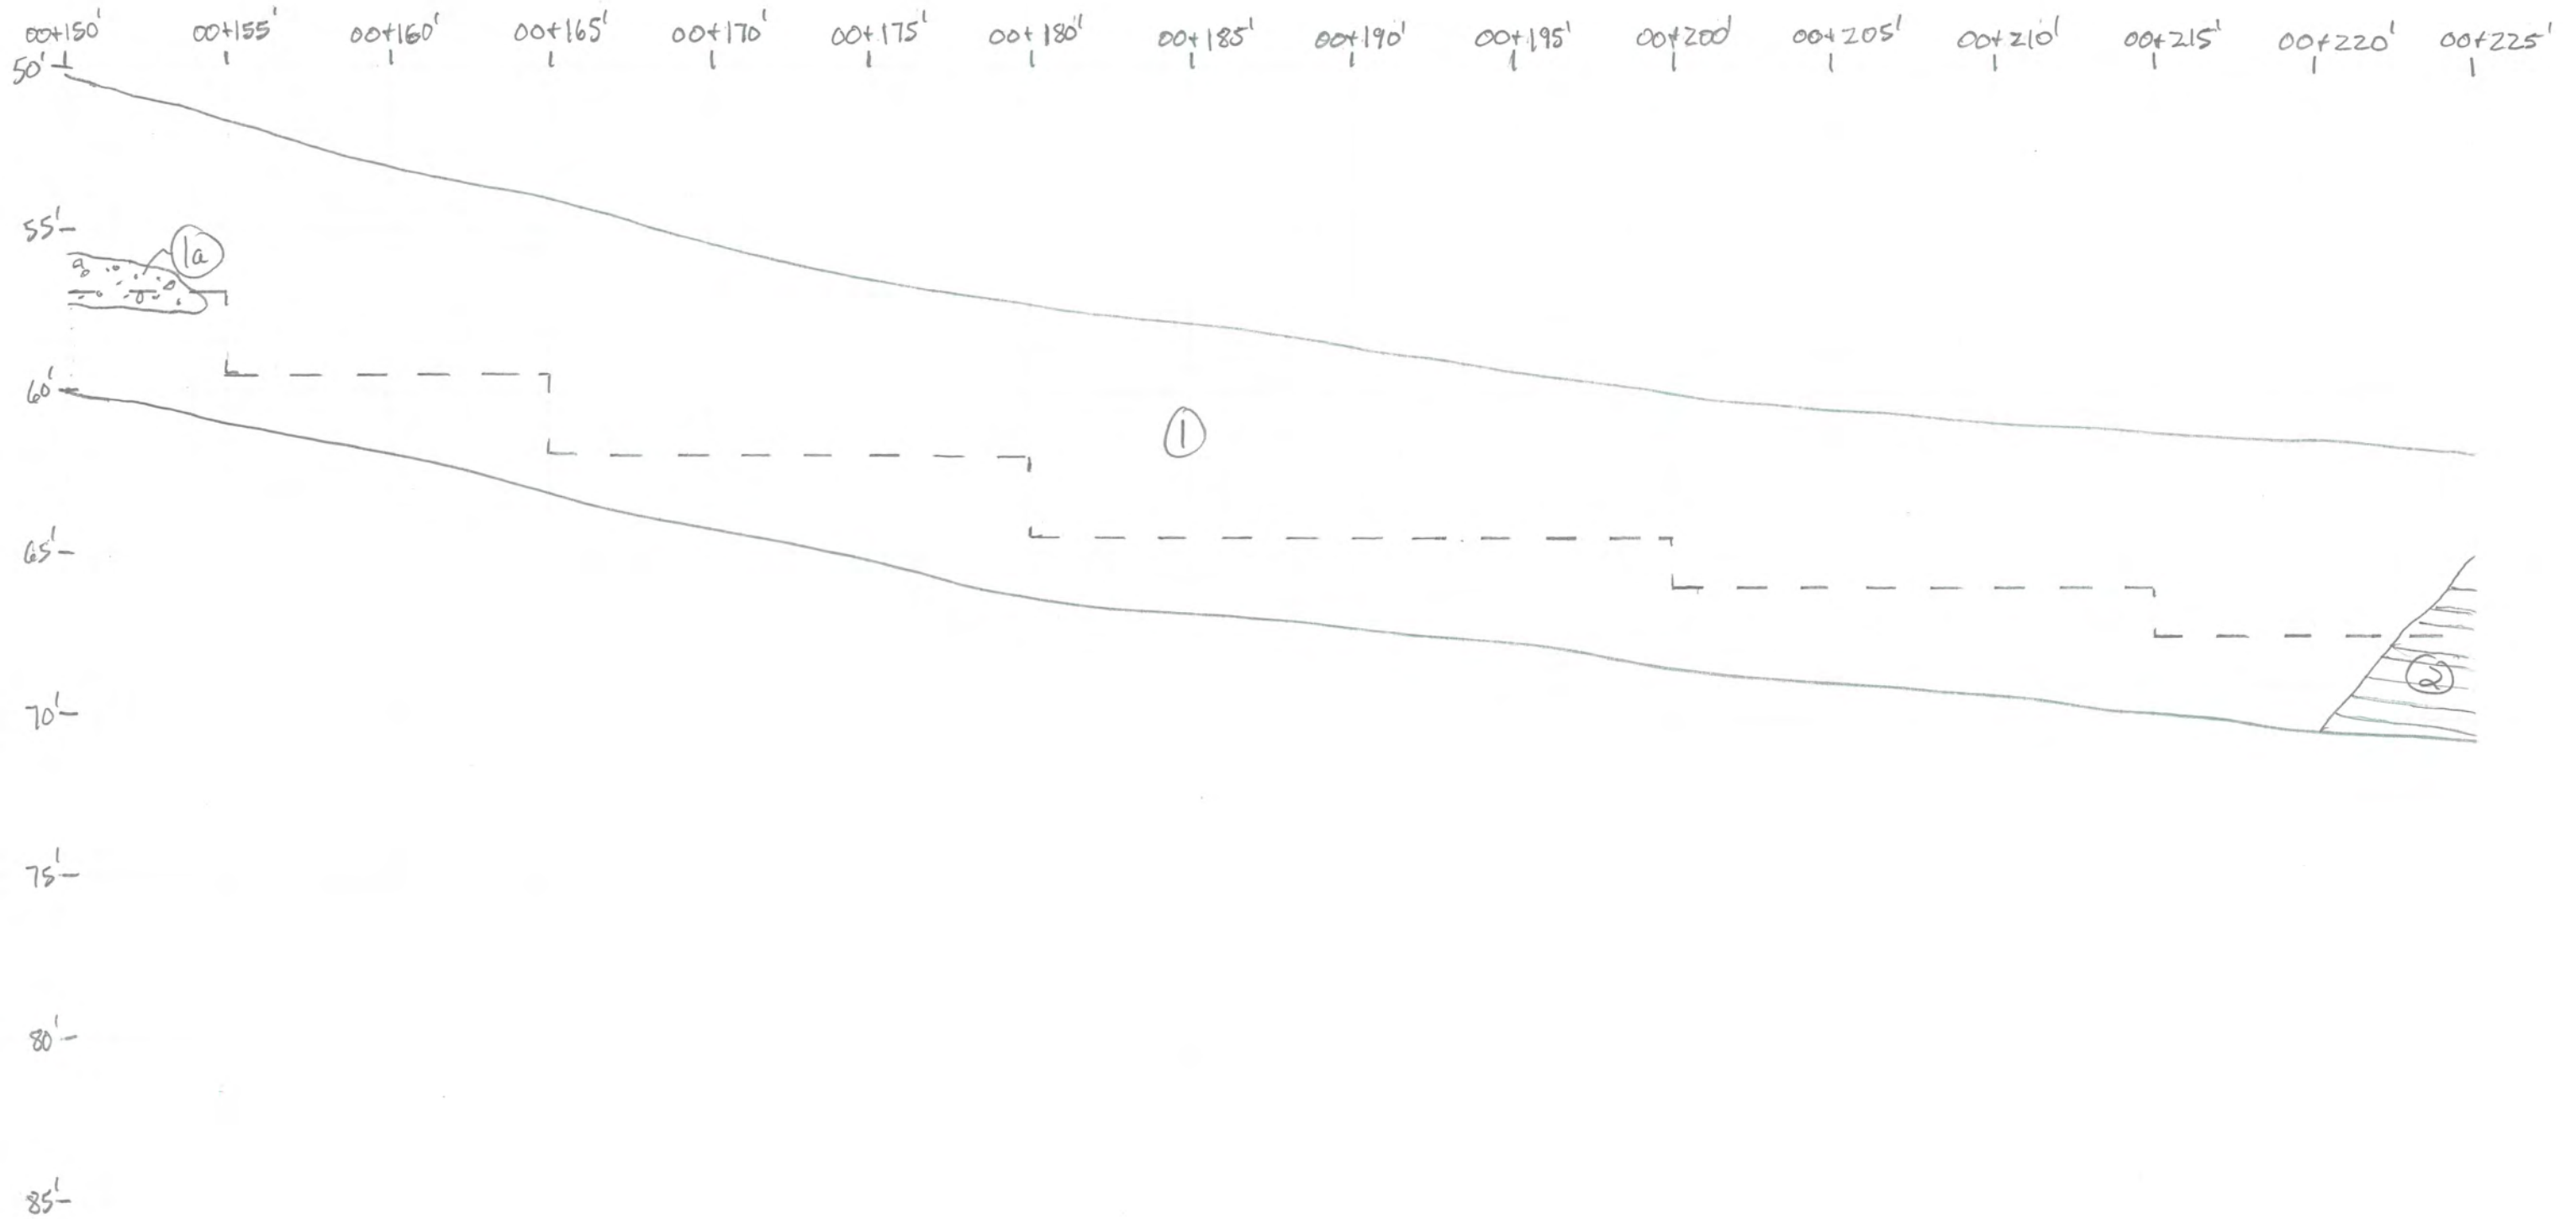
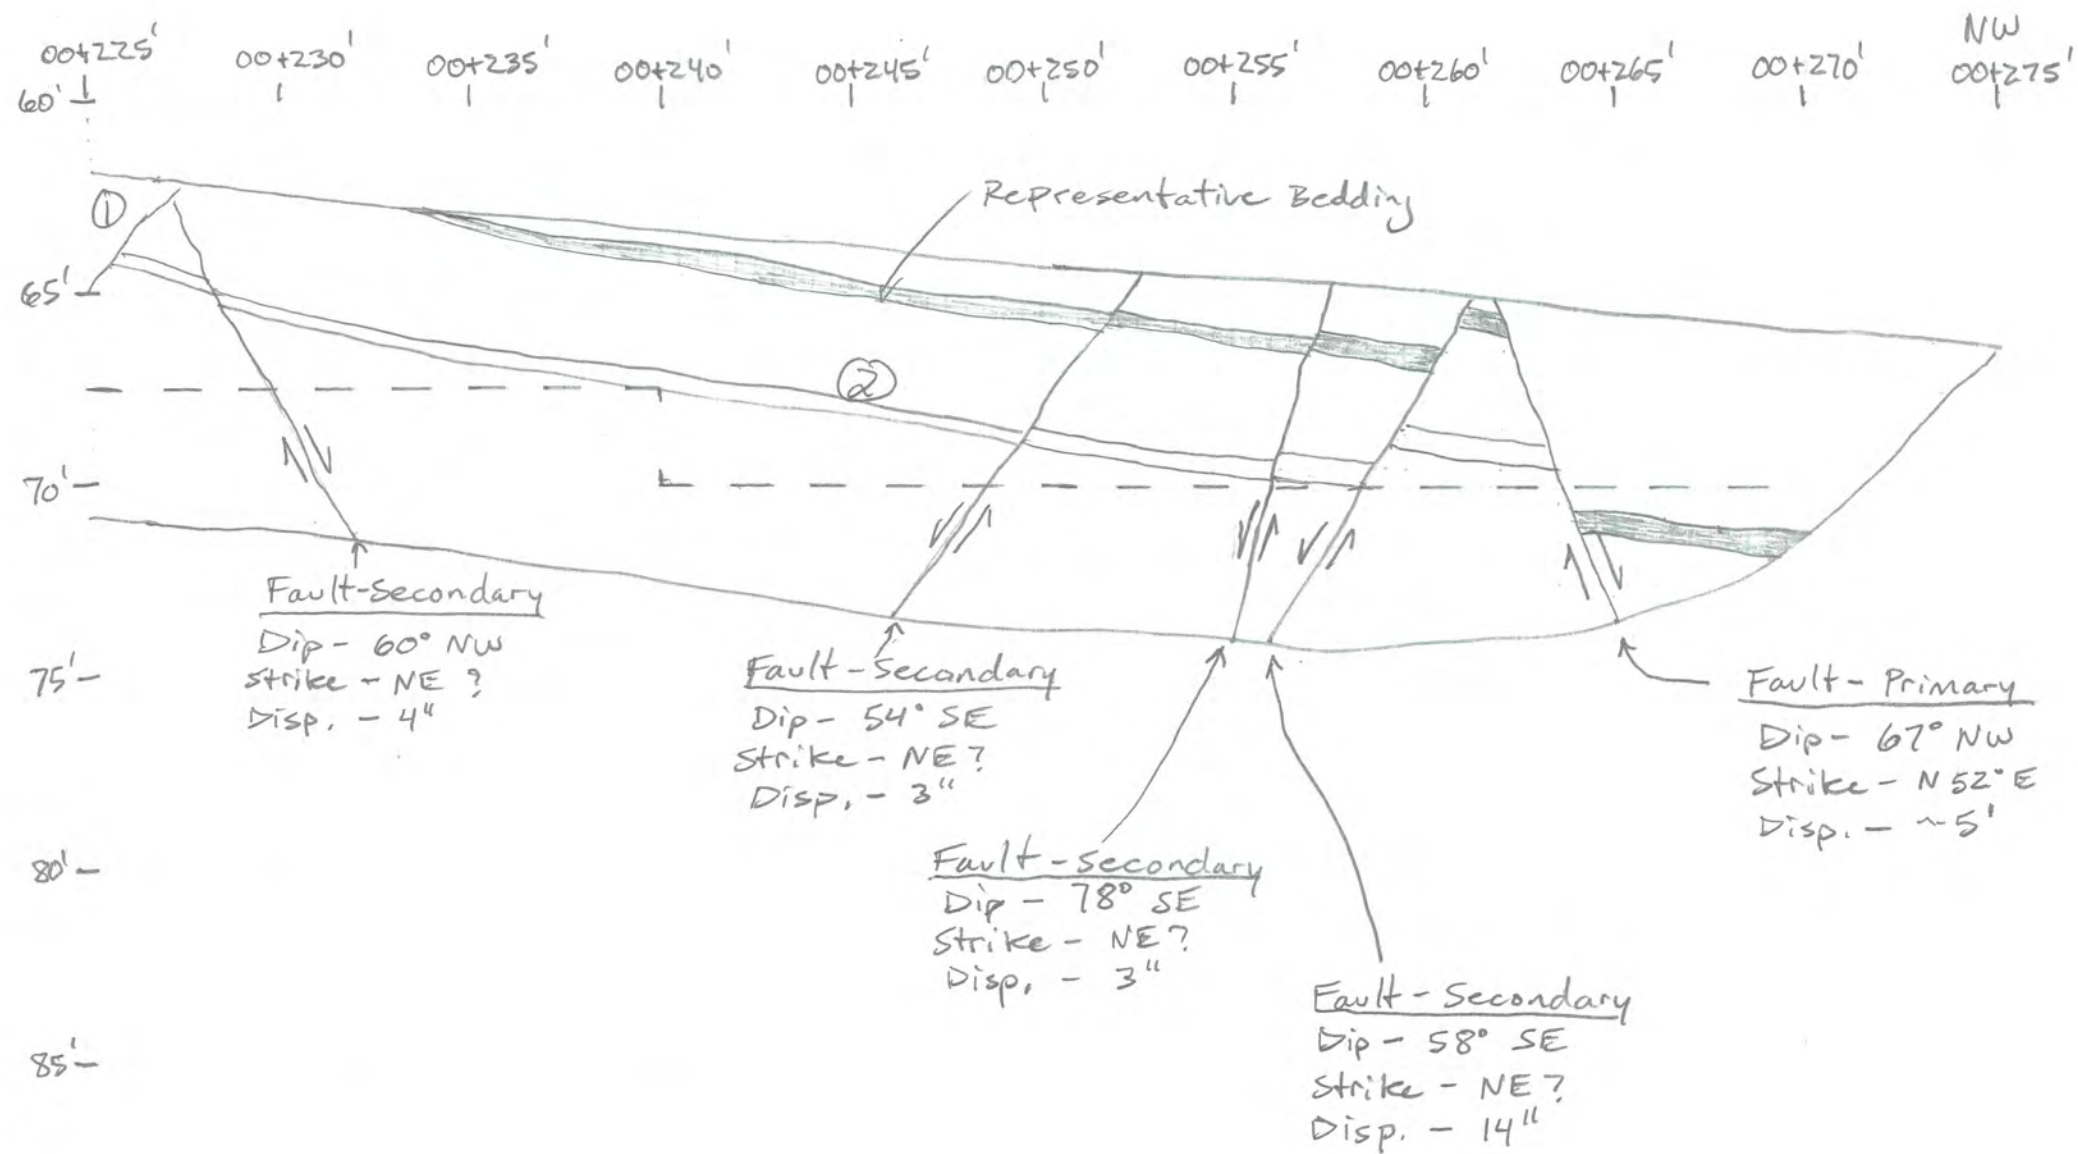
Figure 9

Trench Log - Trench ET-S Santaquin Development, Santaquin, UT  
Logged By: Mark Larsen, P.G. 4/18/19

The maximum net vertical displacement across the fault zone at the subject site was observed and measured to be in excess of 8 feet (**Figures 5 through 12**). As previously discussed in **Section 4.6**, the UGS (DuRoss and others, 2008) observed up to 9 feet of displacement in their trenches just west-southwest of the subject site. To avoid structural failure in habitable structures and critical infrastructure during a future ground-rupturing earthquake event, the only currently accepted form of mitigation is to avoid placing such structures and infrastructure across or adjacent to identified active fault traces, such as those observed and mapped at the subject site. Current guidelines and our recommendations for appropriate building setbacks from the mapped faulting at the subject site are discussed in Section 5.0.
