### NOTICE OF INTENTION TO COMMENCE LARGE MINING OPERATIONS

### **Geotechnical study**

## GEOLOGIC HAZARDS INVESTIGATION

Subject: Geologic Hazards Investigation  
Santaquin Heights  
Approximately 650 North State Road 198  
Santaquin, Utah  
CMT Project Number: 12330

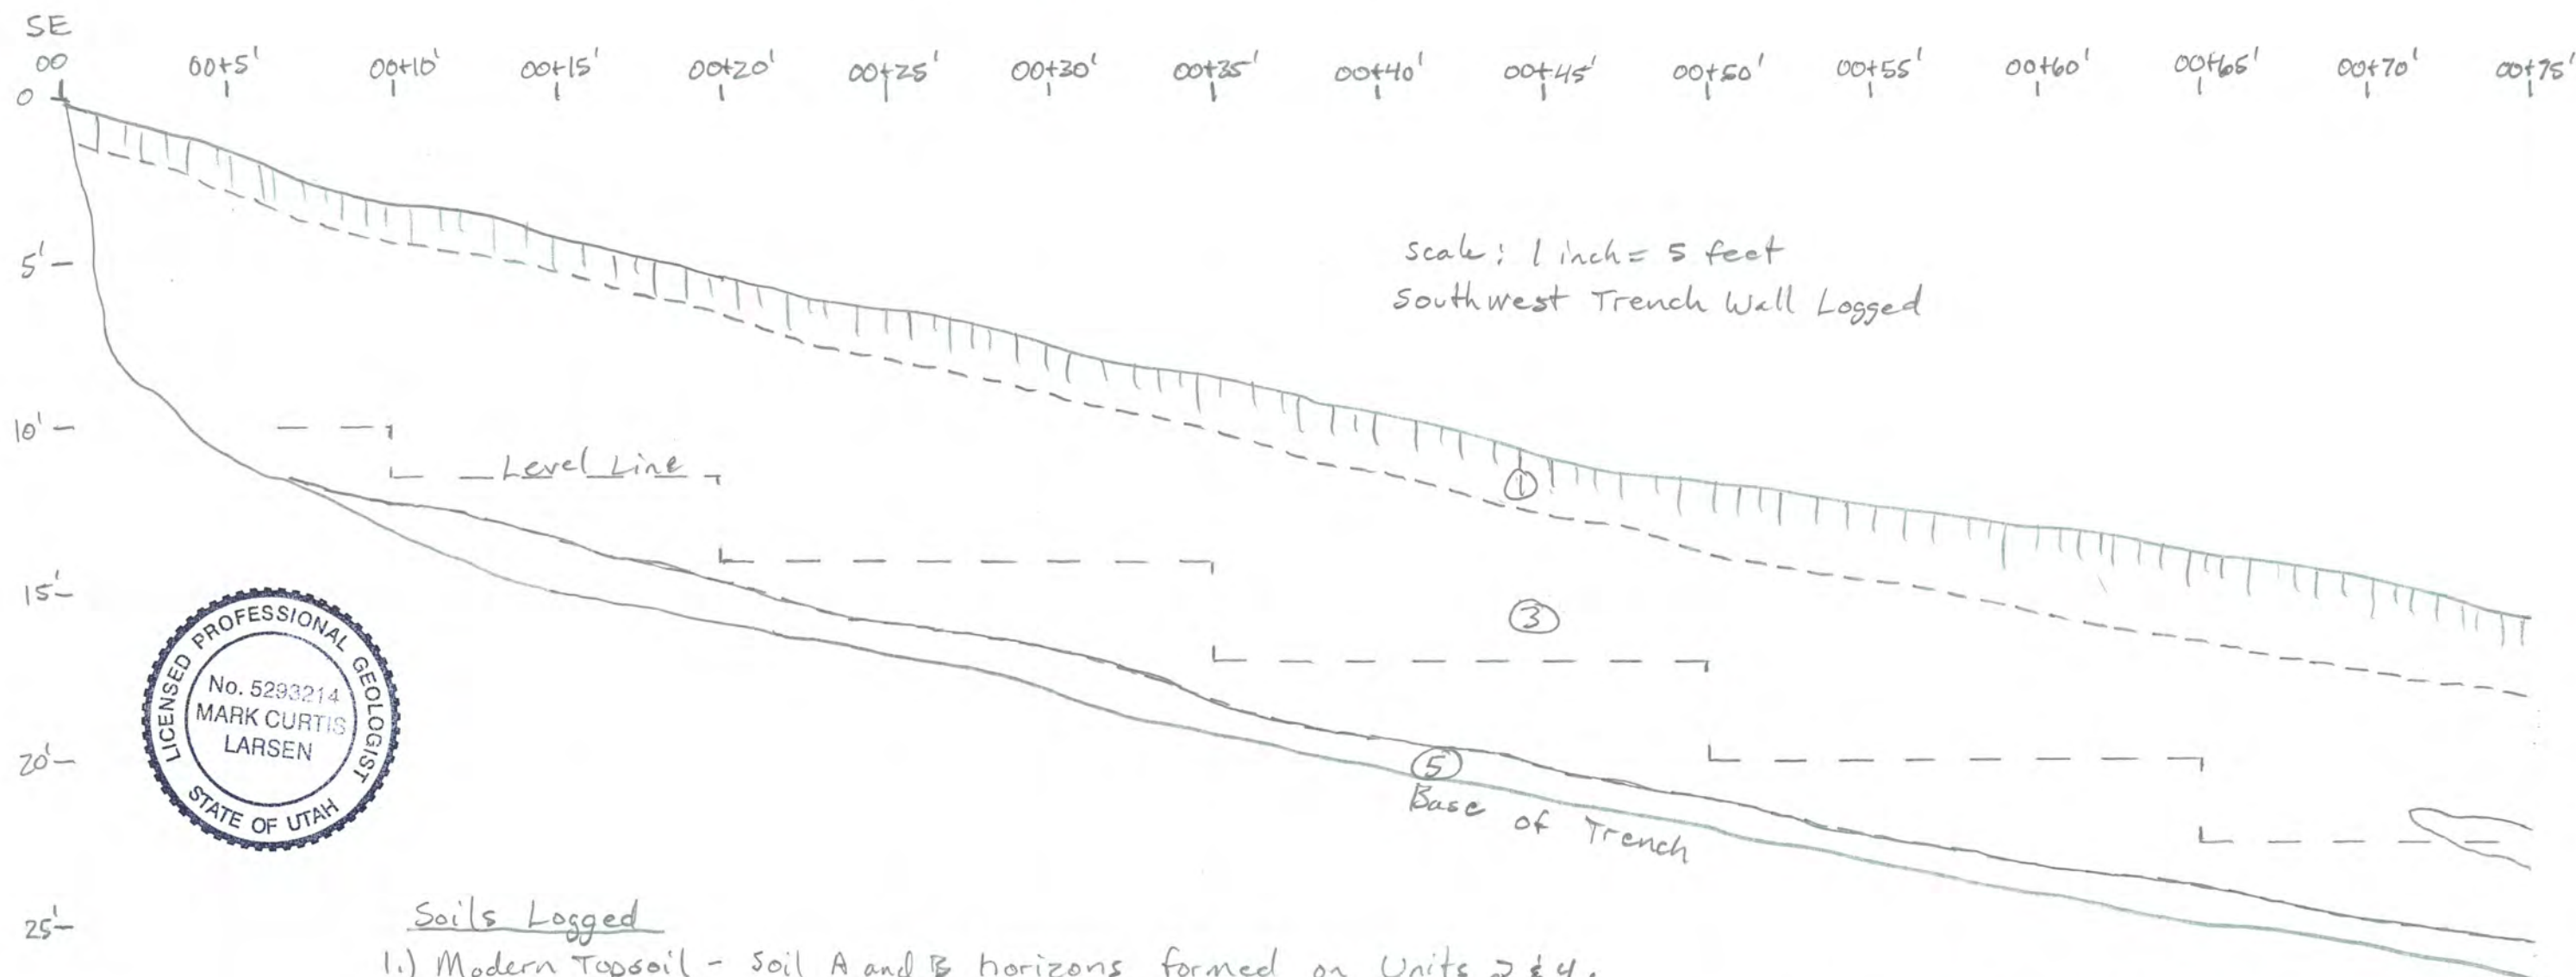
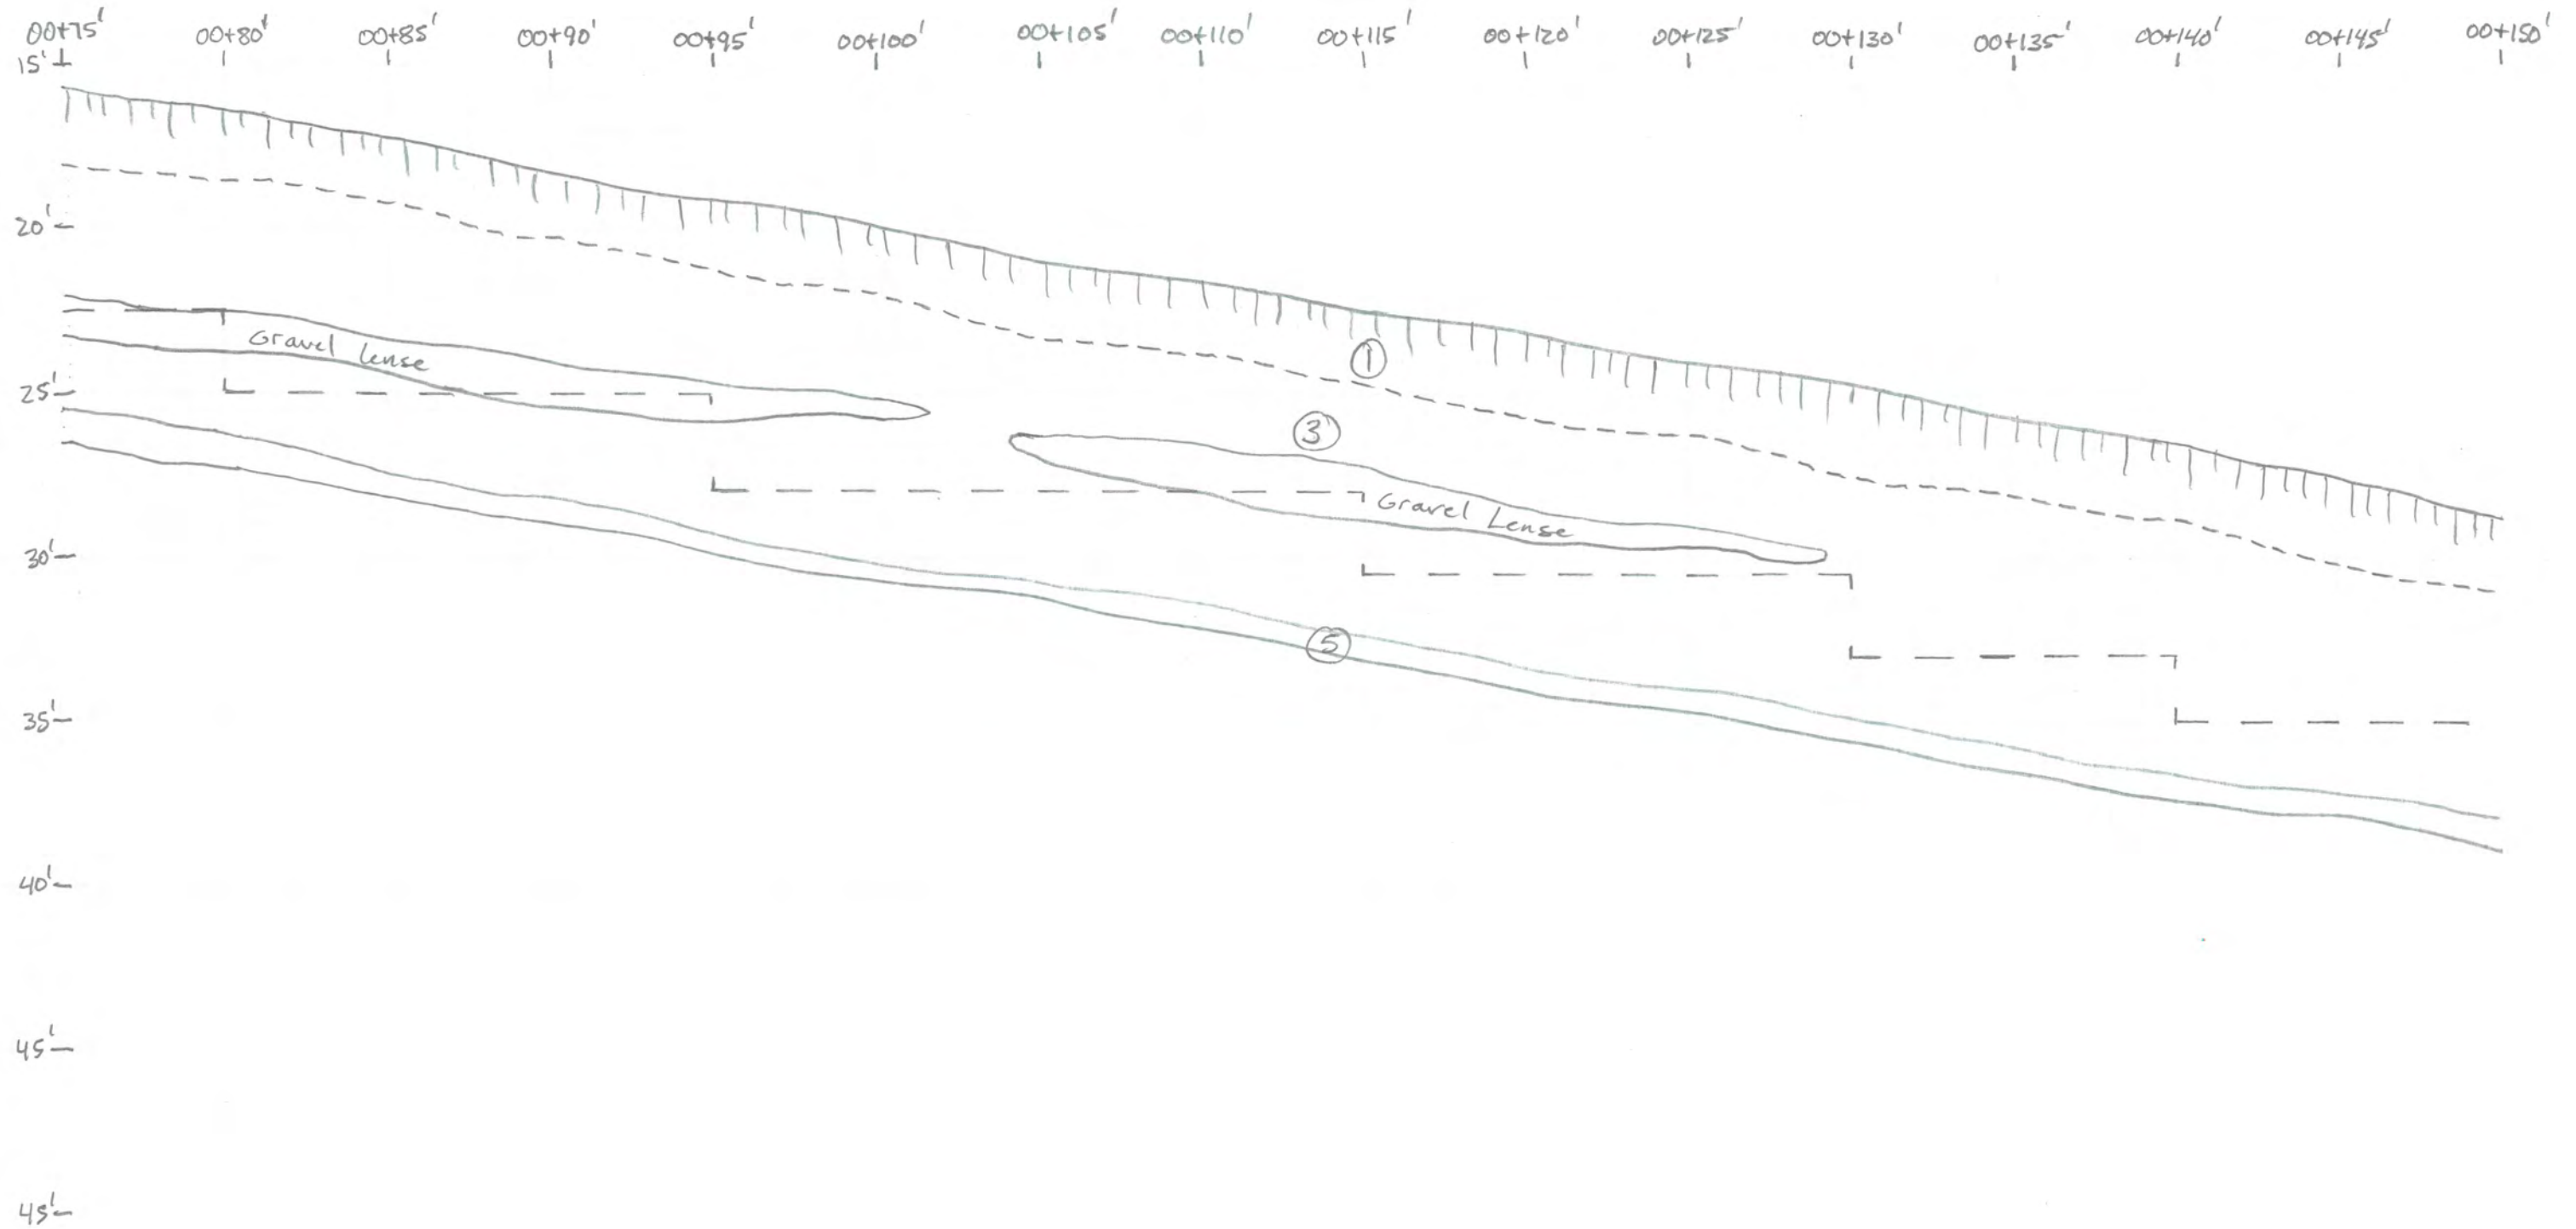
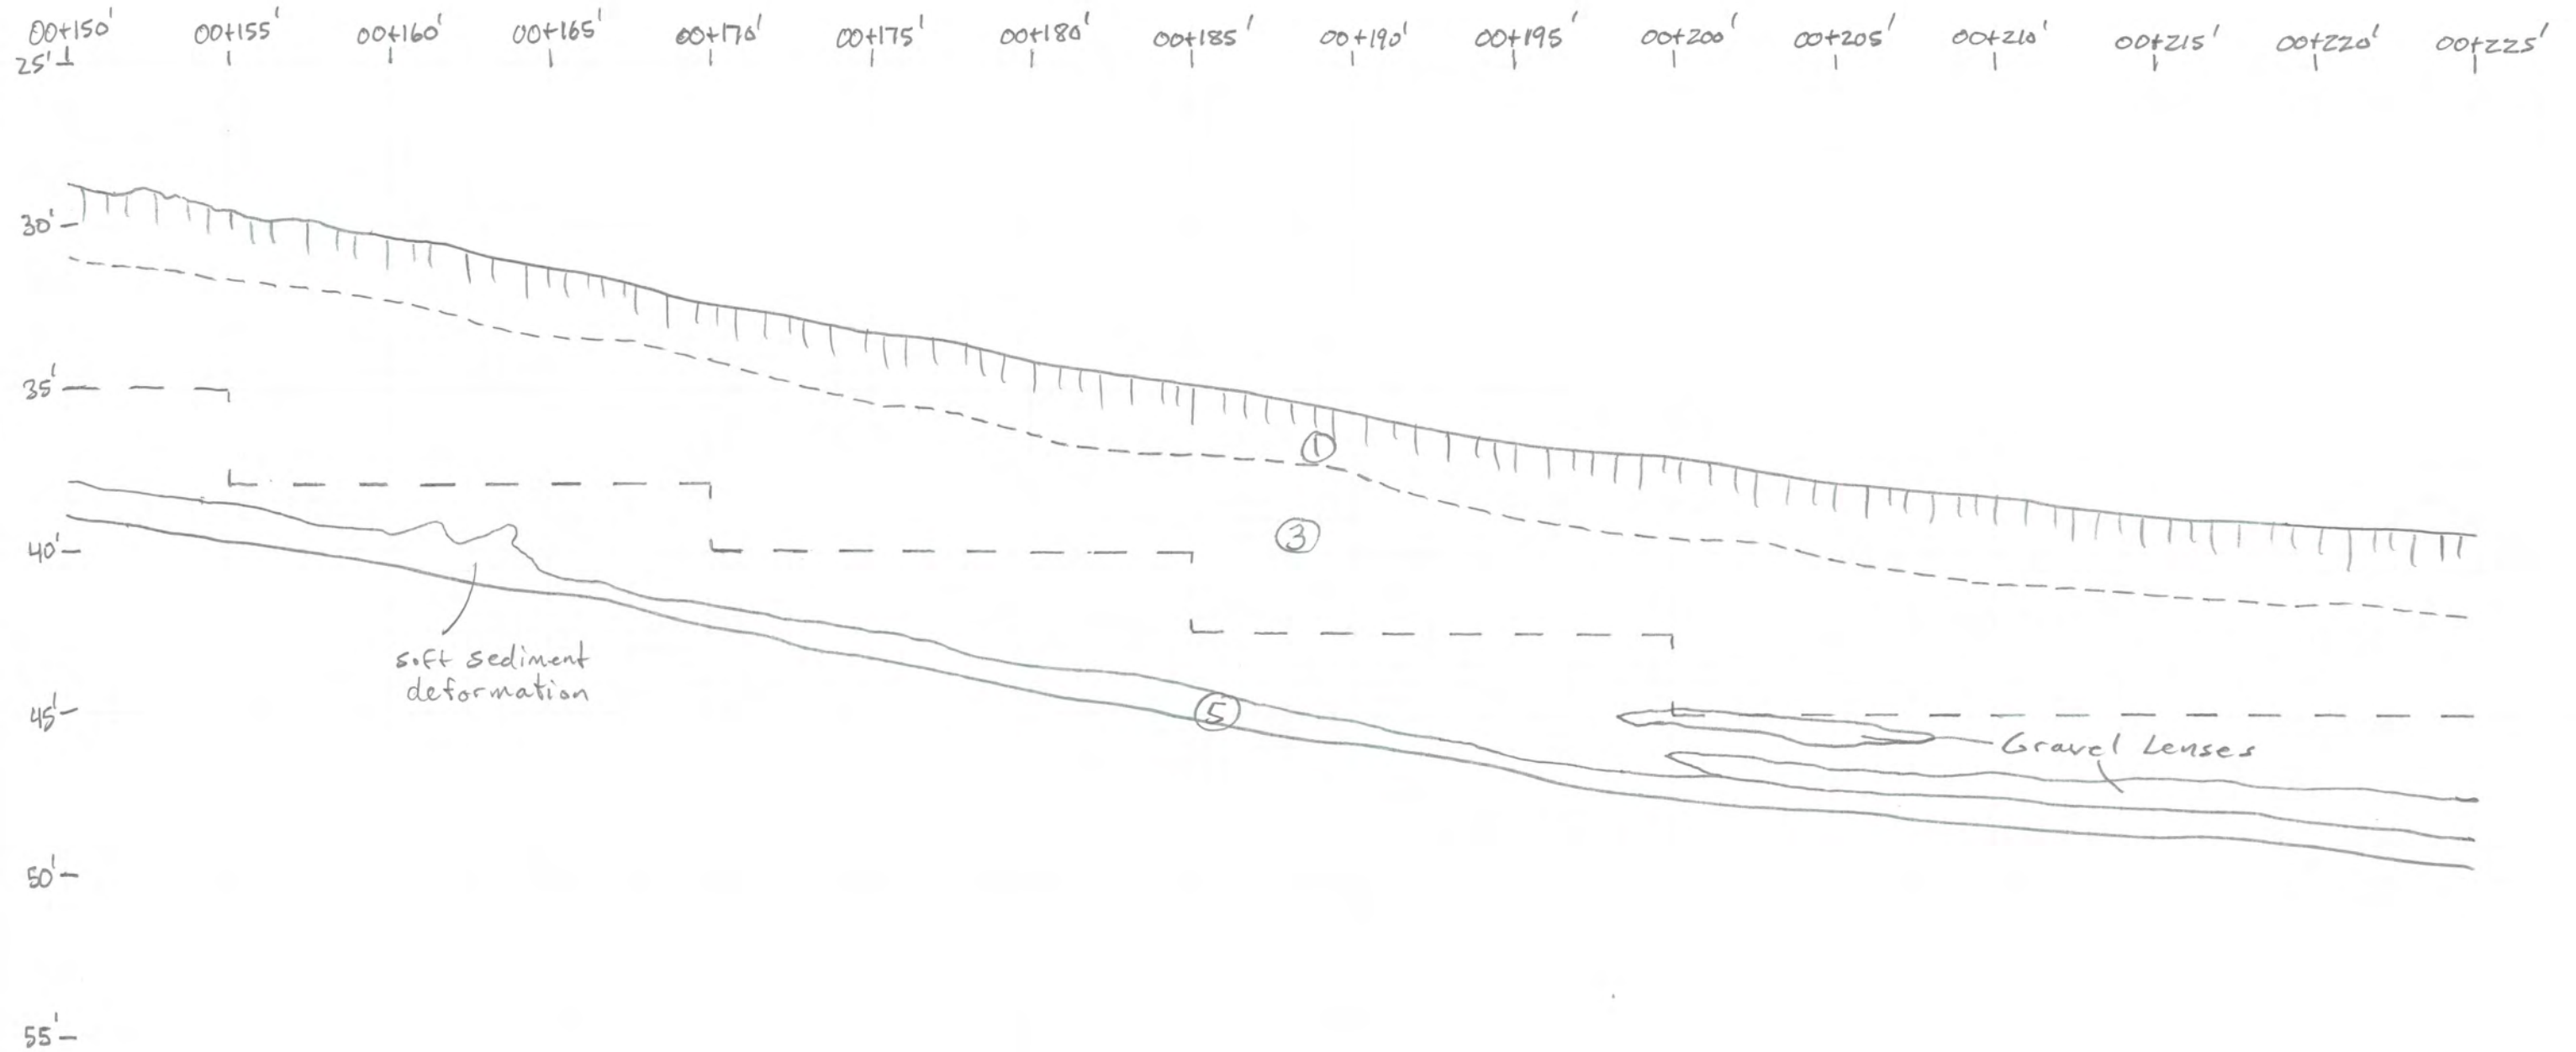
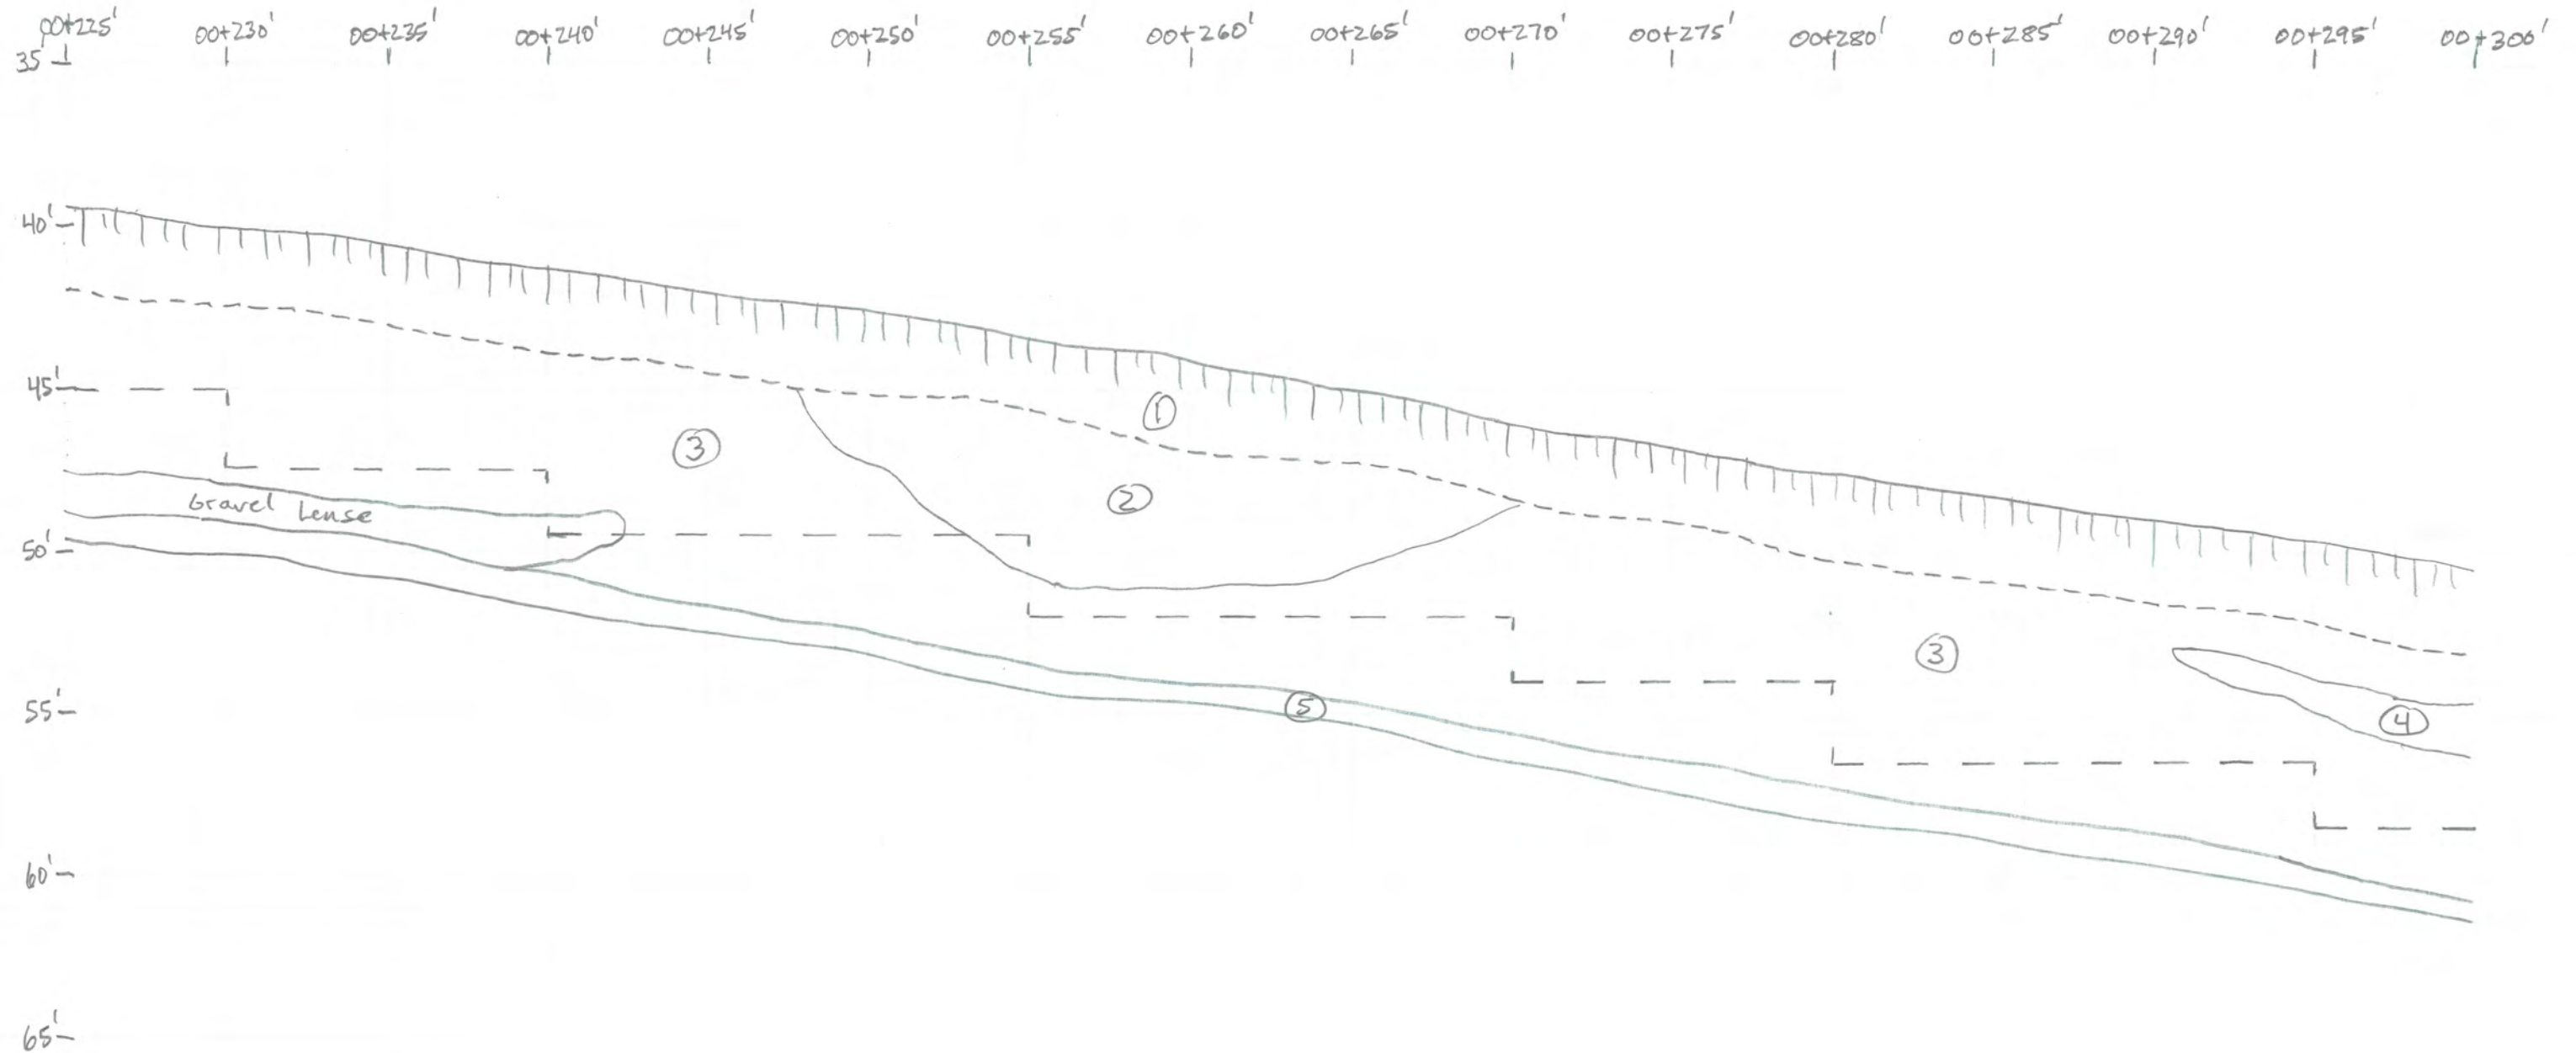
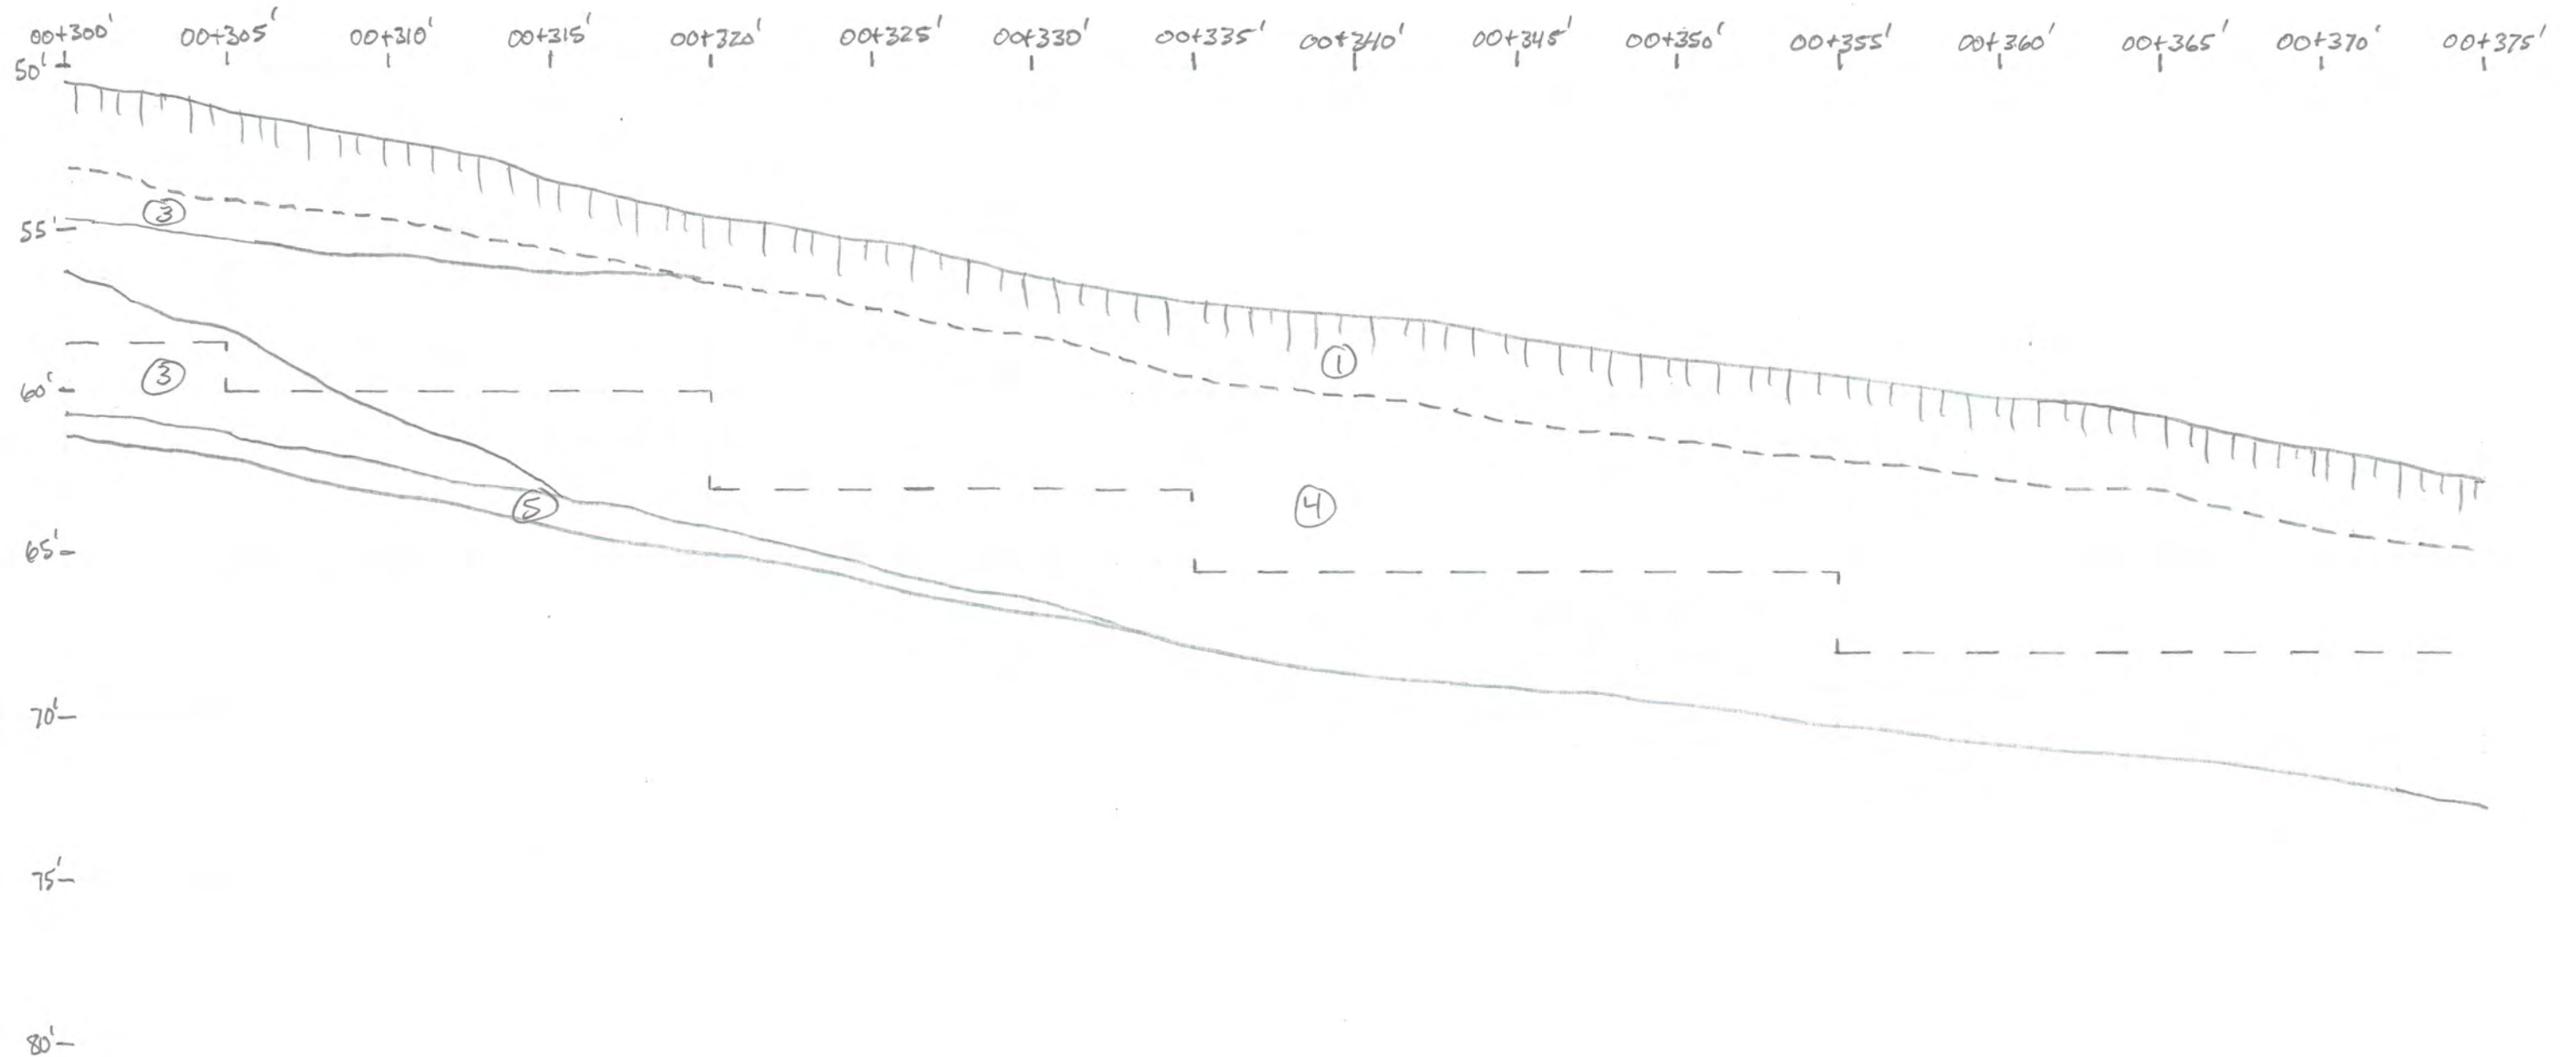
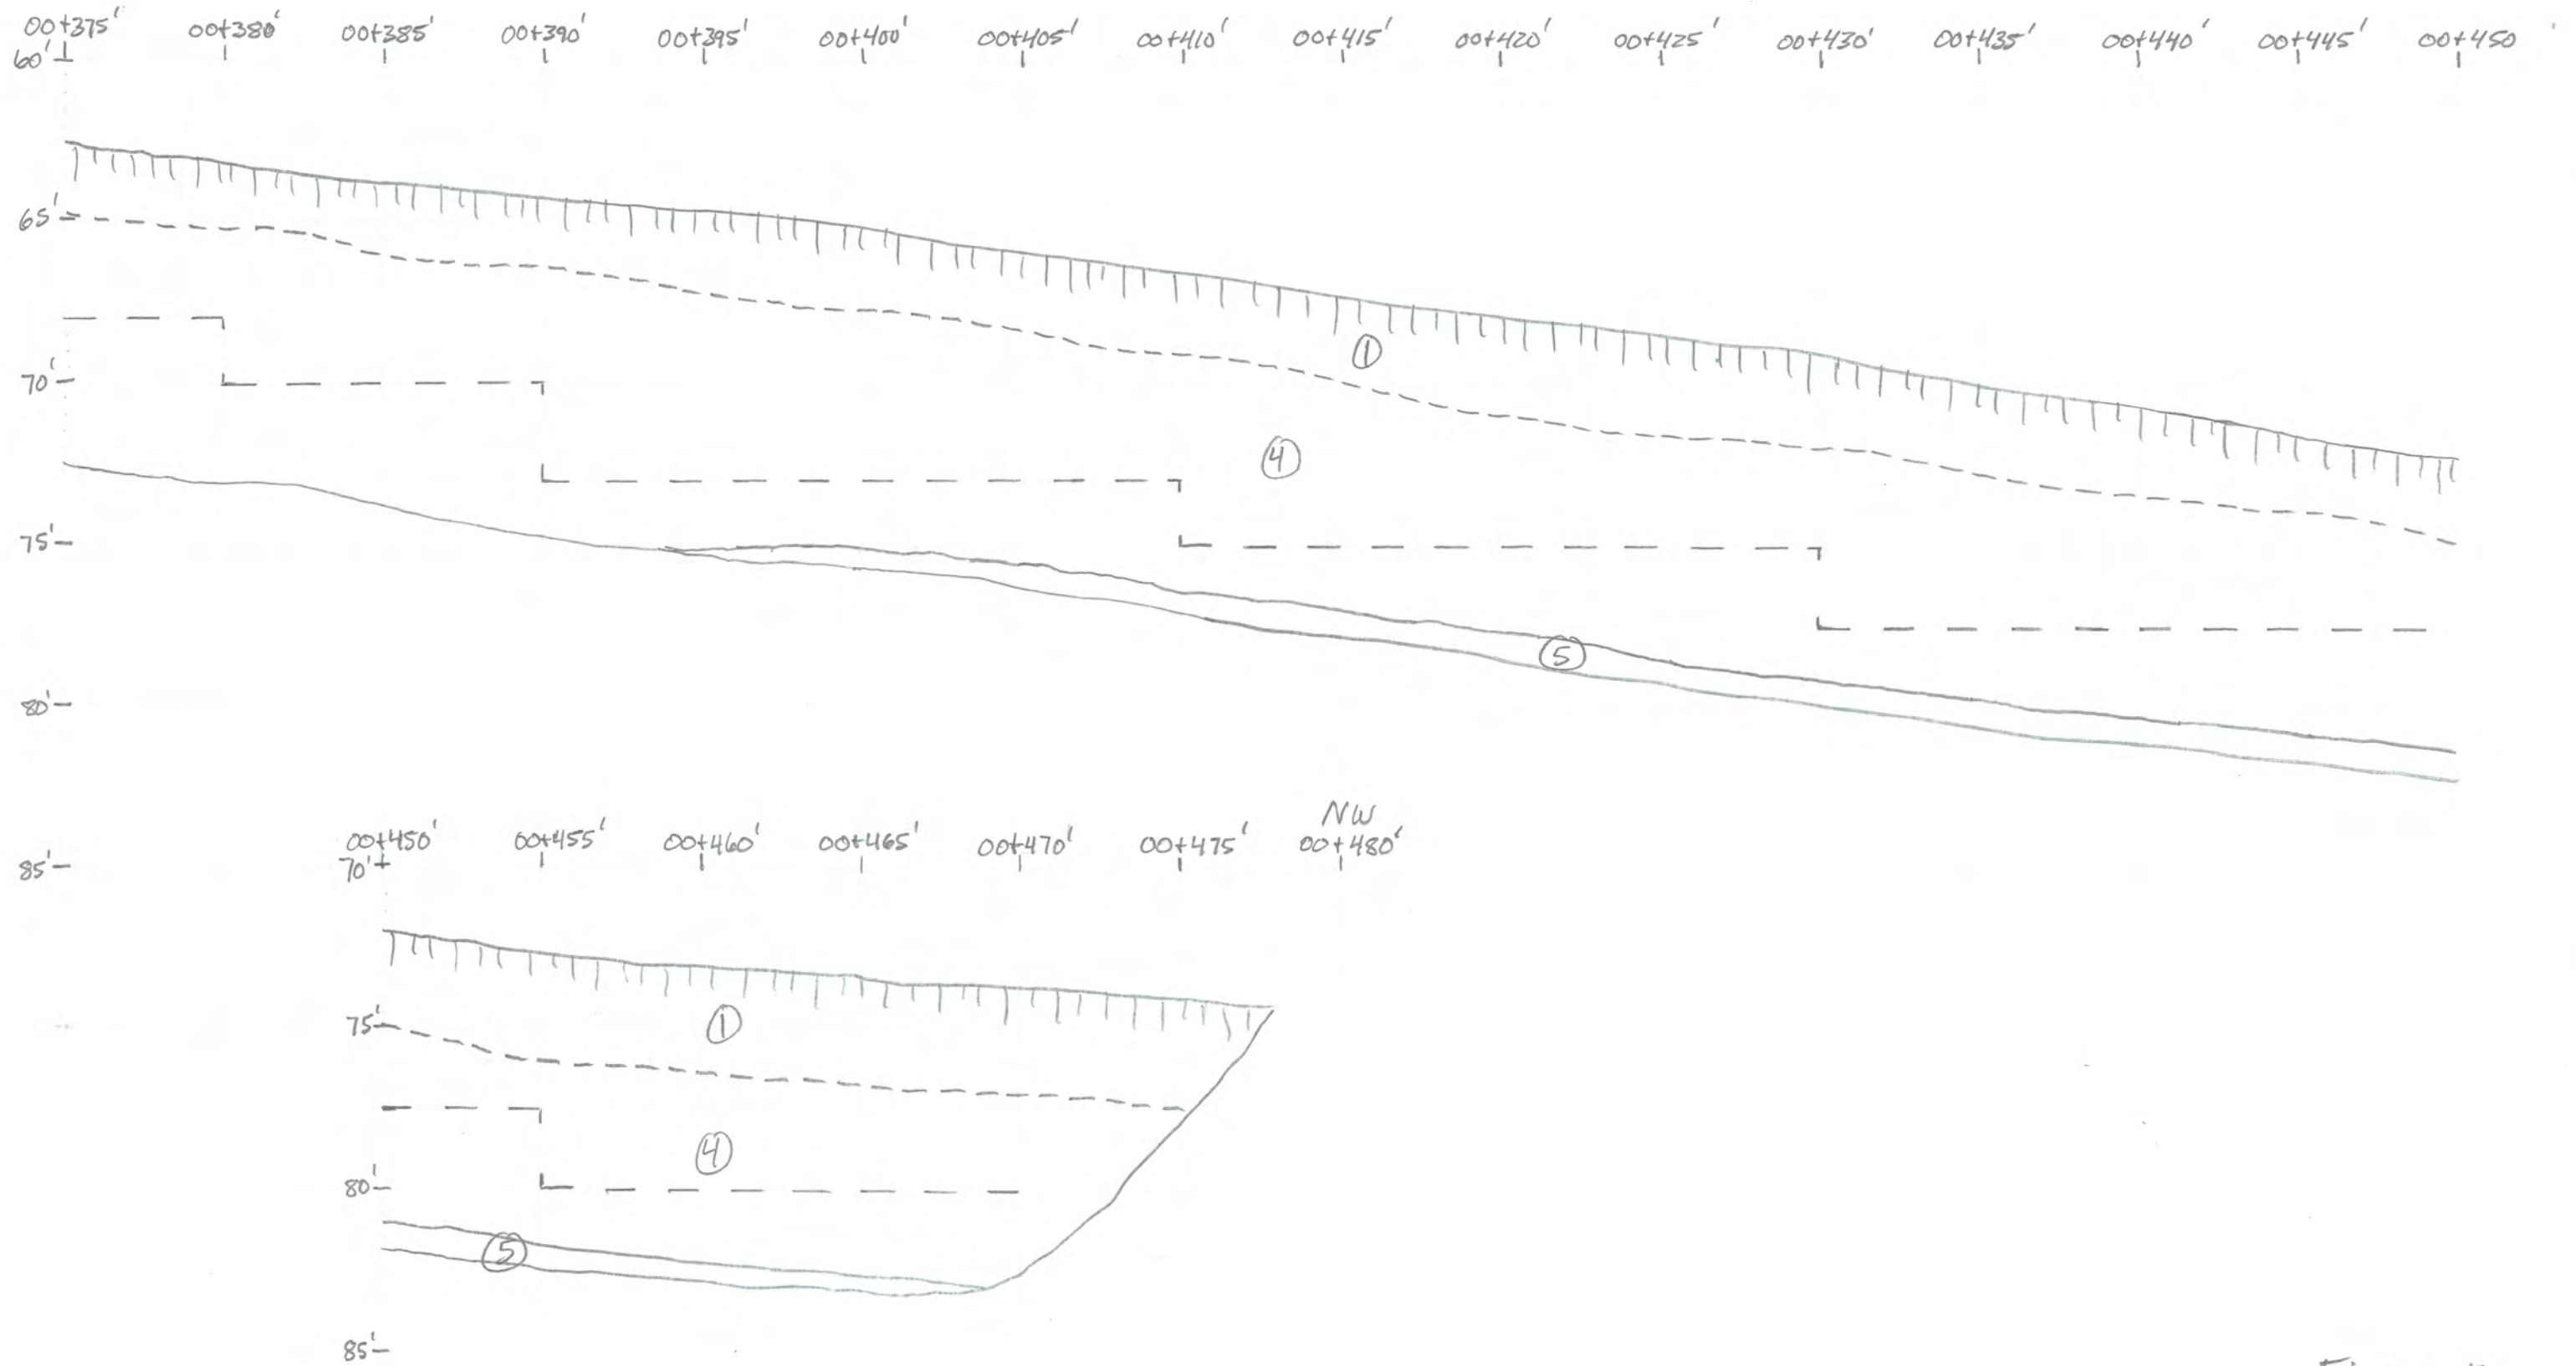
Figure 10

Trench Log - Trench ET-6 Santaquin Development, Santaquin, UT  
Logged By: Mark Larsen, P.G. 4/19/19

- 1.) Modern Topsoil - Soil A and B horizons formed on Units 2 & 4.
- 2.) Channel Fill - Alluvium - Silty gravel w/ sand and some clay, weakly bedded, pebble-sized cobbles, brown.
- 3.) Alluvial-Fan Deposits - Mostly sand w/ gravel and minor silt and clay, pebble to a few cobble-sized gravel clasts, likely deposited in multiple events, brown to light-brown. Includes a few clean gravel lenses.
- 4.) Lacustrine Gravels - Bonneville Lake Cycle - Gravels w/ sand and some silt, rounded to subrounded clasts, pebble to a few cobble-sized clasts, bedded, gray.
- 5.) Lacustrine Sands - Bonneville Lake Cycle - Sands, bedded, light-brown to gray. Did not observe any displacement or deformation that could be directly related to faulting.

The maximum net vertical displacement across the fault zone at the subject site was observed and measured to be in excess of 8 feet (**Figures 5 through 12**). As previously discussed in **Section 4.6**, the UGS (DuRoss and others, 2008) observed up to 9 feet of displacement in their trenches just west-southwest of the subject site. To avoid structural failure in habitable structures and critical infrastructure during a future ground-rupturing earthquake event, the only currently accepted form of mitigation is to avoid placing such structures and infrastructure across or adjacent to identified active fault traces, such as those observed and mapped at the subject site. Current guidelines and our recommendations for appropriate building setbacks from the mapped faulting at the subject site are discussed in Section 5.0.
