### NOTICE OF INTENTION TO COMMENCE LARGE MINING OPERATIONS

### **Geotechnical study**

## GEOLOGIC HAZARDS INVESTIGATION

Subject: Geologic Hazards Investigation  
Santaquin Heights  
Approximately 650 North State Road 198  
Santaquin, Utah  
CMT Project Number: 12330

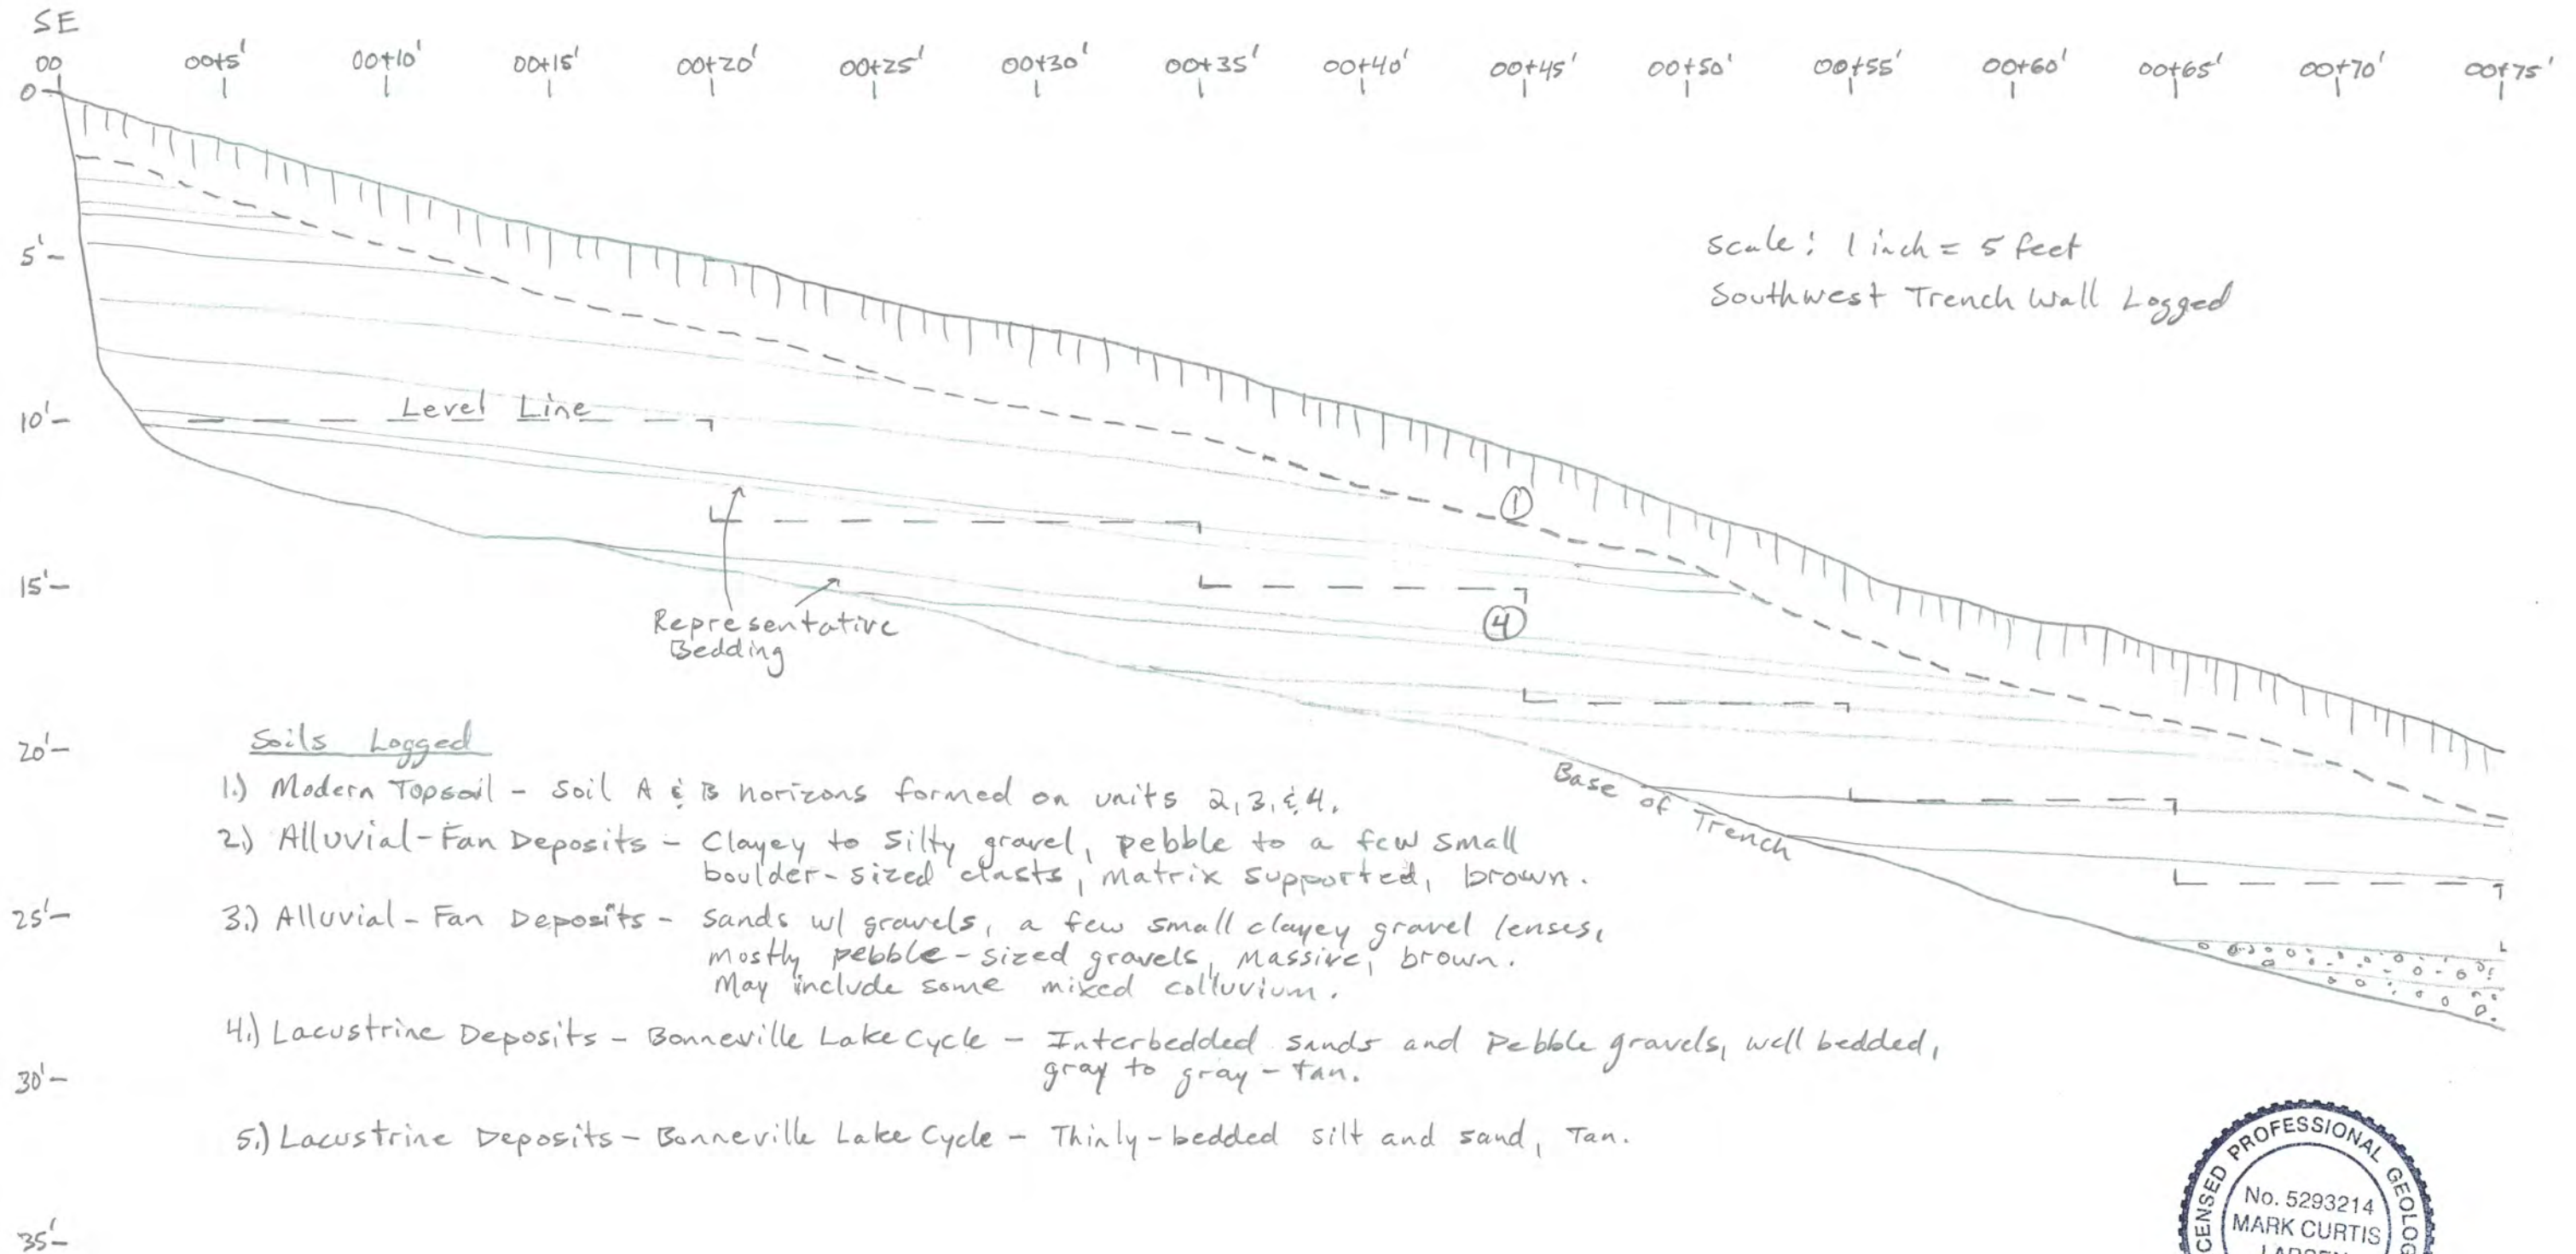
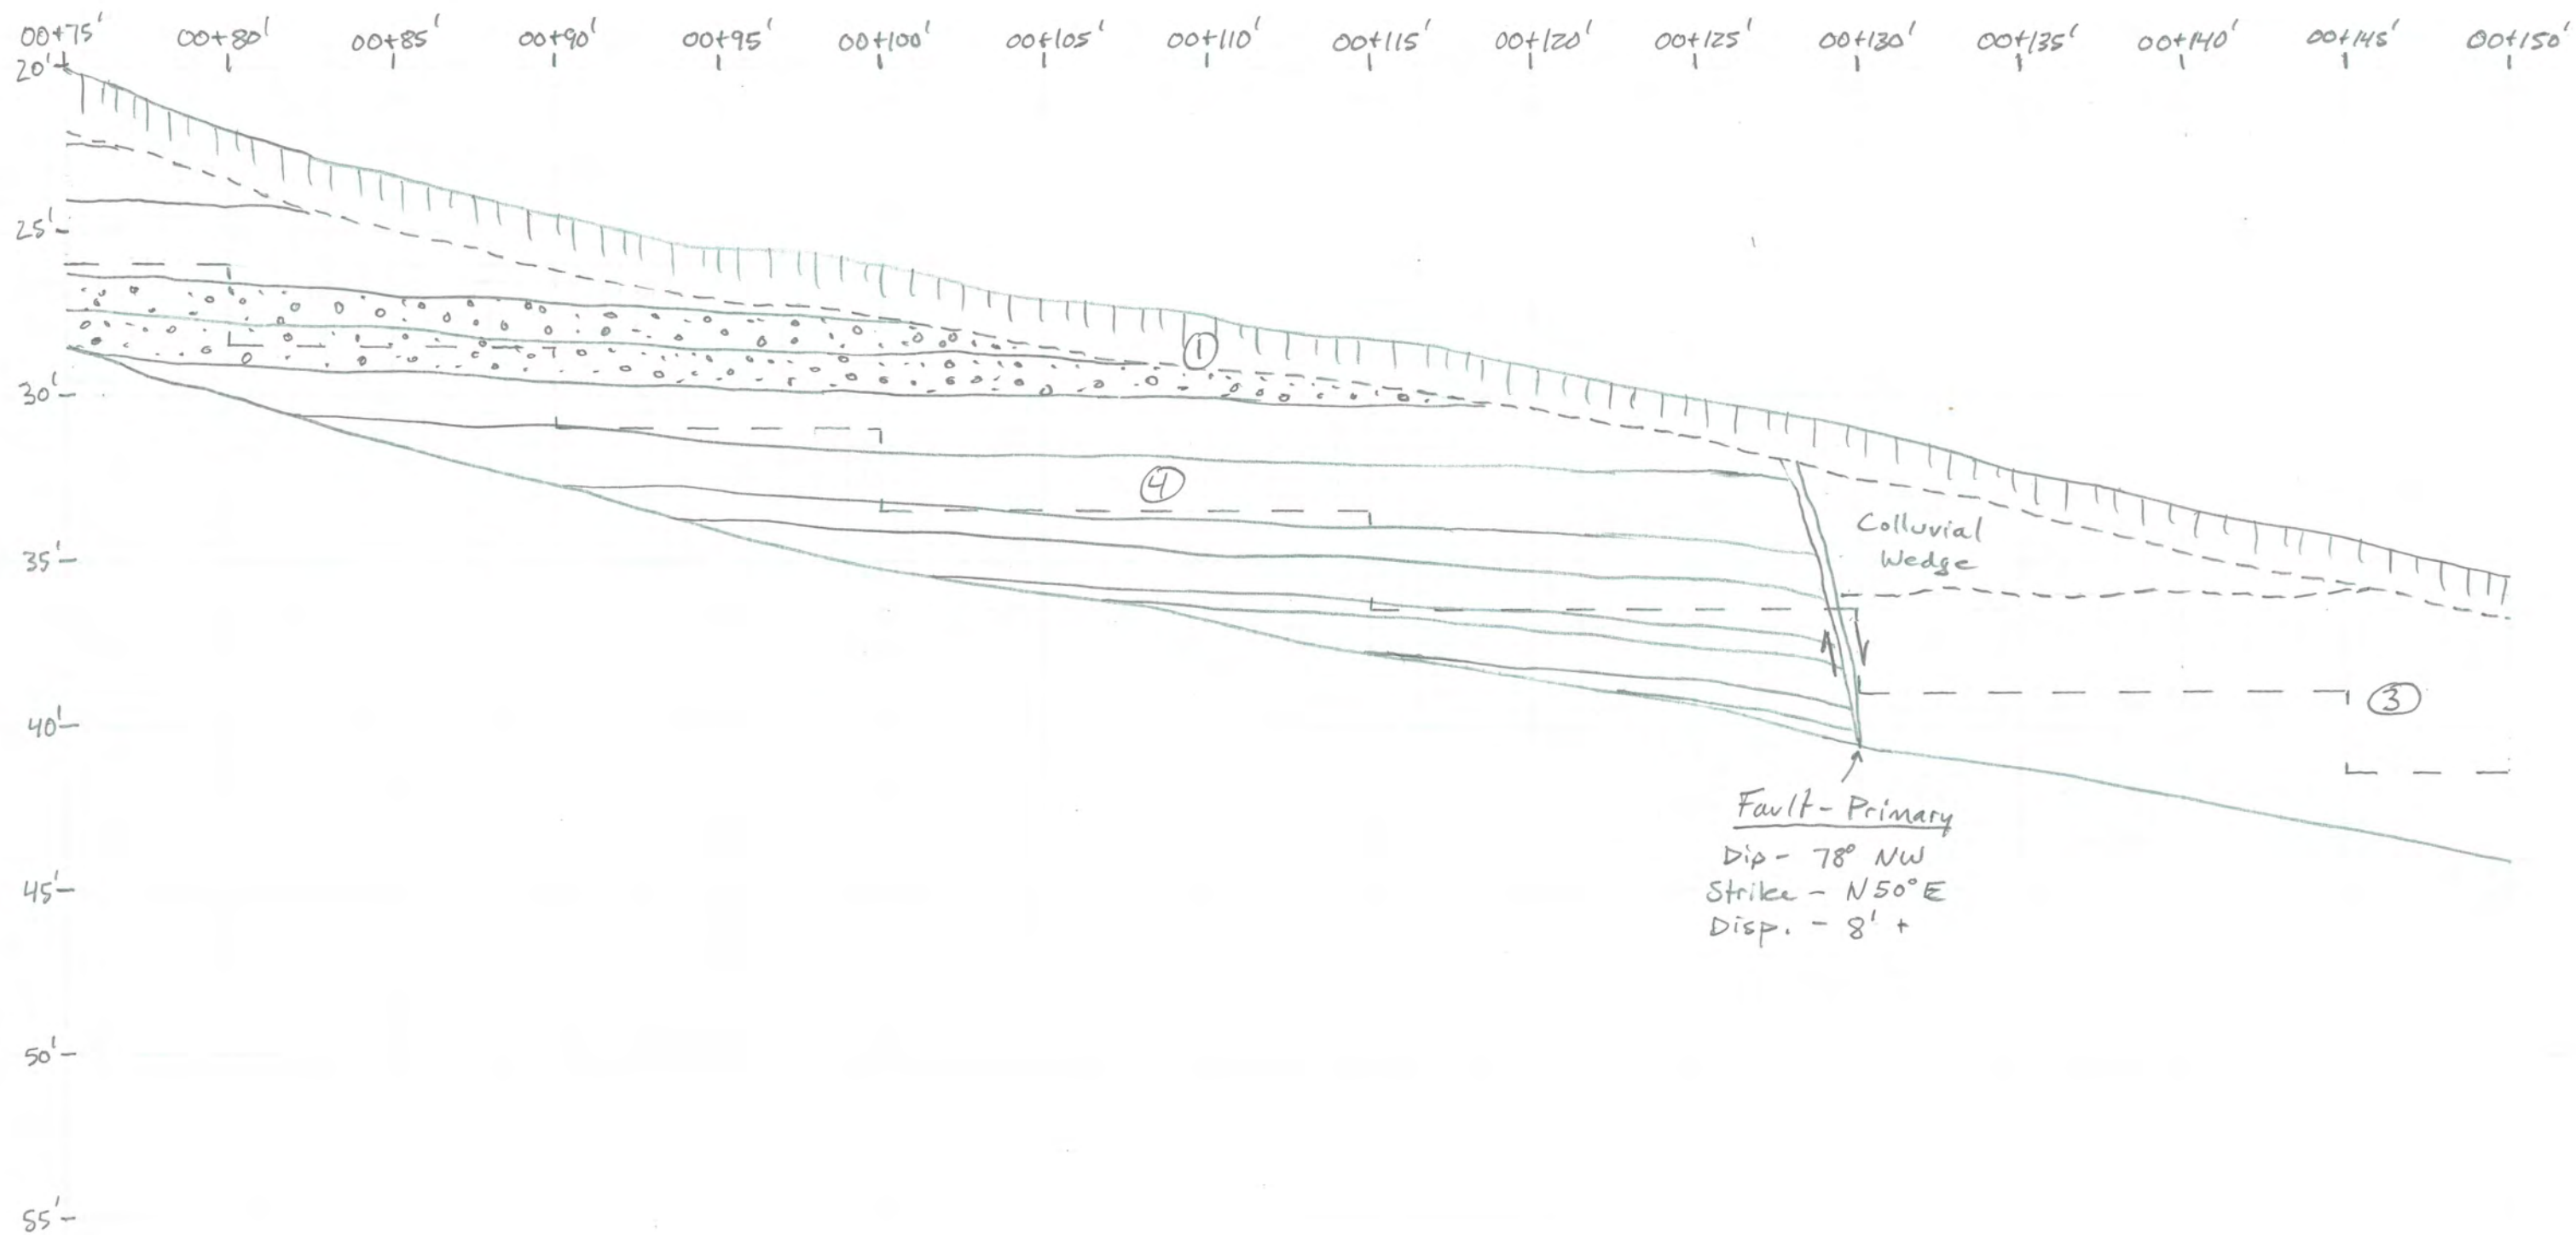
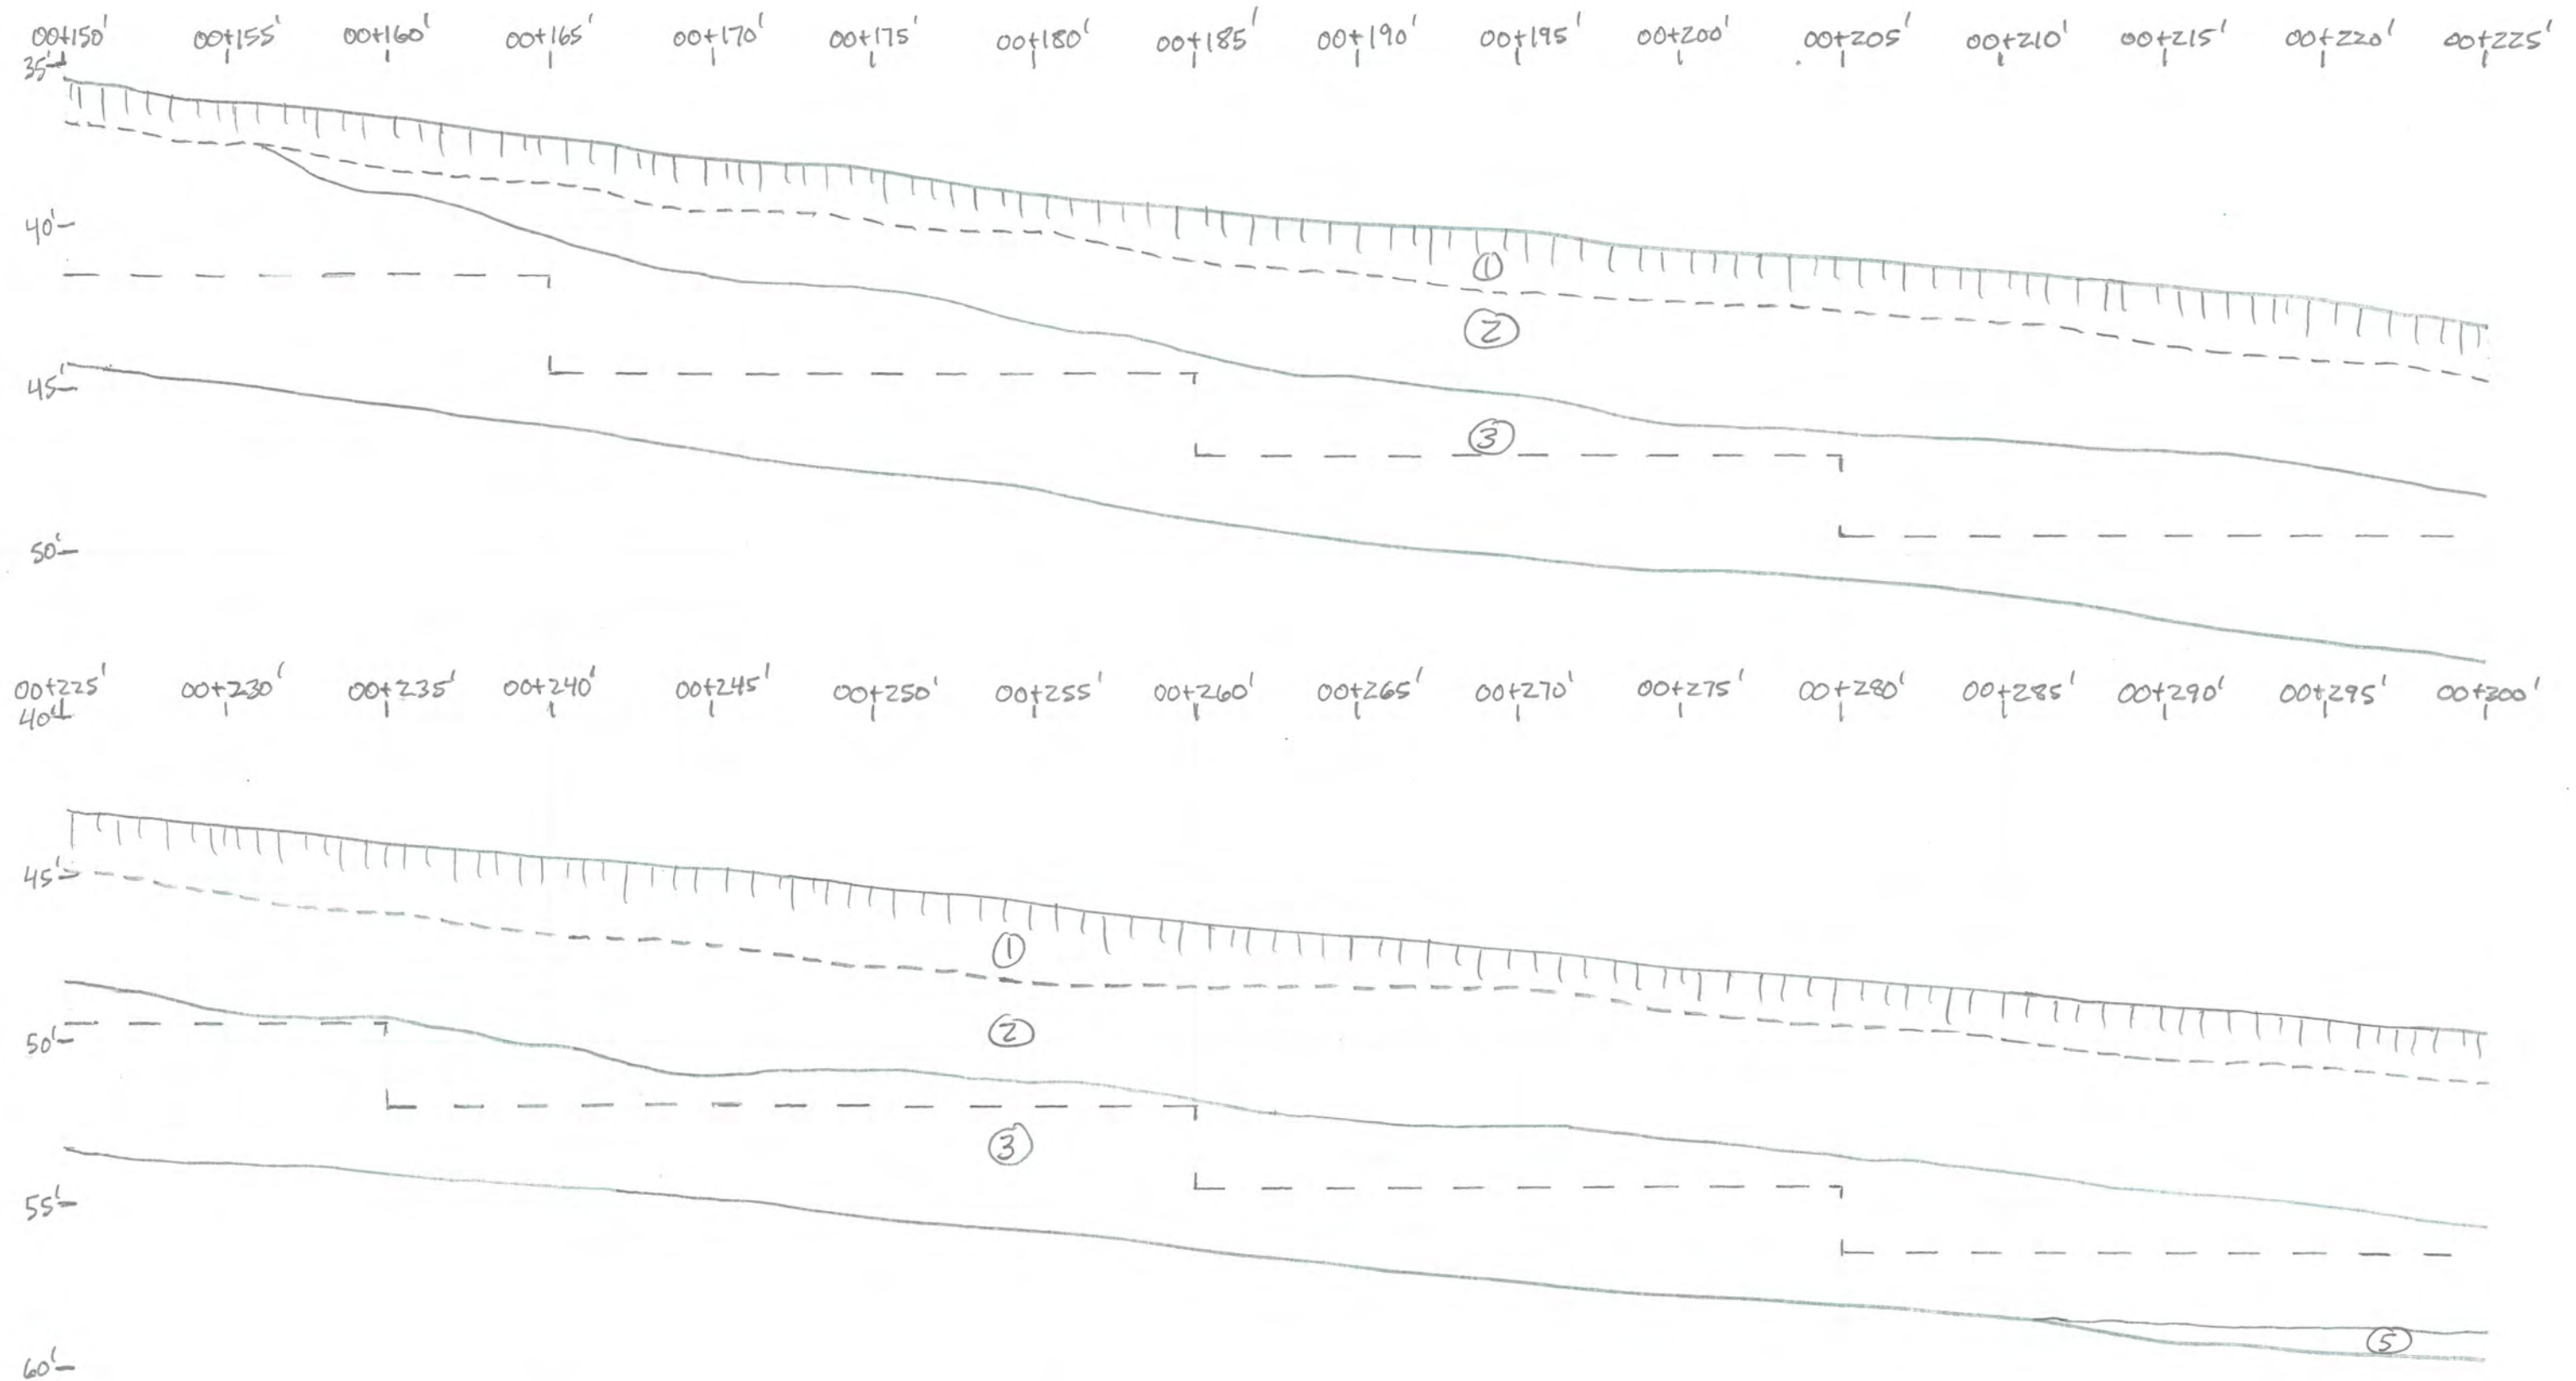
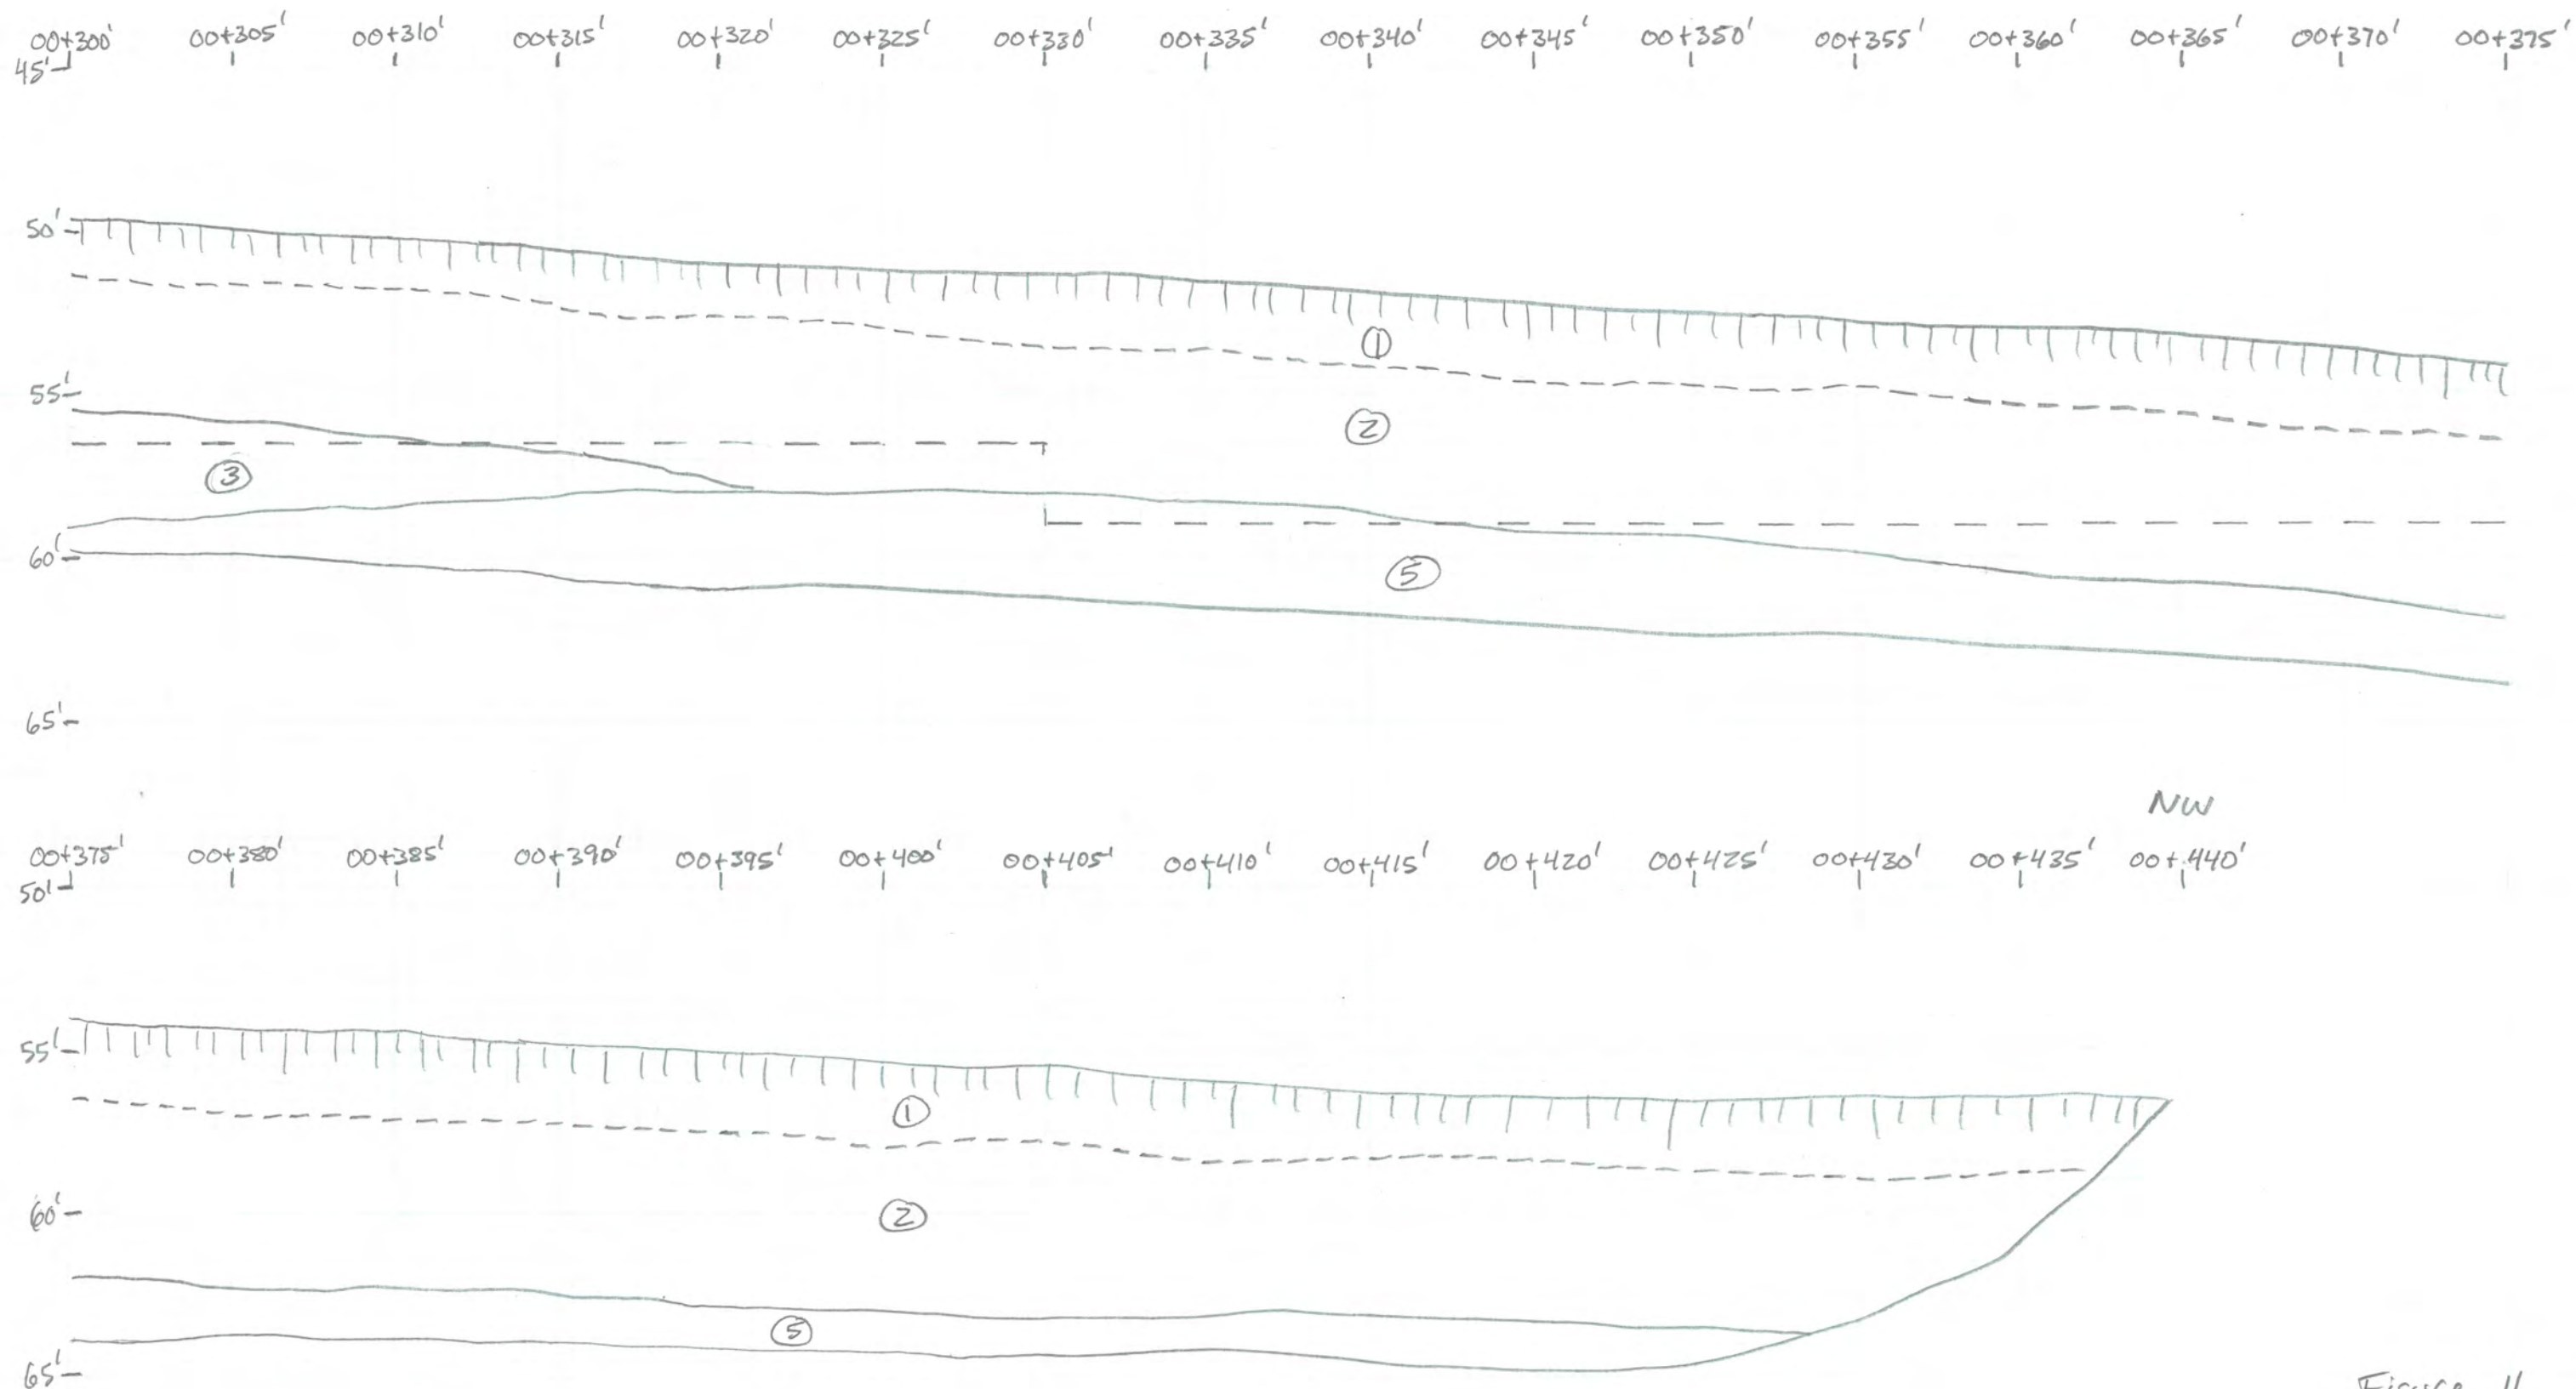
Figure 11

Trench Log - Trench ET-7 Santaquin Development, Santaquin, UT  
Logged By: Mark Larsen, P.G. 4/19 - 4/20, 2019

The maximum net vertical displacement across the fault zone at the subject site was observed and measured to be in excess of 8 feet (**Figures 5 through 12**). As previously discussed in **Section 4.6**, the UGS (DuRoss and others, 2008) observed up to 9 feet of displacement in their trenches just west-southwest of the subject site. To avoid structural failure in habitable structures and critical infrastructure during a future ground-rupturing earthquake event, the only currently accepted form of mitigation is to avoid placing such structures and infrastructure across or adjacent to identified active fault traces, such as those observed and mapped at the subject site. Current guidelines and our recommendations for appropriate building setbacks from the mapped faulting at the subject site are discussed in Section 5.0.

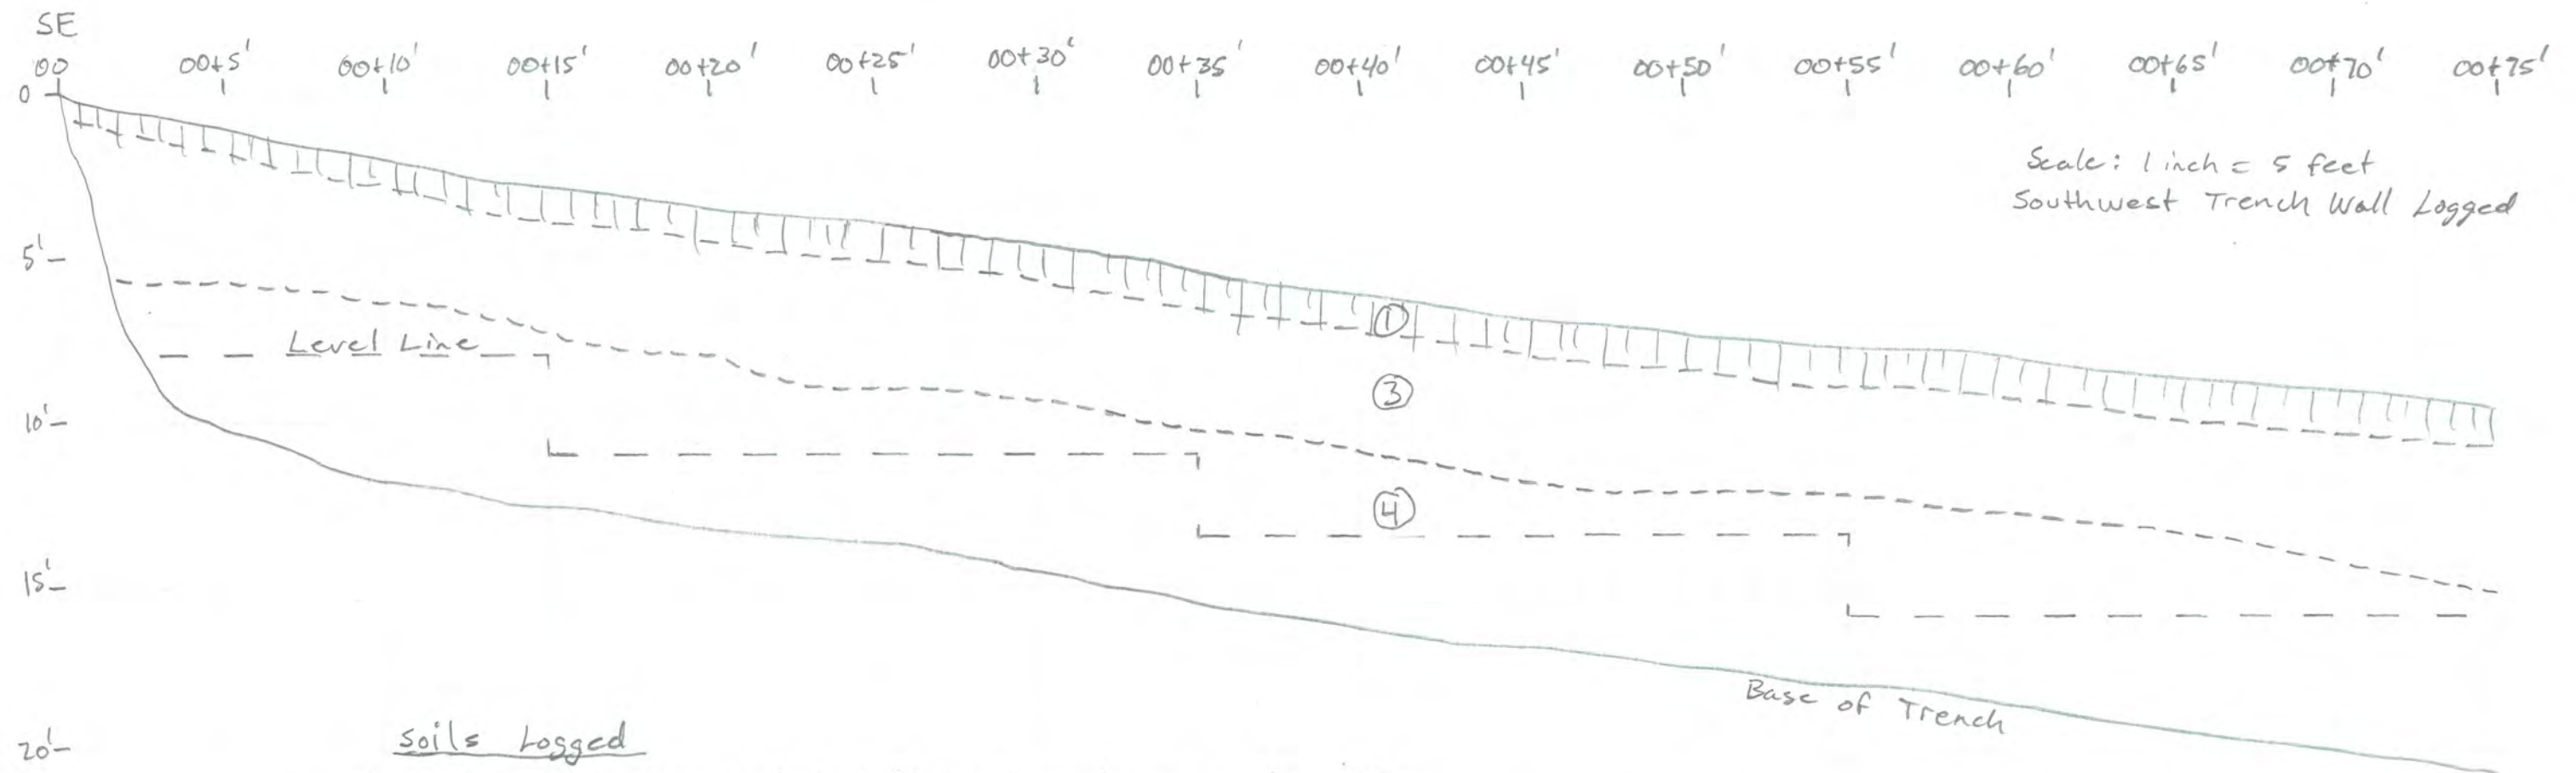
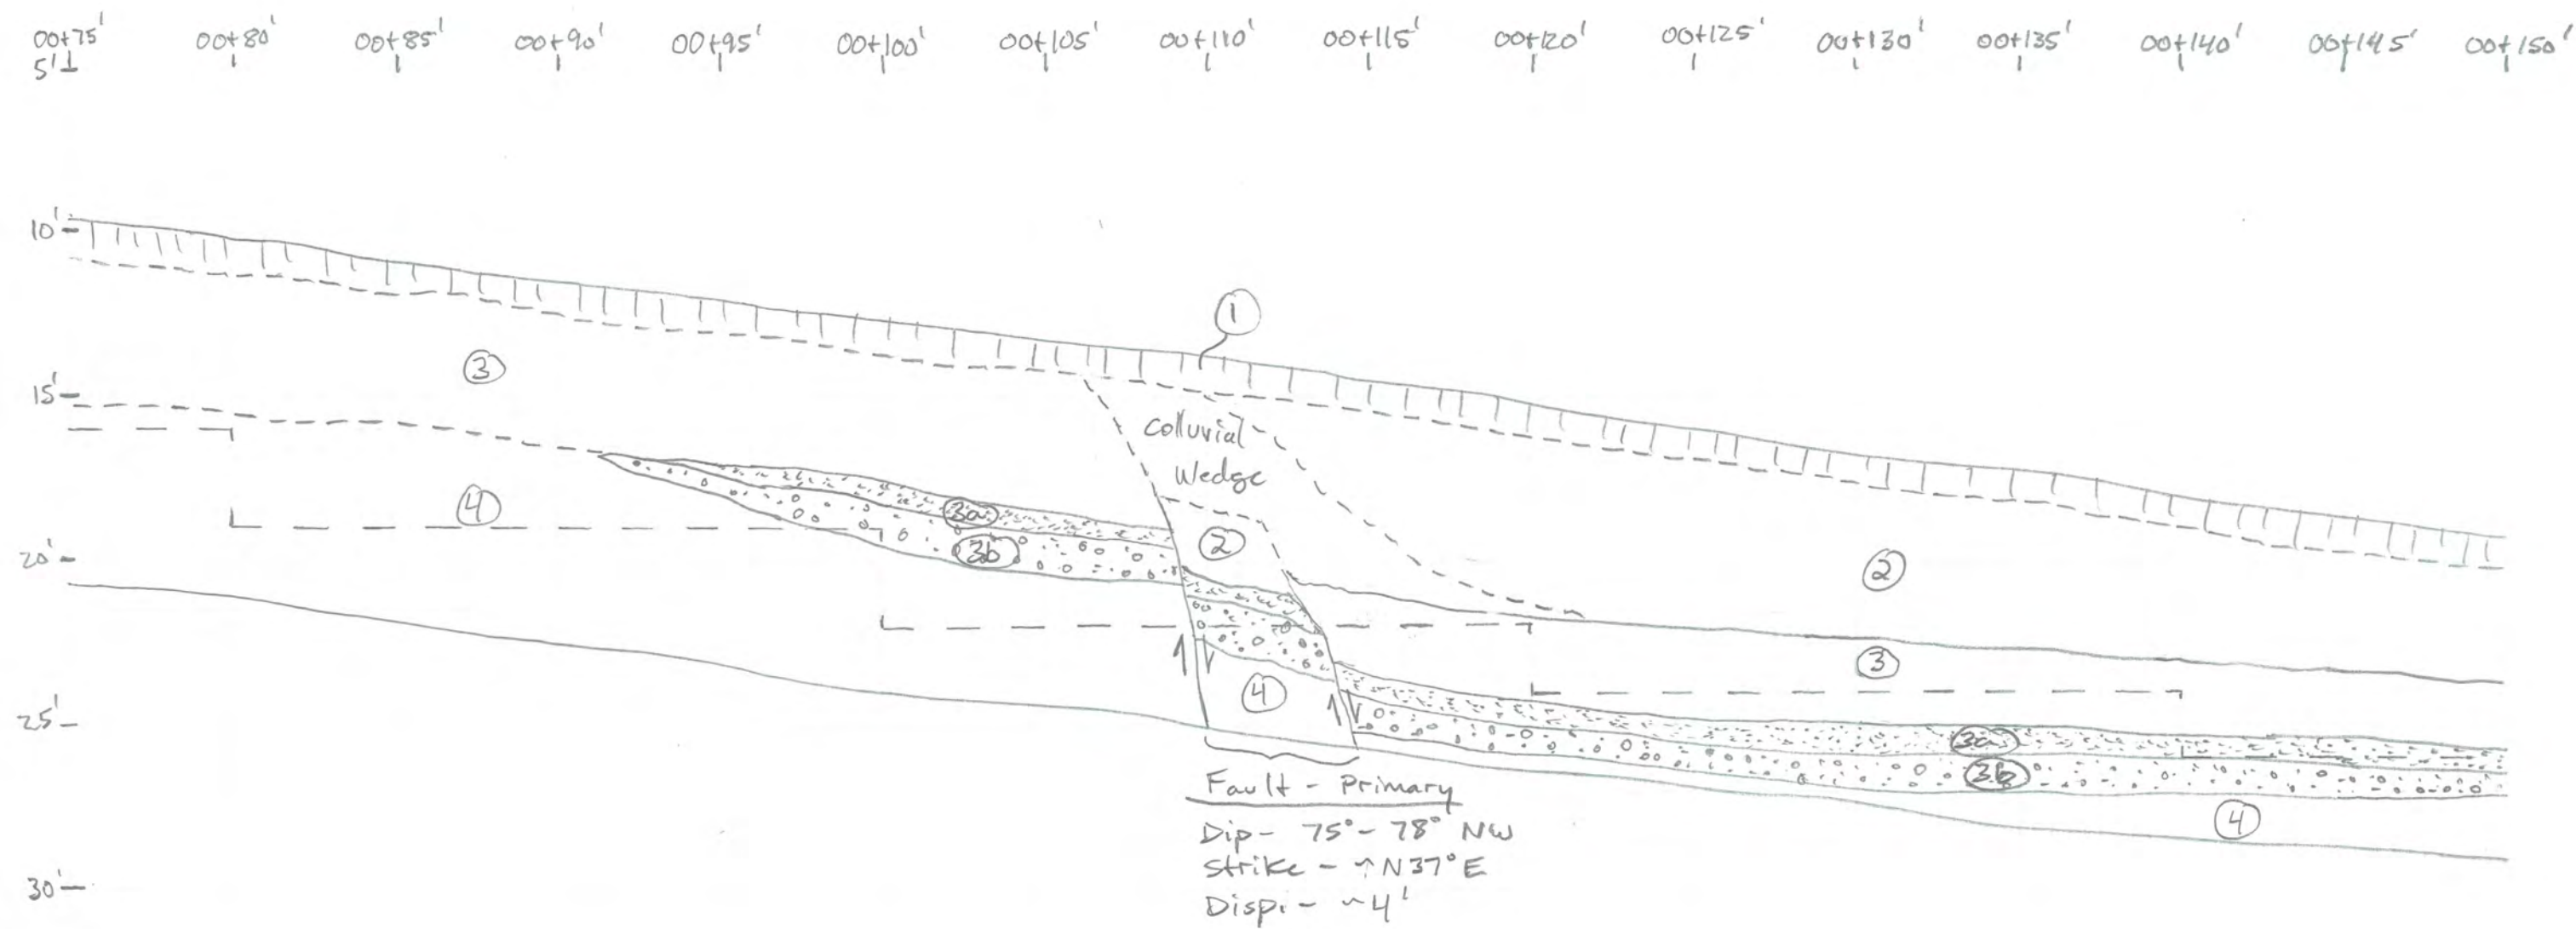
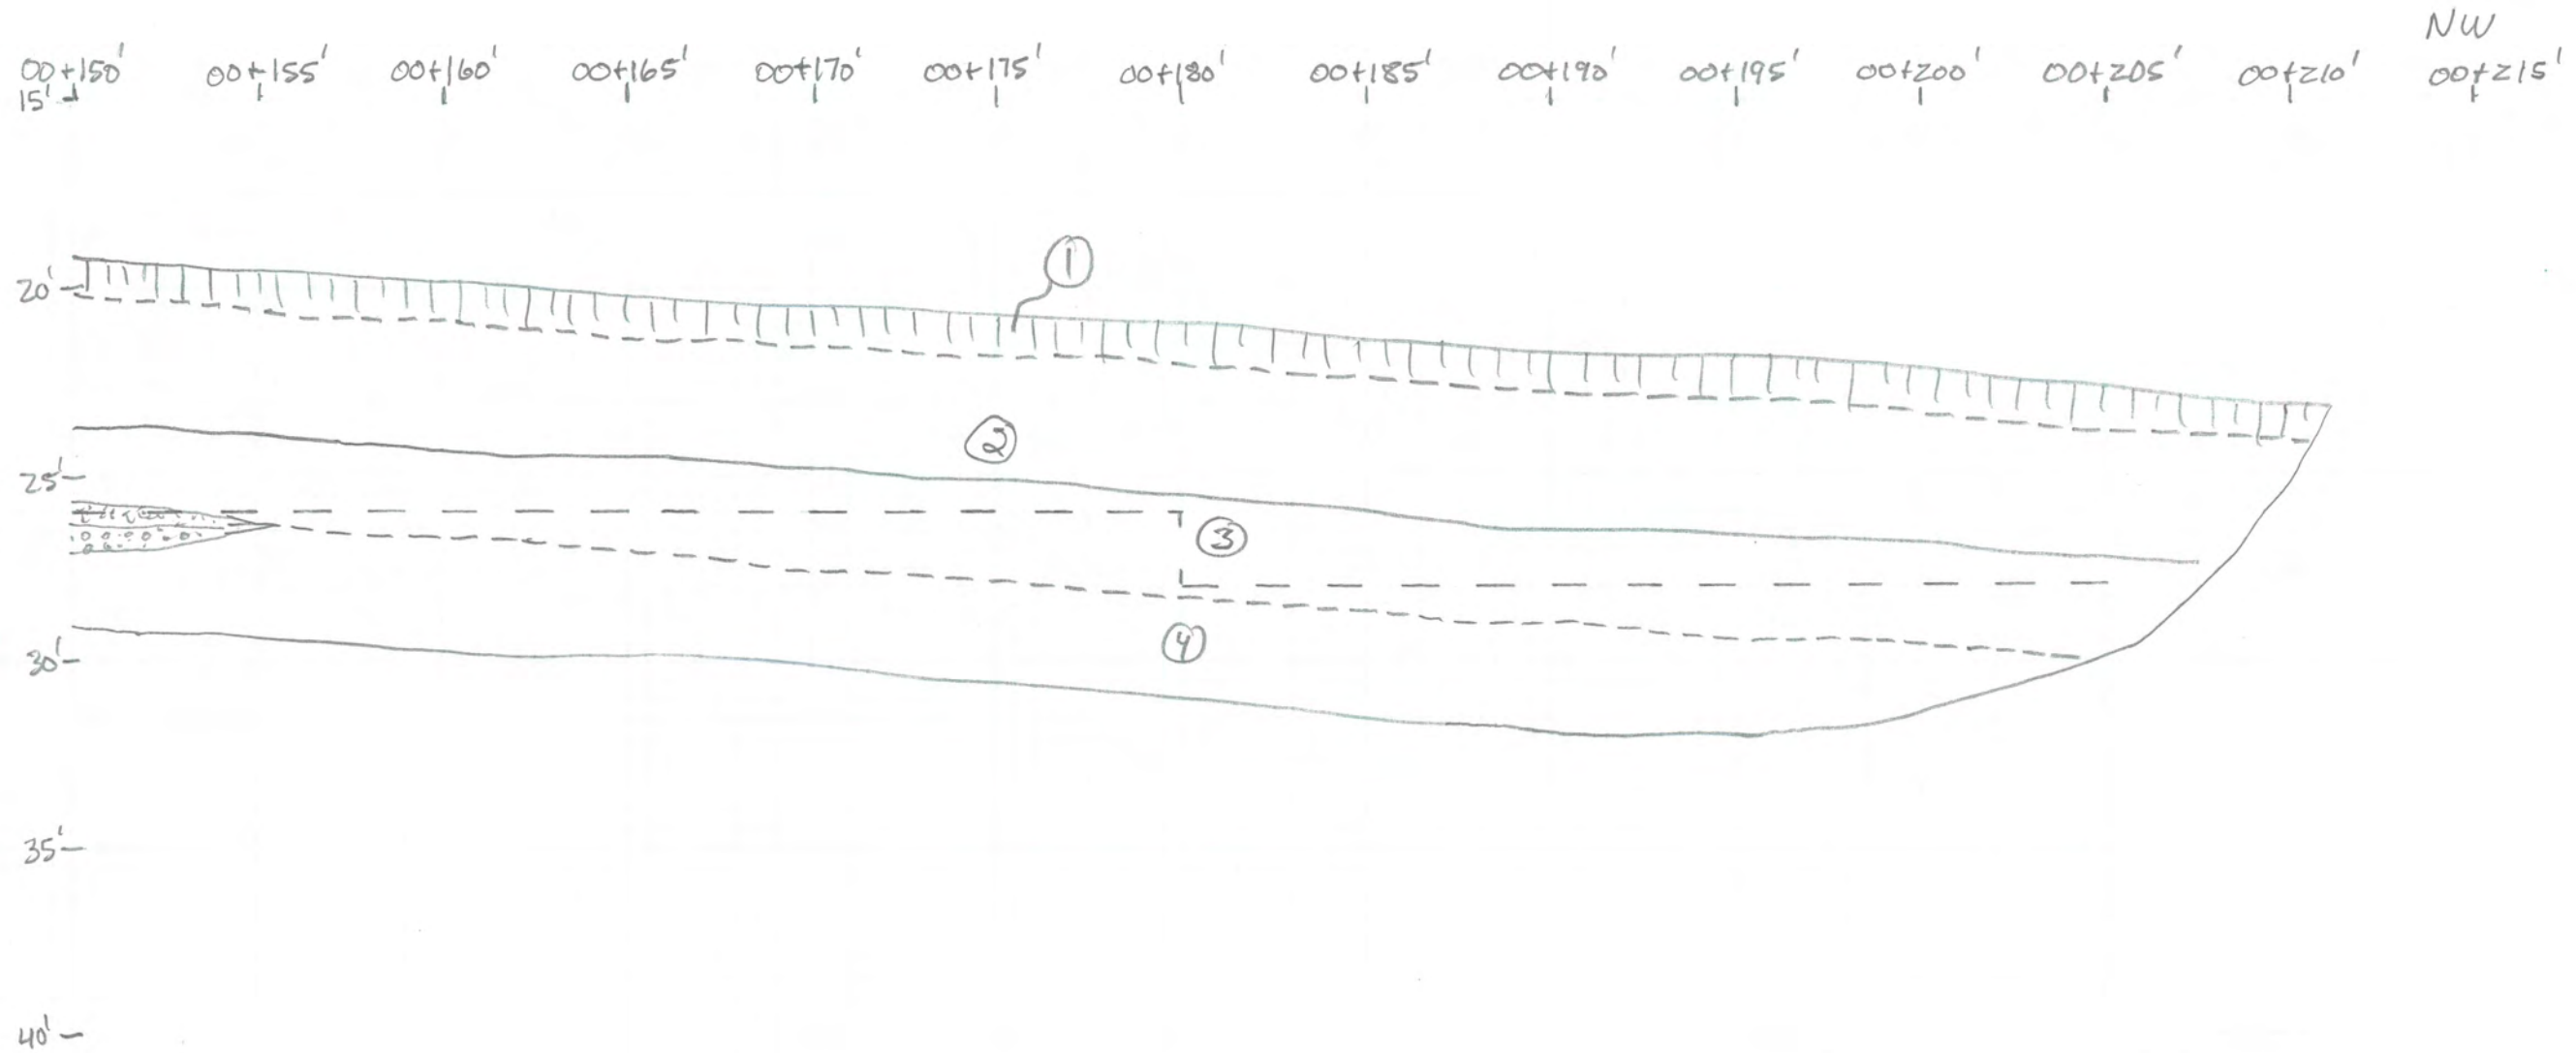
Figure 12

Trench Log, Trench ET-8 Santaquin Development, Santaquin, UT  
Logged By: Mark Larsen, P.G. 4/23/19

- 1.) Modern Topsoil - Soil A horizon formed on units 2 & 3.
- 2.) Younger Alluvial-Fan Deposits - Clayey gravel w/ sand and silt, pebble to a few small boulder-sized clasts, clasts are angular to subrounded, mostly matrix supported, brown.
- 3.) Alluvial-Fan Deposits - Clayey gravel w/ sand and silt, pebble to a few small boulder-sized clasts, clasts are angular to subrounded, matrix supported, brown to light-brown.
  - 3a.) Sand lense w/ pebble gravel.
  - 3b.) Gravel lense w/ silty sand.
- 4.) Alluvial-Fan Deposits - Clayey gravel w/ sand and silt, pebble to cobble-sized clasts, clasts are angular to subrounded, matrix supported, brown.

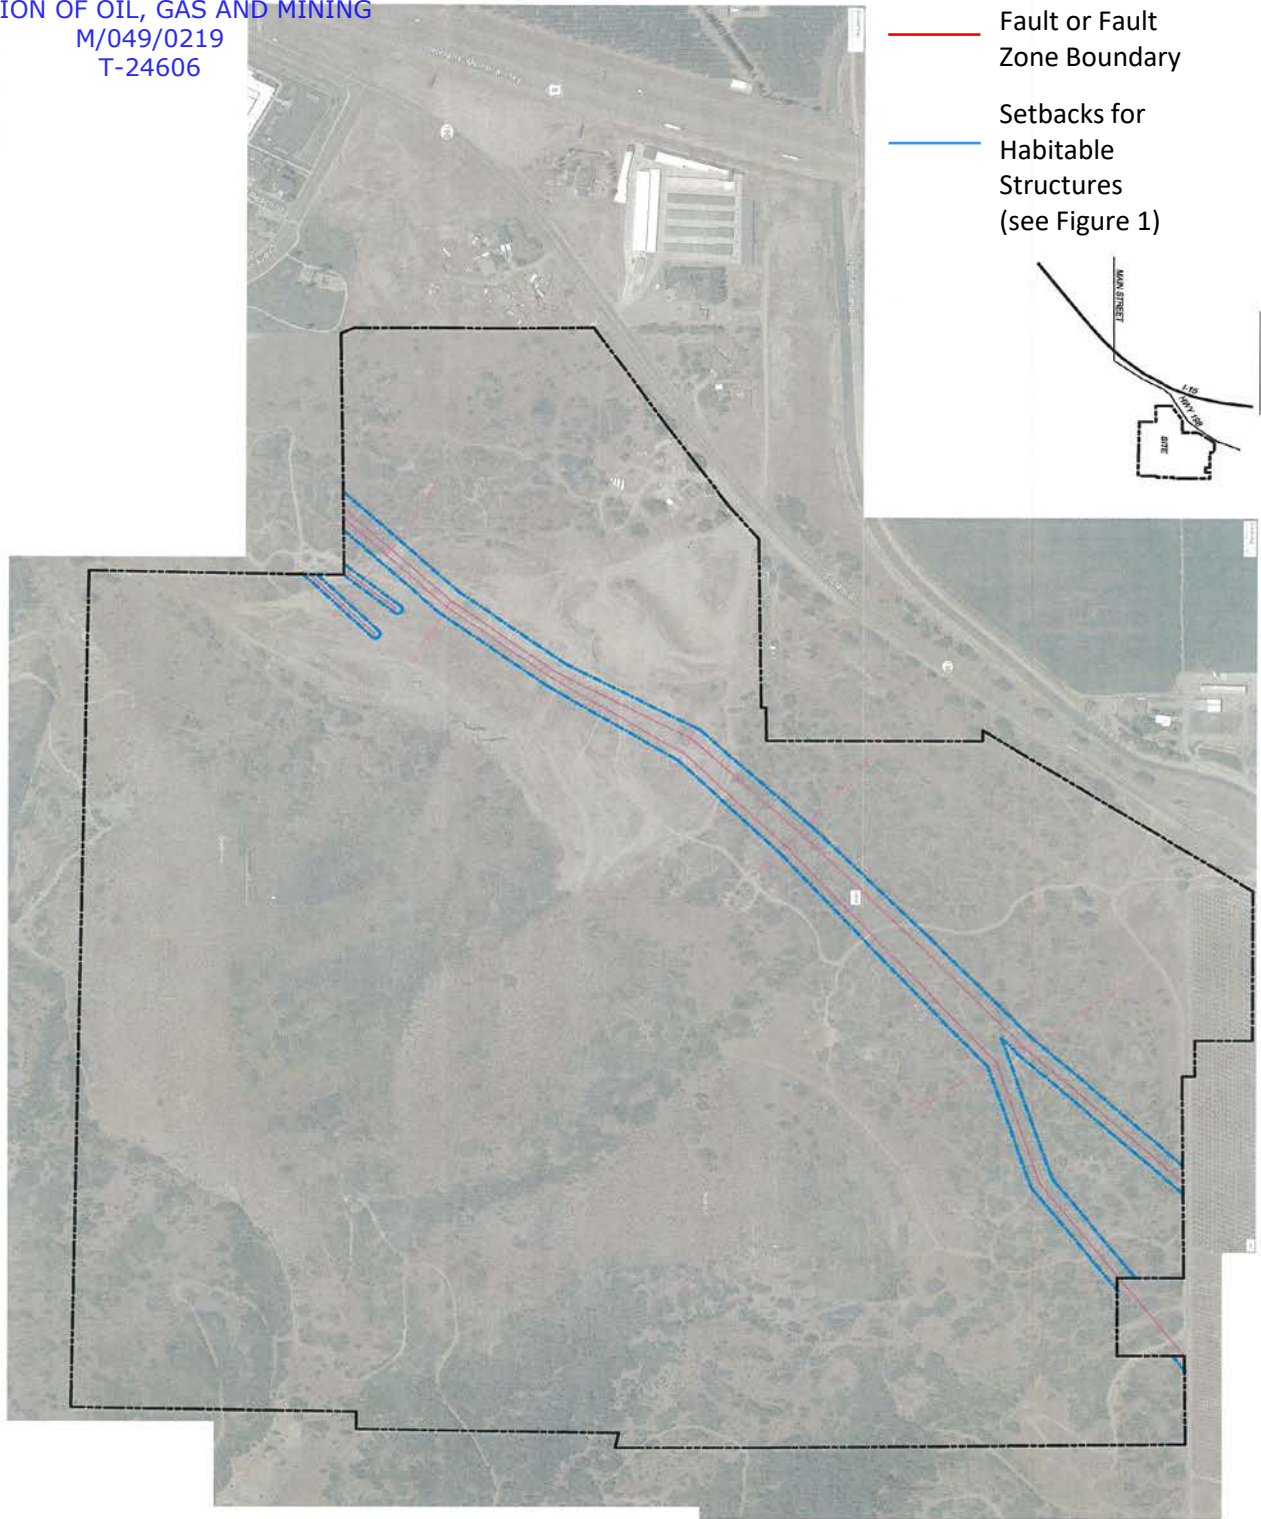
Fault or Fault  
 Zone Boundary

Setbacks for  
 Habitable  
 Structures  
 (see Figure 1)

The locations of the zone of faulting observed in the exploration trenches at the site were marked during our field work and later surveyed by the client. Based on these locations, along with information provided in our review of the previous geologic mapping by Solomon (2010, 2010), DEM model (Figure 4) and reviewed aerial photographs, the zone of surface faulting associated with the northern stand of the Nephi Segment of the WFZ crossing the site was mapped. The mapped zone of faulting is shown on **Figure 14, Fault and Setback Map**. The recommended building setbacks in relation to the zone of faulting are also shown on **Figure 1** in relation to the proposed development at the site. The zone of faulting and/or individual traces of the fault are mapped as red lines on **Figure 14**.
