### NOTICE OF INTENTION TO COMMENCE LARGE MINING OPERATIONS

### **Geotechnical study**

## GEOLOGIC HAZARDS INVESTIGATION

Subject: Geologic Hazards Investigation  
Santaquin Heights  
Approximately 650 North State Road 198  
Santaquin, Utah  
CMT Project Number: 12330

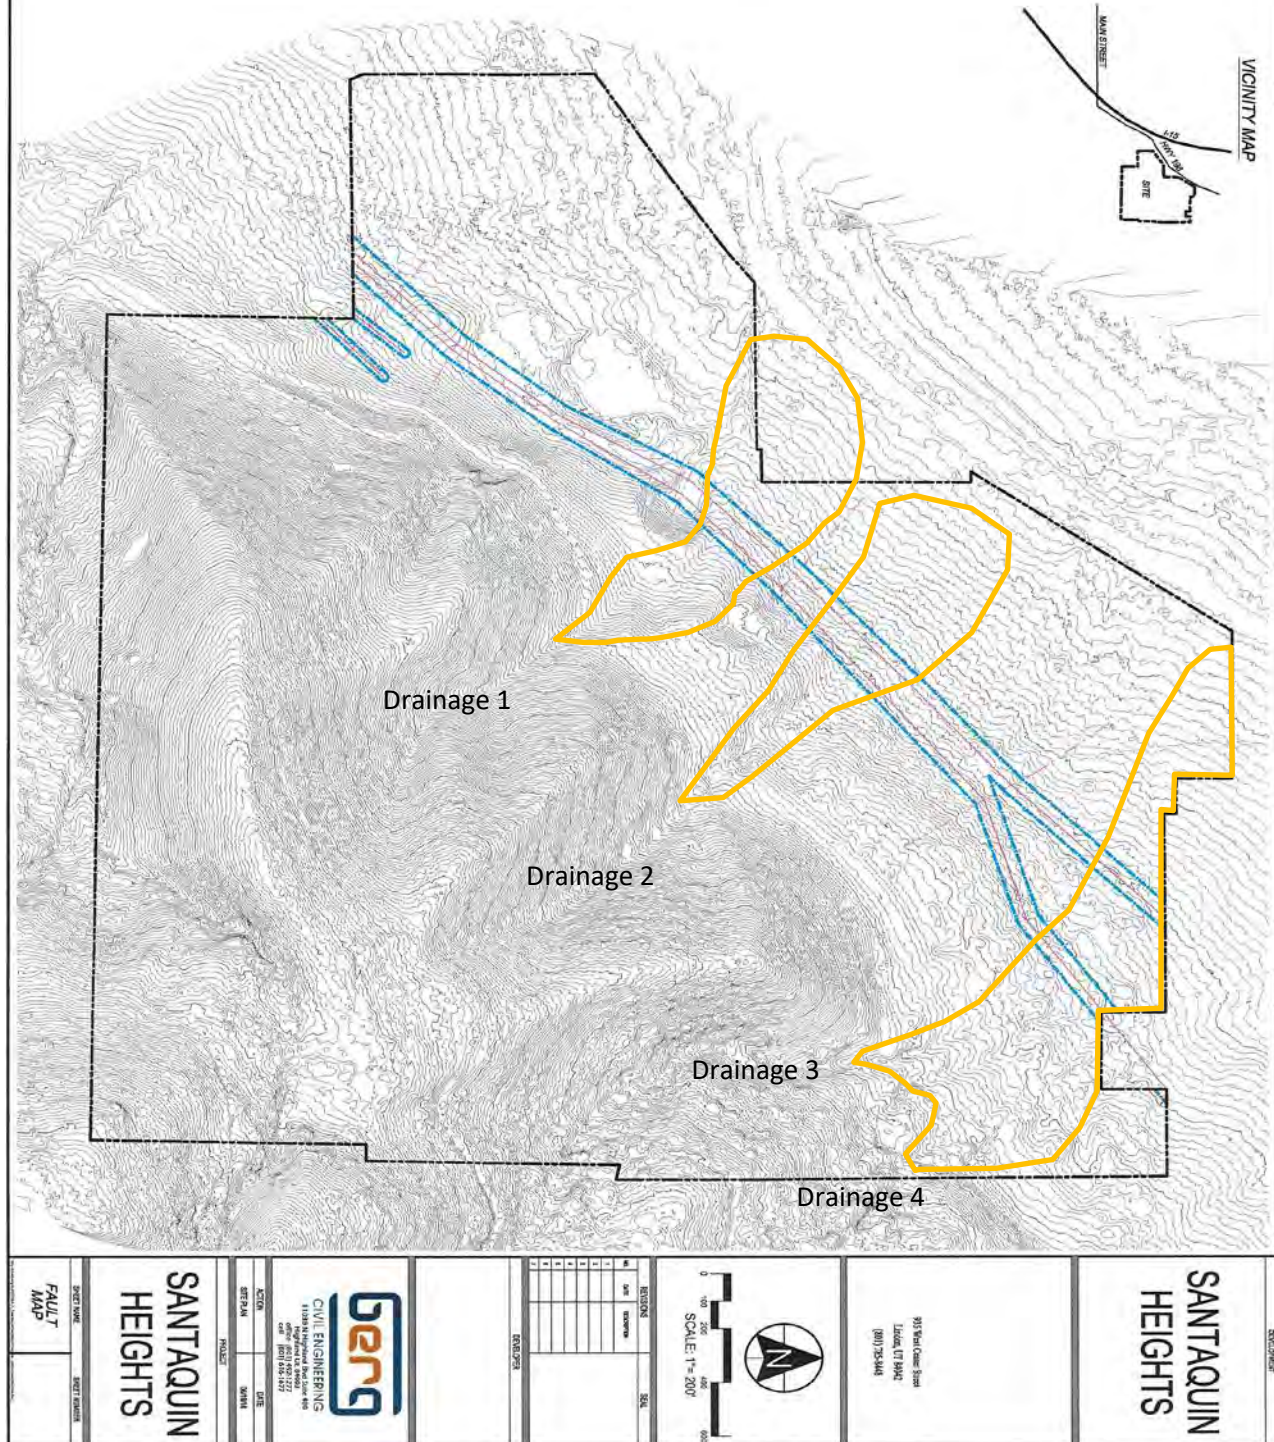
Potential Debris Flow  
 and Fan Flooding Area
